Condition Survey Report

ND/2019/05 - Condition Survey for Fanling North New Development Area, Phase 1 Fanling Bypass Eastern Section (Shung Him Tong to Kau Lung Hang)

Reference No.
Prepared for CRCC – Paul Y. Joint Venture
24 July 2020

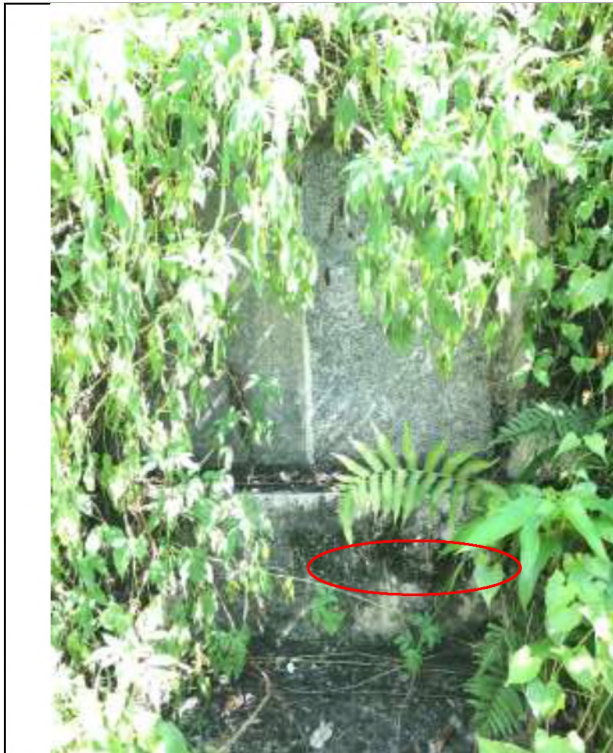
1A-D1(1) - Moderate Crack on Tablet
(General View)

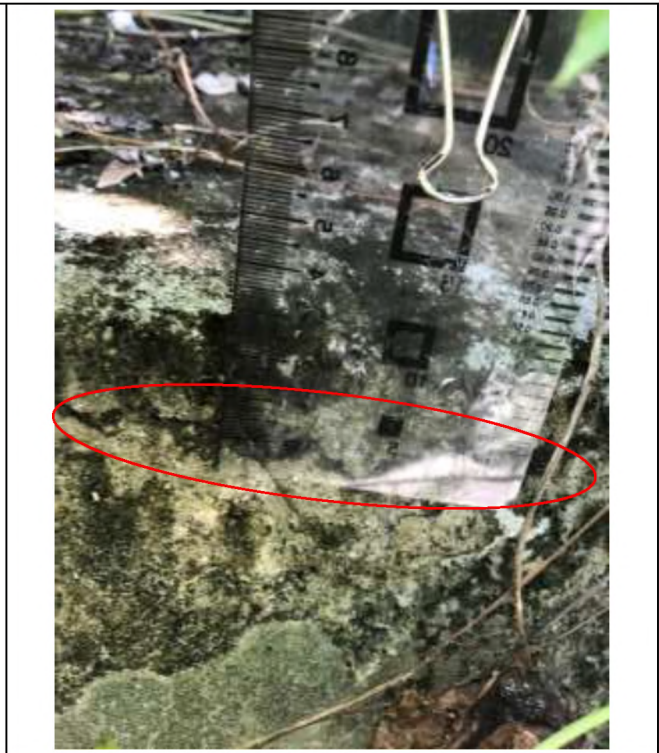
1A-D1(2) - Moderate Crack on Tablet
(Length:300mm/Width:2mm)

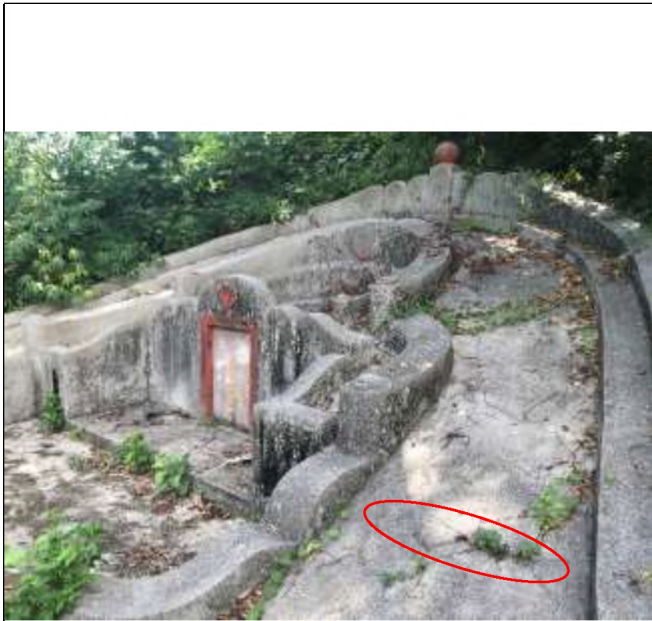
2A-D1(1) - Moderate Crack on Surface
(General View)

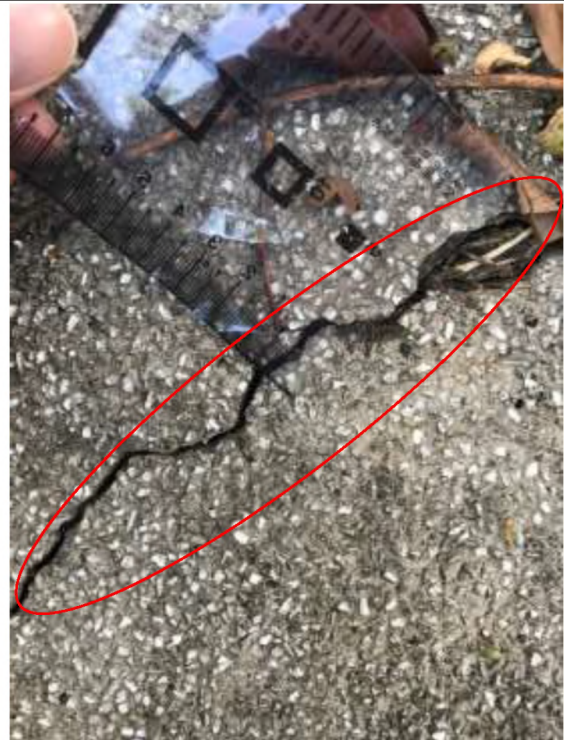
2A-D1(2) - Wide Crack on Surface
(Length:1000mm/Width:2.5mm)

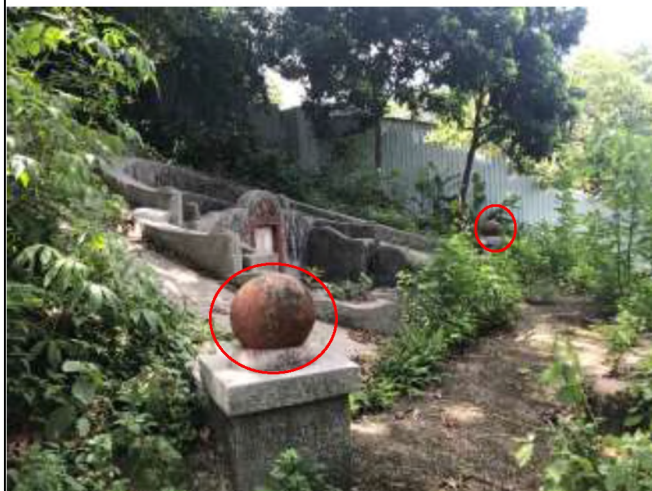
2A-D2(1) - Peeling Paint from Surface
(General View)

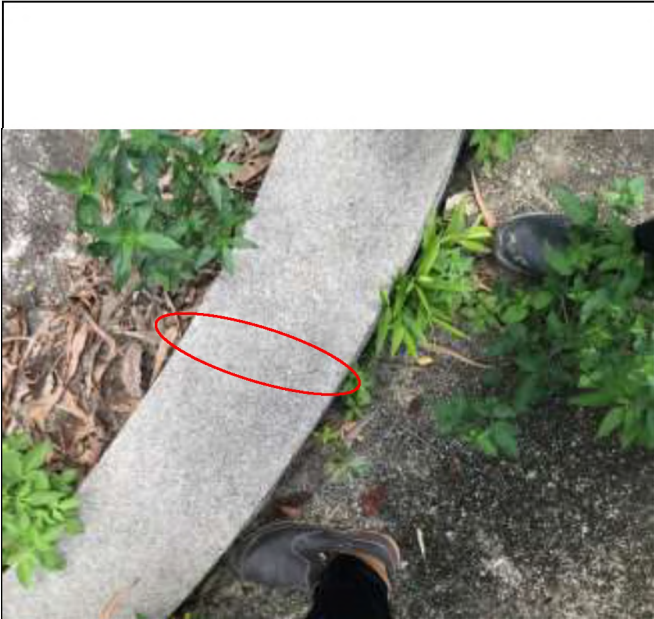
2A-D3(1) - Fine Crack on Surface
(General View)

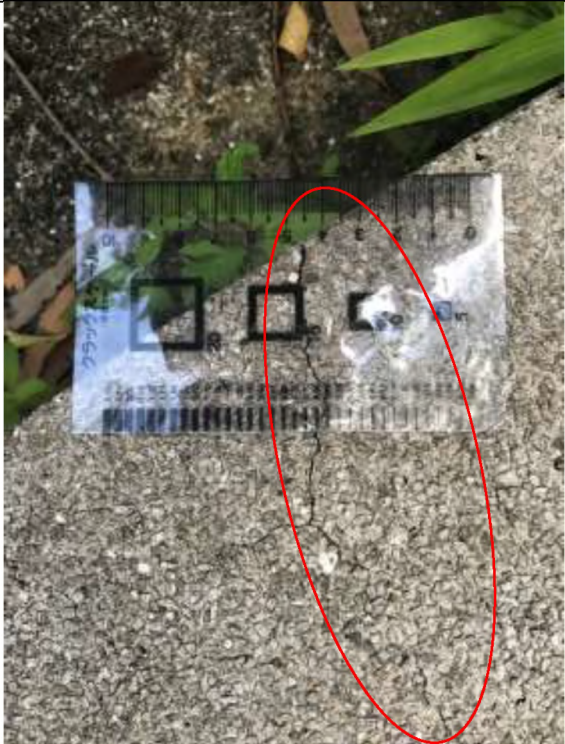
2A-D3(2) - Fine Crack on Surface
(Length:200mm/Width:0.65mm)

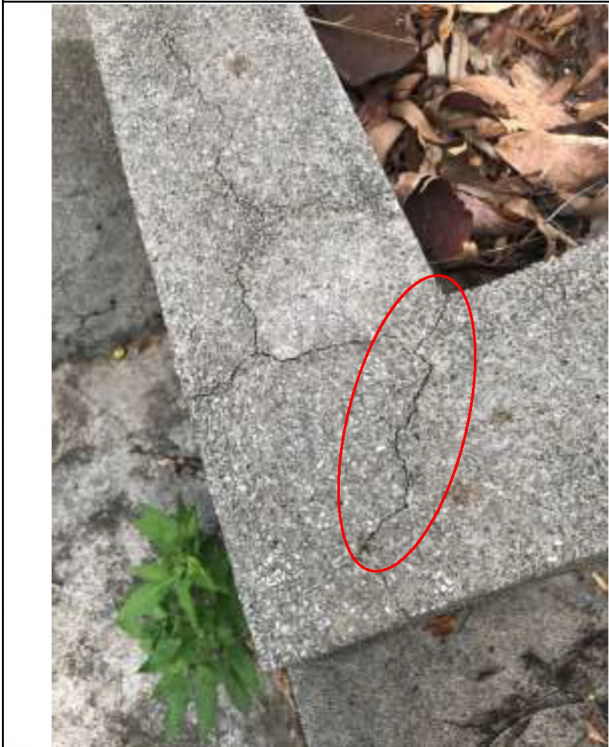
2A-D4(1) - Fine Crack on Surface
(General View)

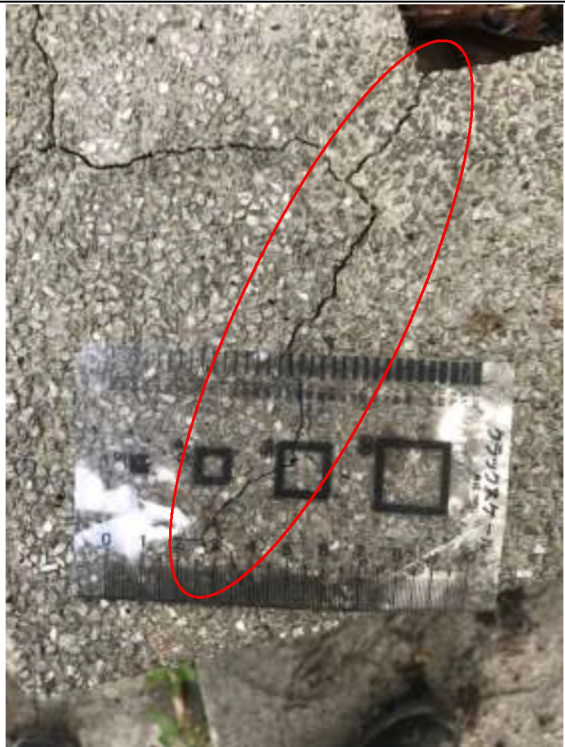
2A-D4(2) - Fine Crack on Surface
(Length:200mm/Width:0.80mm)

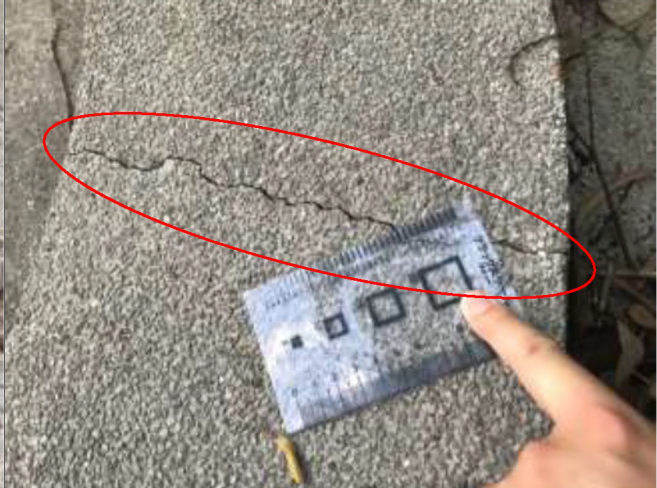
2A-D5(1) - Moderate Crack on Surface (General View)	2A-D5(2) - Moderate Crack on Surface (Length:250mm/Width:1.20mm)

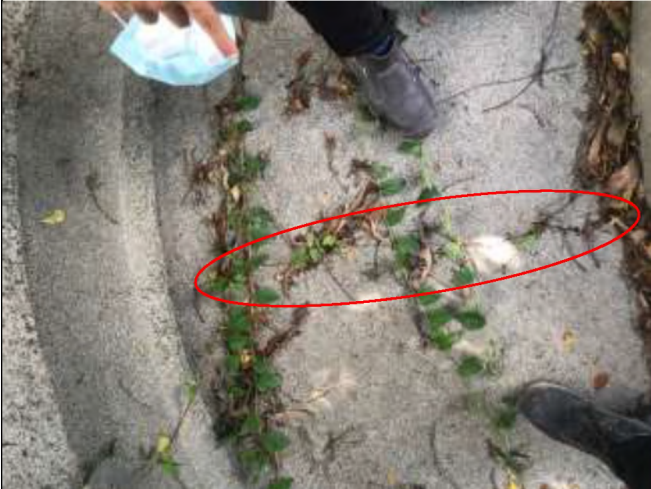
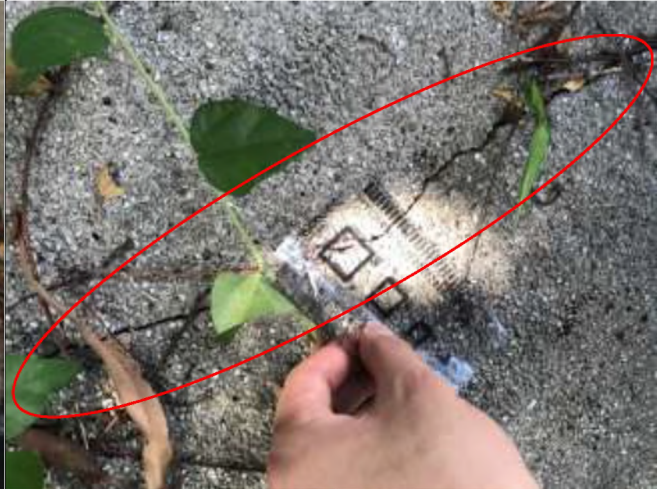
2A-D6(1) - Moderate Crack on Surface (General View)	2A-D6(2) - Moderate Crack on Surface (Length:1200mm/Width:1.50mm)

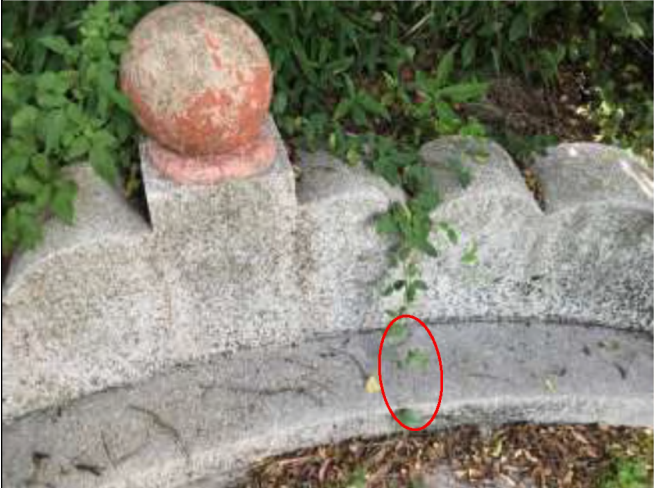
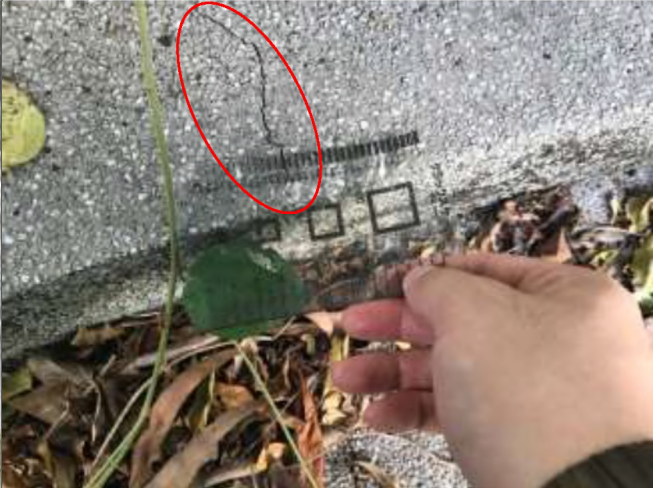
<p>2A-D7(1) - Fine Crack on Surface (General View)</p>	<p>2A-D7(2) - Fine Crack on Surface (Length:250mm/Width:0.60mm)</p>

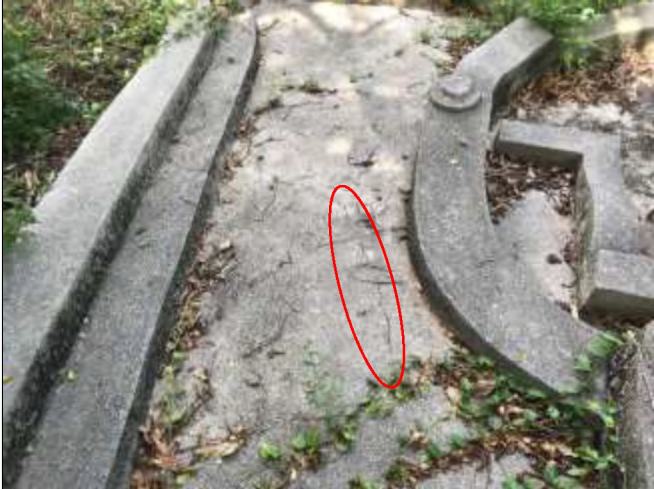
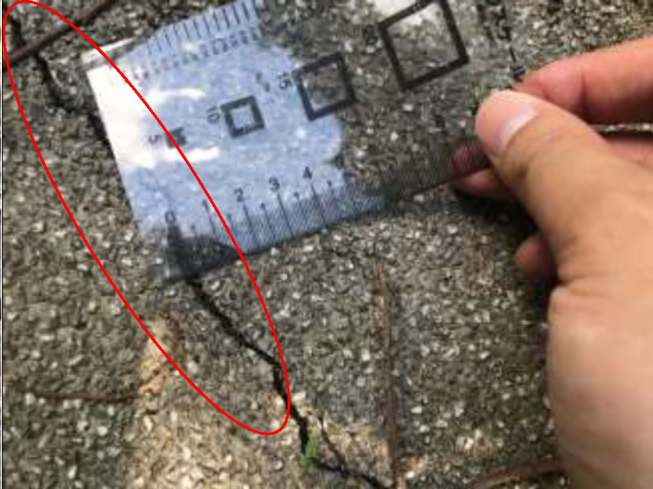
<p>2A-D8(1) - Wide Crack on Surface (General View)</p>	<p>2A-D8(2) - Wide Crack on Surface (Length:1200mm/Width:3.00mm)</p>

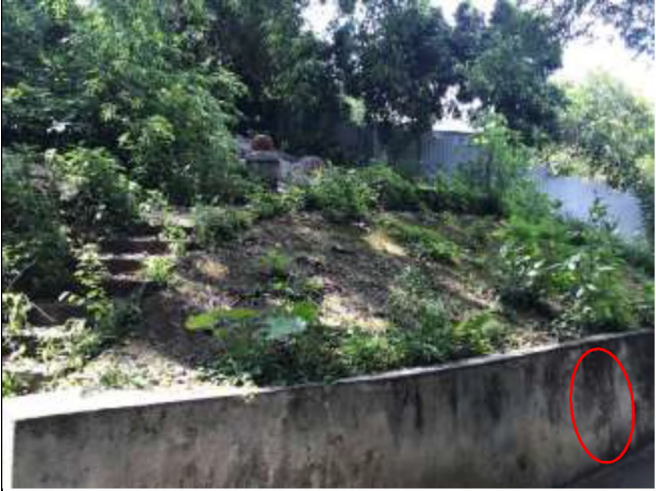
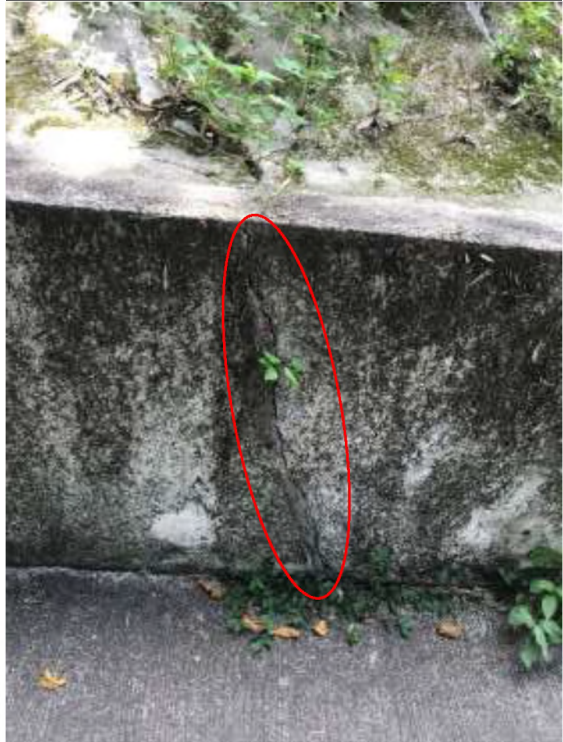
<p>2A-D9(1) - Wide Crack on Surface (General View)</p>	<p>2A-D9(2) - Wide Crack on Surface (Length:1000mm/Width:3.00mm)</p>

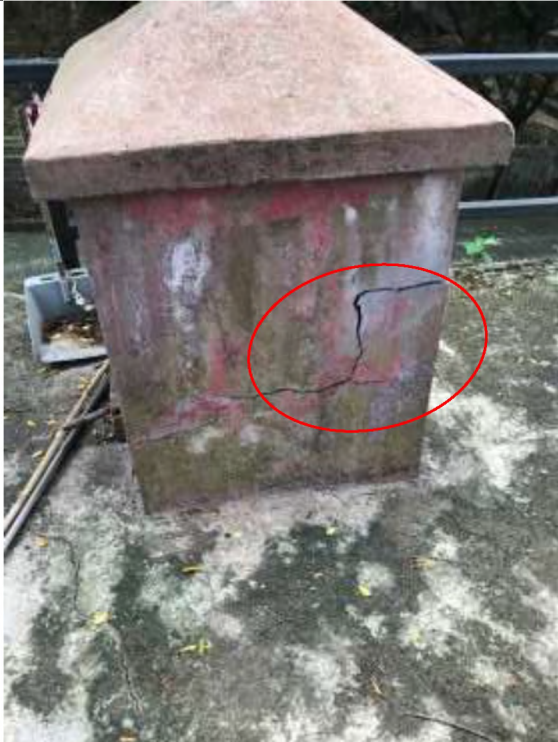
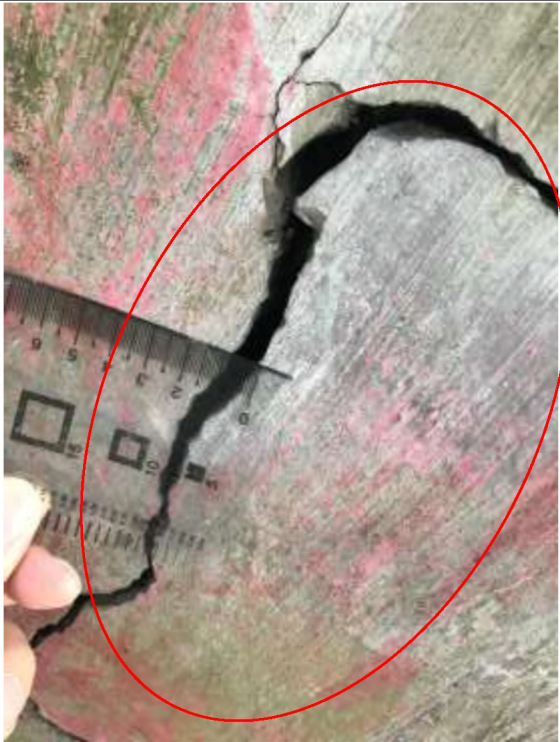
<p>3A-D1(1) - Moderate Crack on Surface (General View)</p>	<p>3A-D1(2) - Wide Crack on Surface (Length:1000mm/Width:2.00mm)</p>

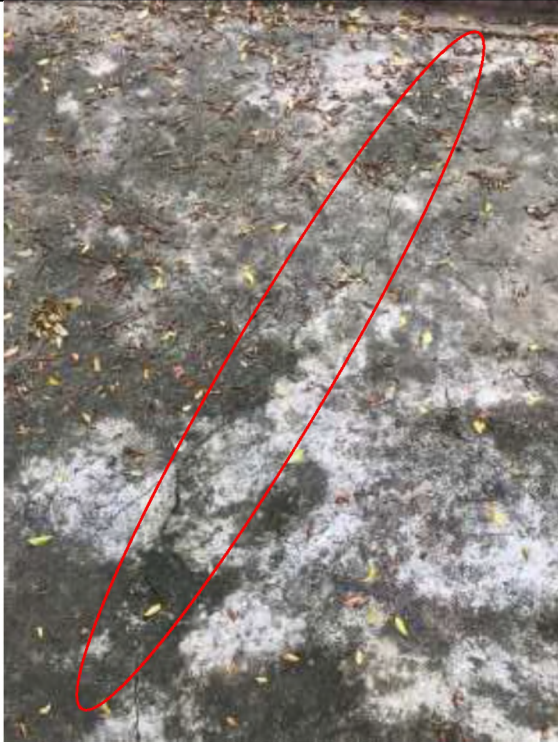
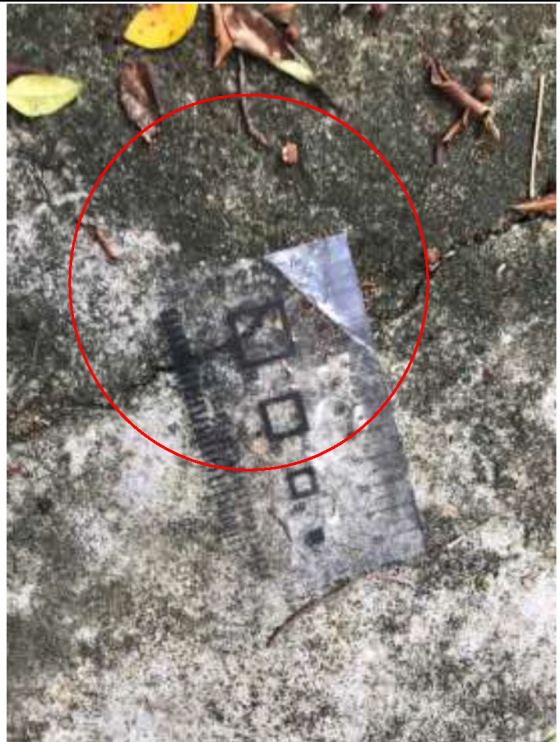
<p>3A-D2(1) - Moderate Crack on Floor (General View)</p>	<p>3A-D2(2) – Moderate Crack on Floor (Length:3000mm/Width:1.10mm)</p>

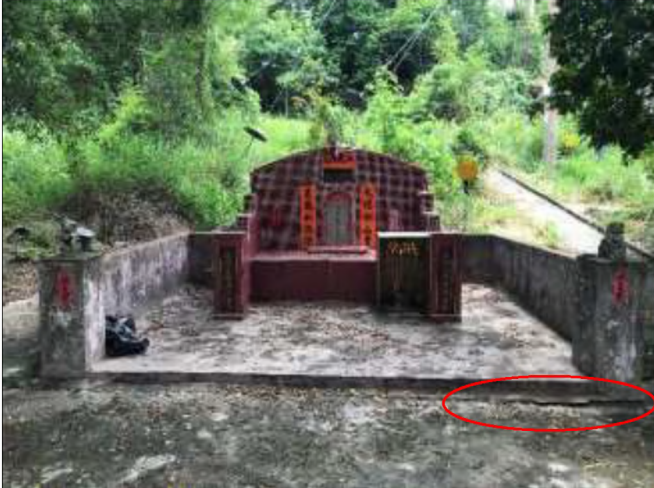
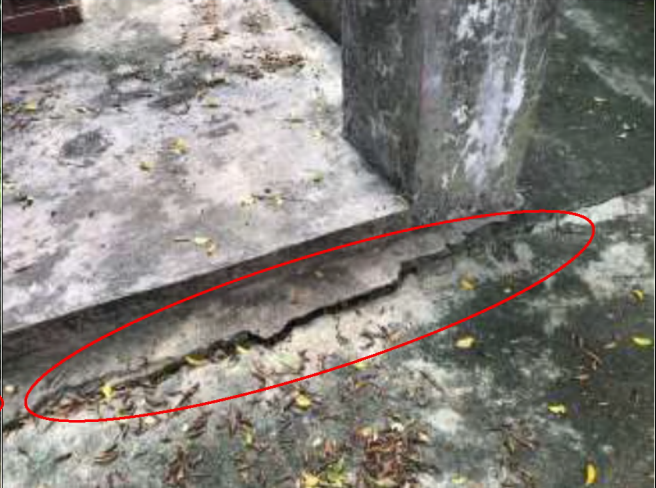
<p>3A-D3(1) - Shoving on Floor Surface (General View)</p>	<p>3A-D3(2) - Shoving on Floor Surface</p>

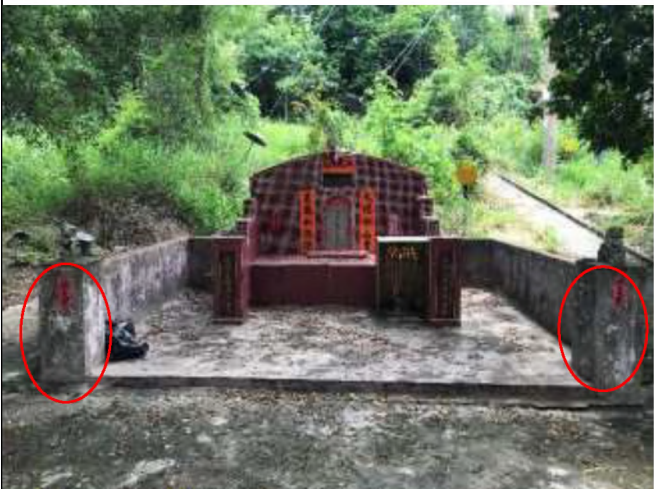
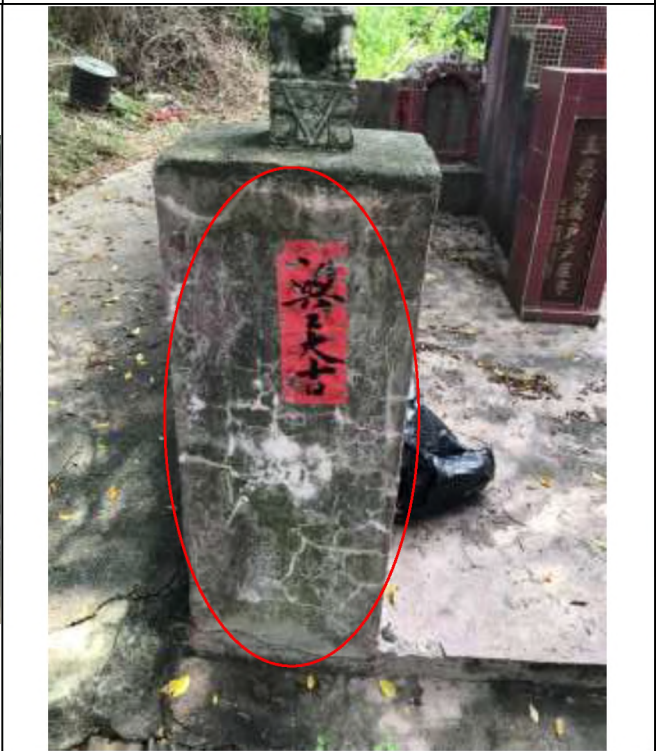
<p>3A-D4(1) - Fine Crack on Surface (General View)</p>	<p>3A-D4(2) - Ravelling on Surface</p>

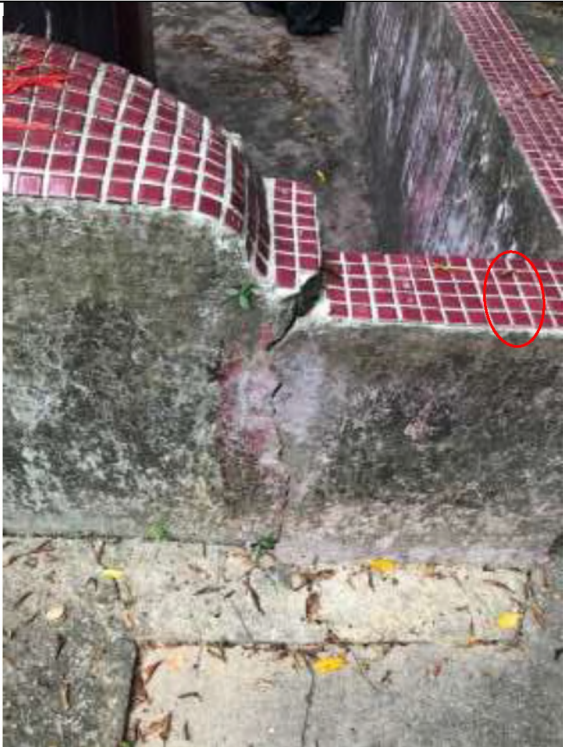
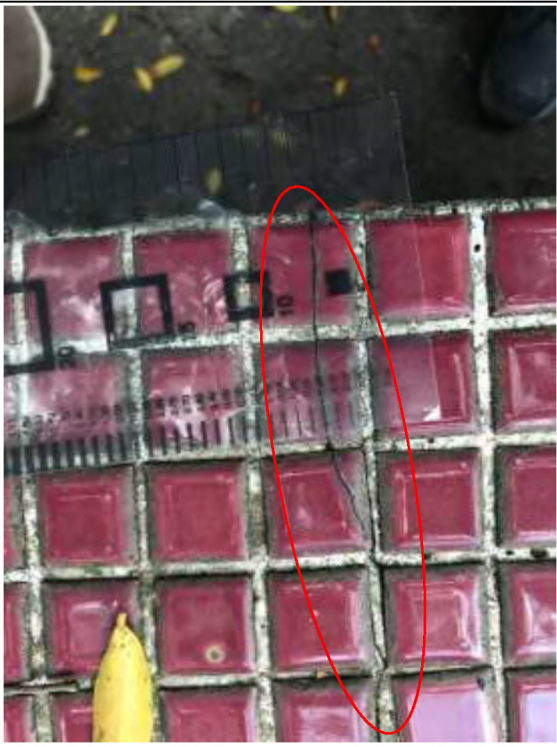
<p>3A-D9(1) - Fine Crack on Surface (General View)</p>	<p>3A-D9(2) - Fine Crack on Surface (Length:100mm/Width:0.20mm)</p>

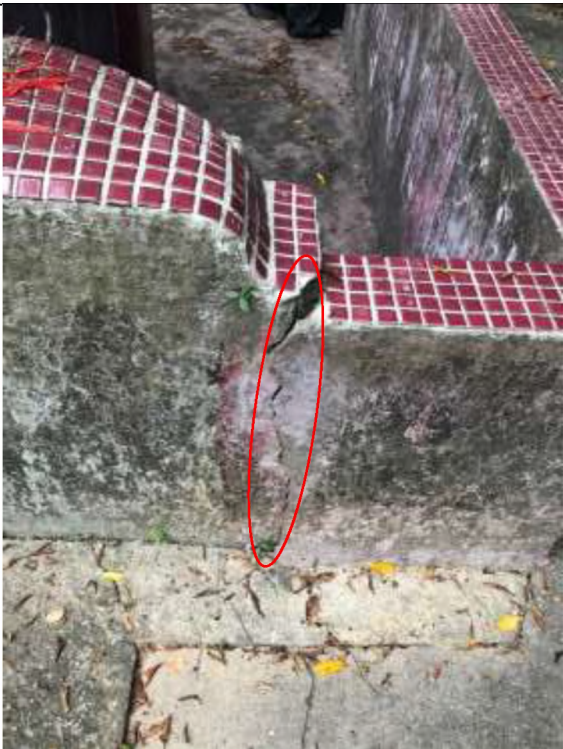
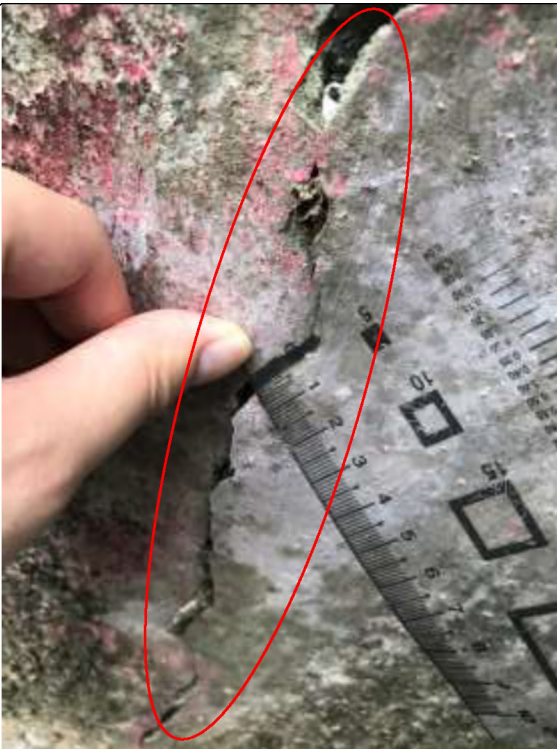
<p>3A-D10(1) - Wide Crack on Surface (General View)</p>	<p>3A-D10(2) - Wide Crack on Surface (Length:800mm/Width:3.40mm)</p>

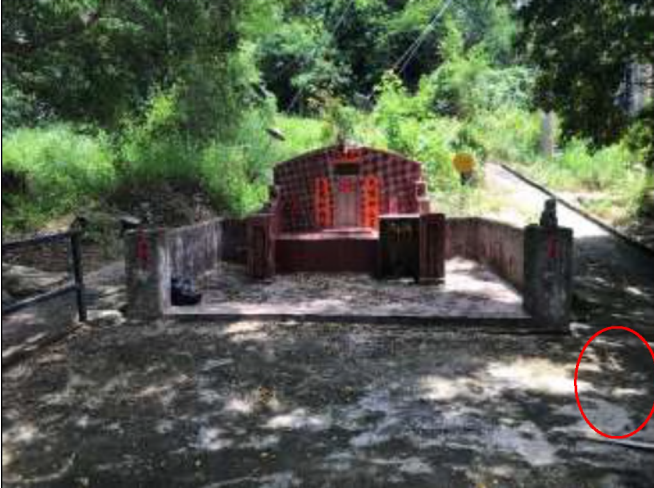
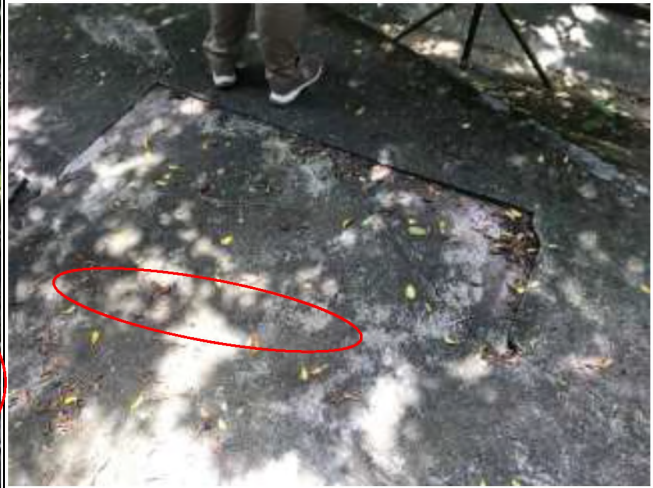
<p>3A-D13(1) - Ravelling on Floor Surface (General View)</p>	<p>3A-D13(1) - Ravelling on Floor Surface</p>

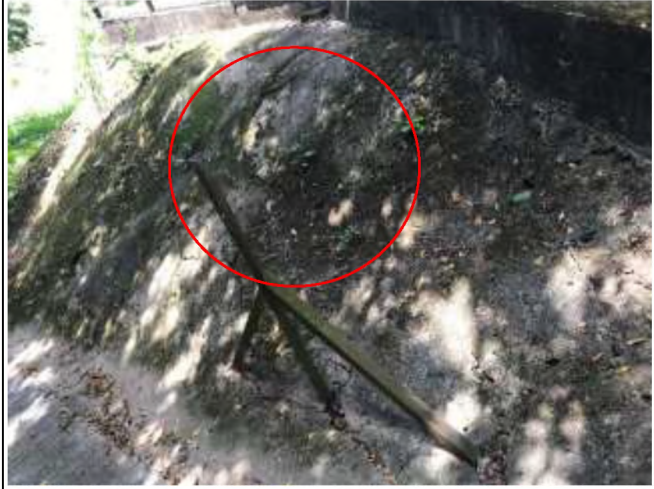
<p>3A-D14(1) - Wide Crack on Slope (General View)</p>	<p>3A-D14(2) - Wide Crack on Slope (Width:8.00mm)</p>

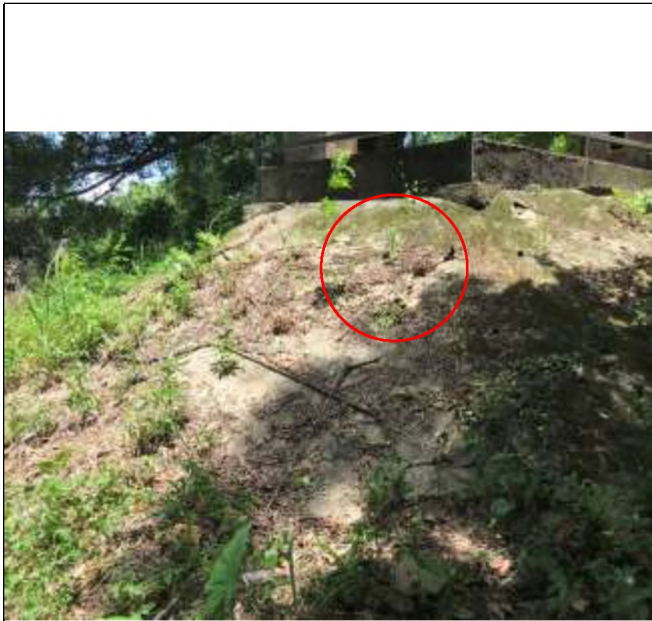
3A-D15(1) - Wide Crack on Slope
(General View)

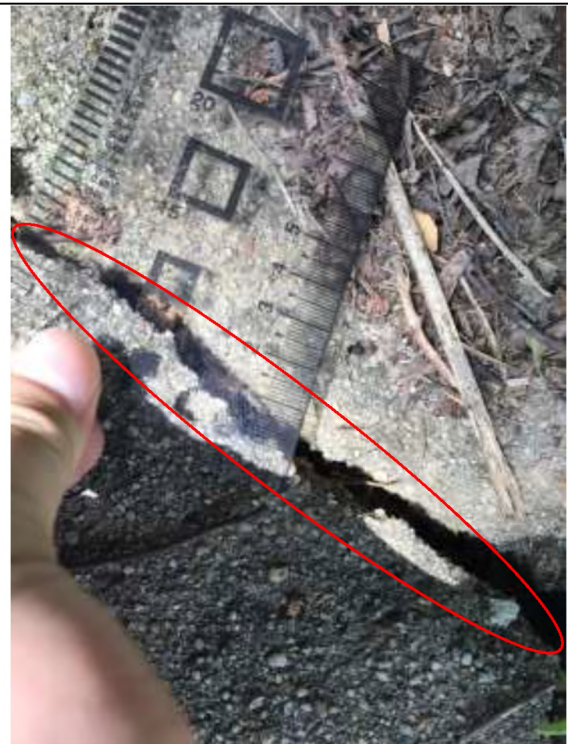
3A-D15(1) – Wide Crack on Slope
(Length:600mm/Width:5.00mm)

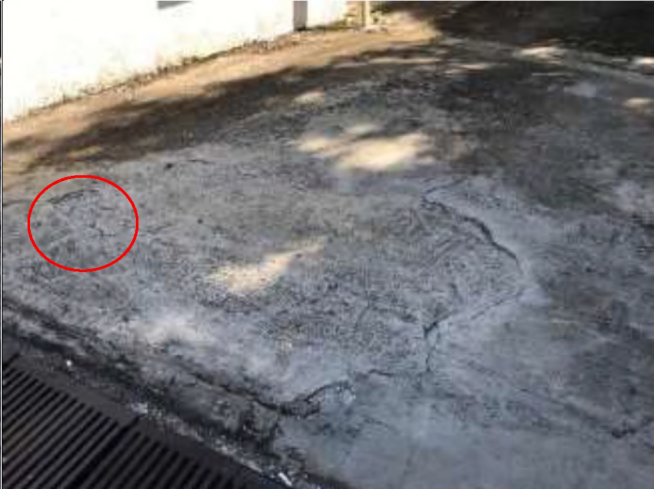
<p>4A-D2- Moderate Crack on Floor (Length:200mm/Width:2.50mm)</p>	<p>4A-D3(1) – Spalling on Floor Surface</p>

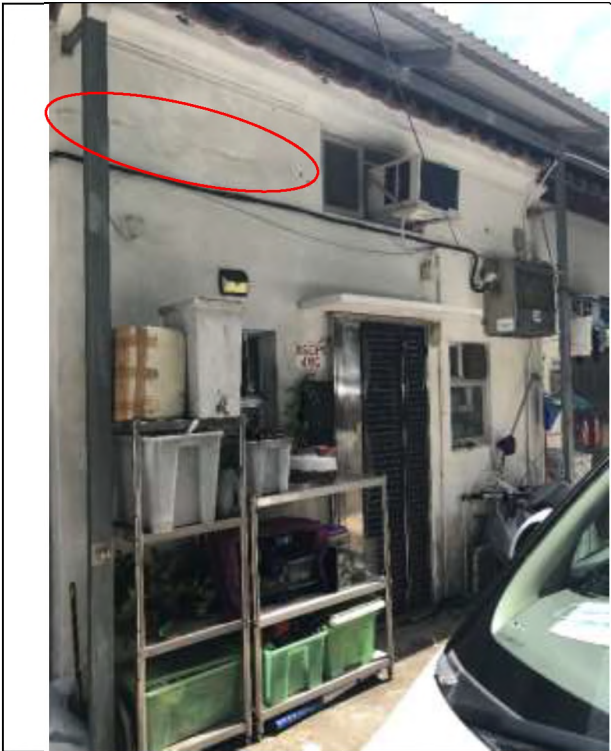
5A2-D1(1) - Crack on Surface

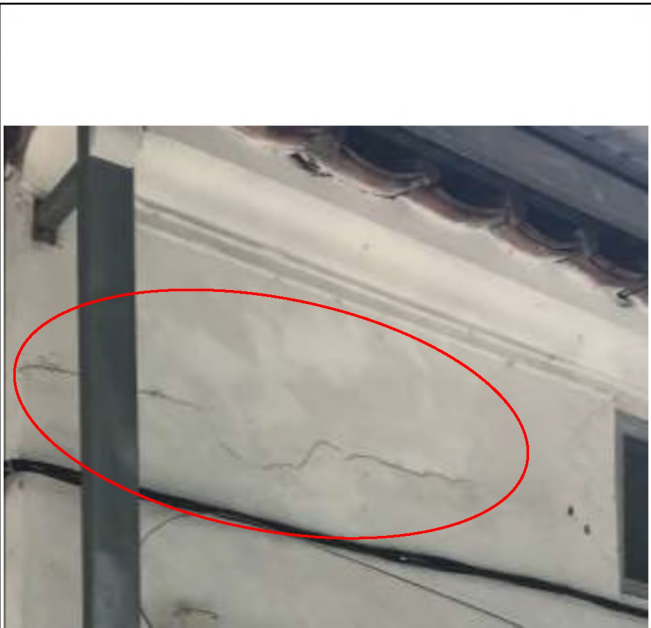
5A2-D1(2) - Crack on Surface

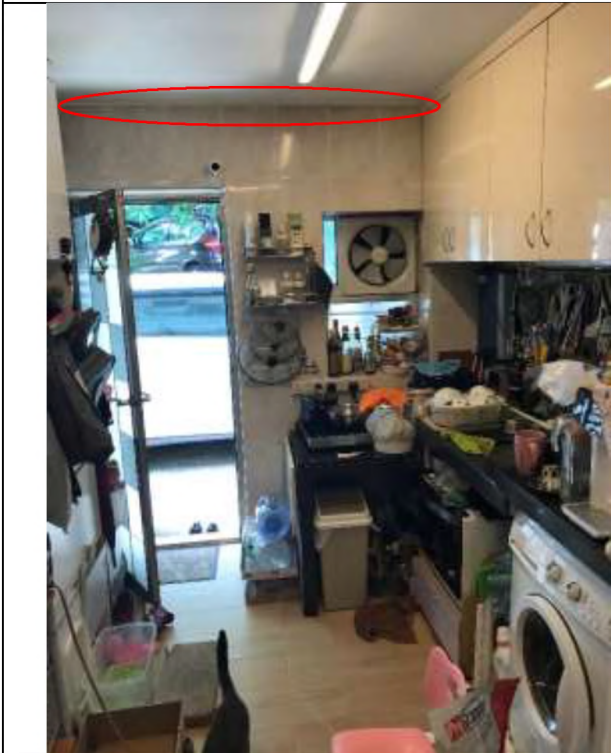
5A2-D2(1) – Spalling between Wall & Ceiling

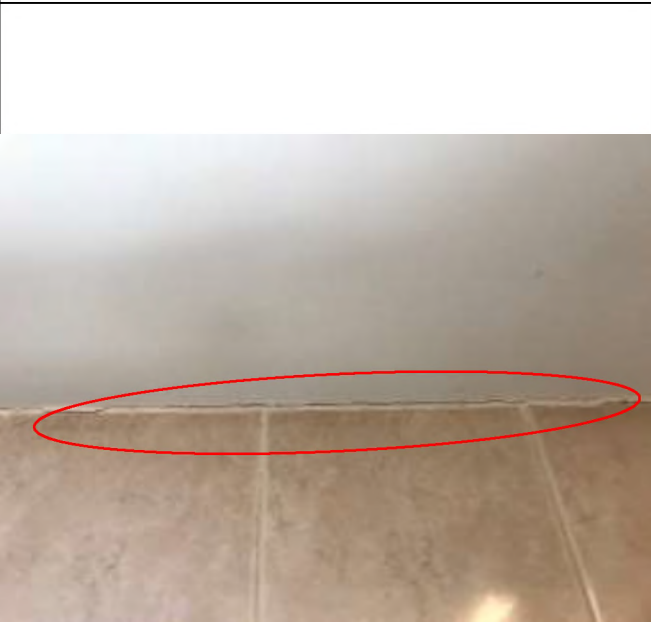
5A2-D2(2) – Spalling between Wall & Ceiling

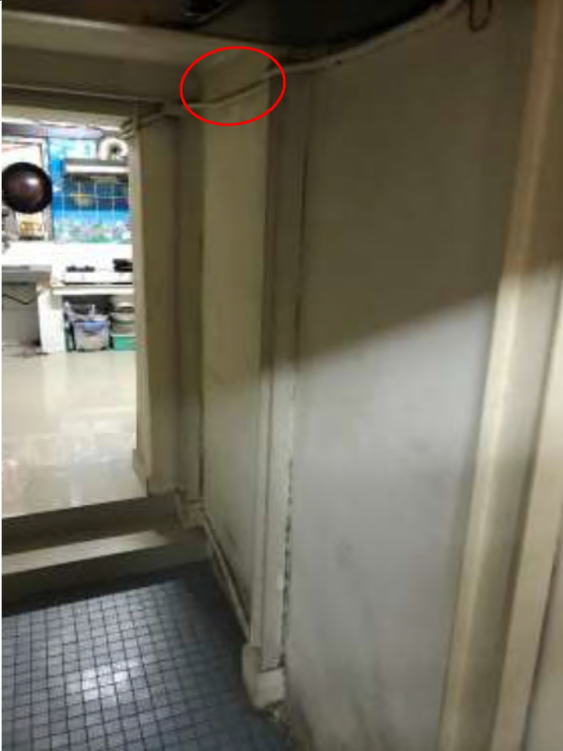
<p>5A3-D1(1) - Water Stain on Surface (General View)</p>	<p>5A3-D1(2) – Water Stain on Surface</p>

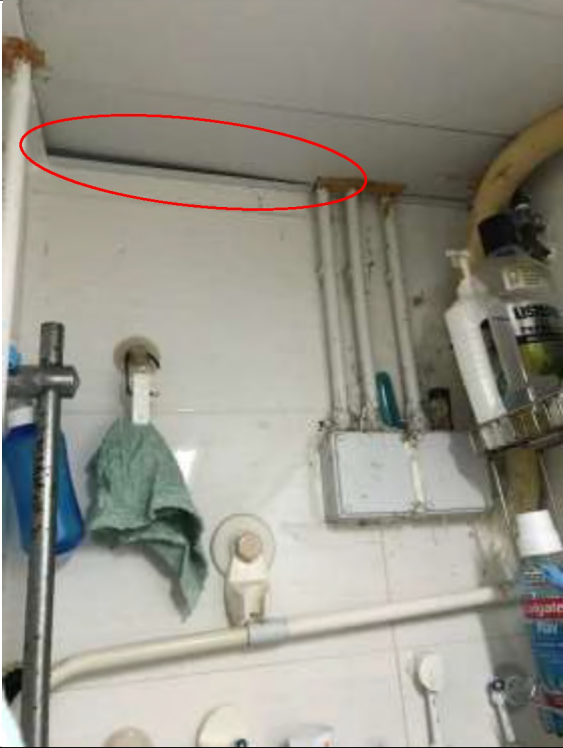
A close-up photograph of the dislodged ceiling panel. A red oval highlights the gap between the panel and the ceiling structure, showing the extent of the damage.
<p>5A4-D1(1) – Dislodged false ceiling (General View)</p>	<p>5A4-D1(2) – Dislodged false ceiling</p>

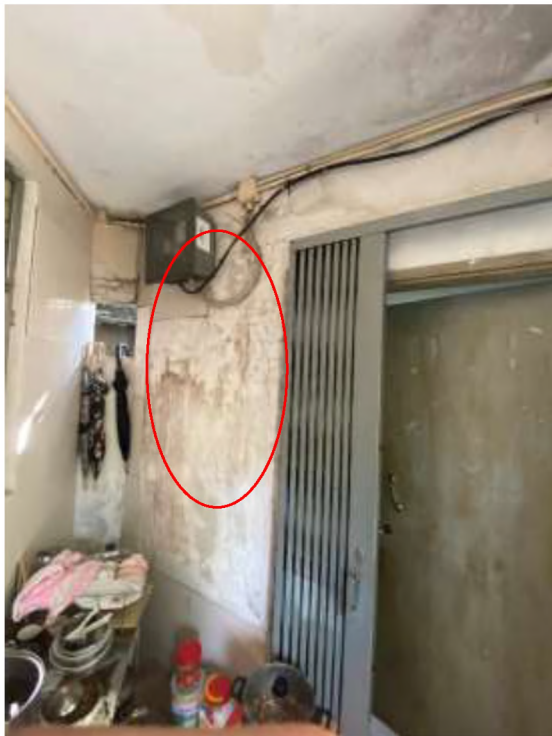
5A5-D6 – Water Stain and Crazing

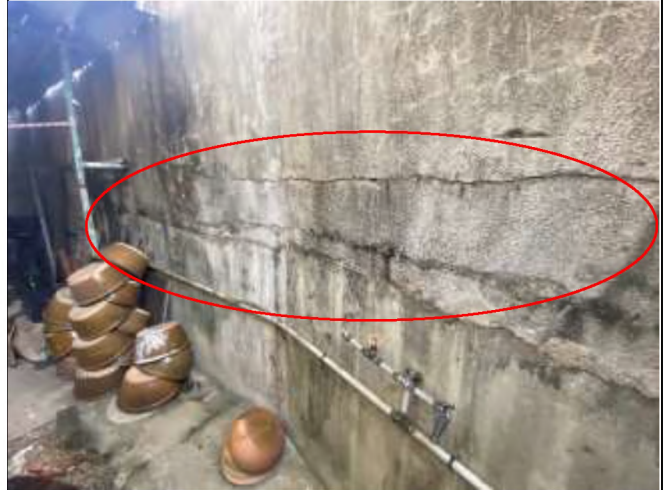
5A5-D7(1) – Wide Crack on Wall Surface
(General View)

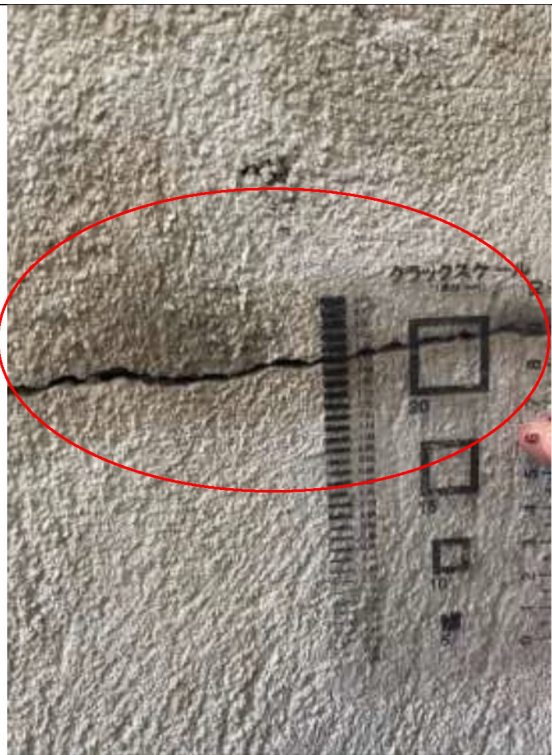
5A5-D7(2) –Moderate Crack on Wall Surface
(Length:2000mm/Width:1.75mm)

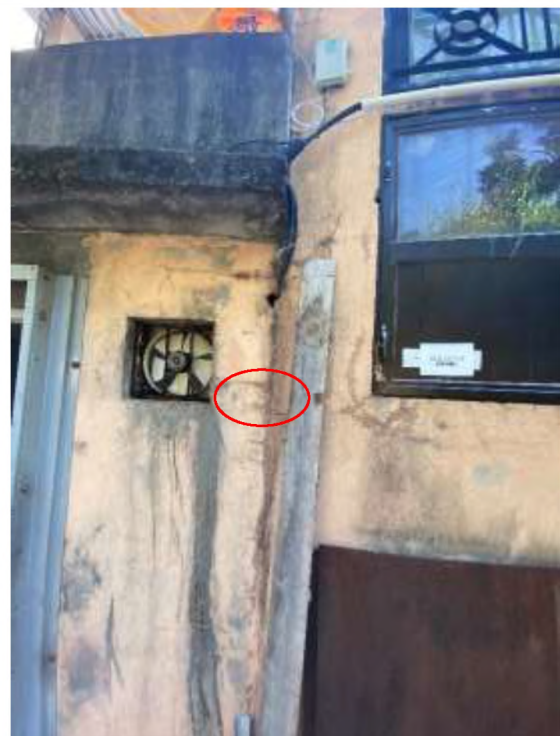
5A5-D8(1) – Moderate Crack on Wall Surface
(General View)

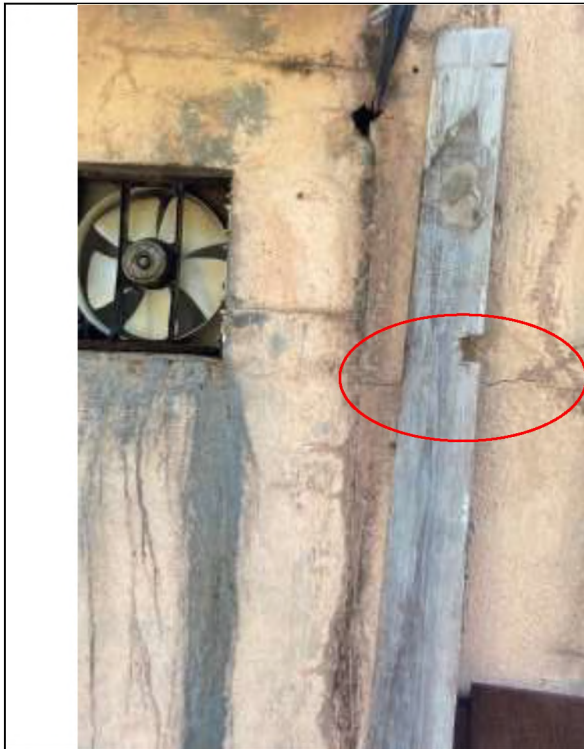
5A5-D8(2) – Moderate Crack on Wall Surface
(Length:400mm/Width:1.80mm)

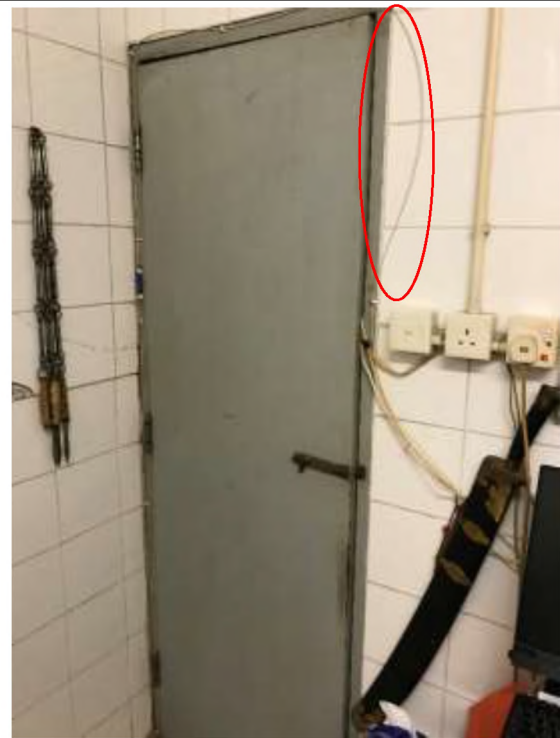
5A5-D9(1) – Moderate Crack on Wall Surface
(General View)

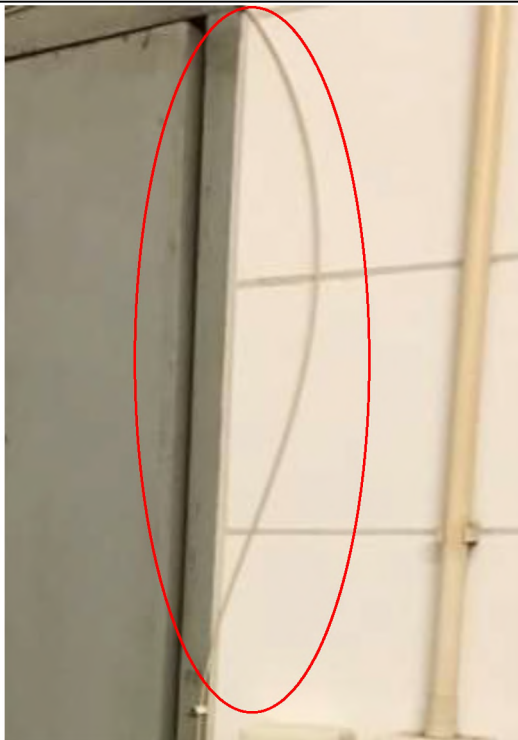
5A5-D9(2) – Moderate Crack on Wall Surface
(Length:300mm/Width:1.80mm)

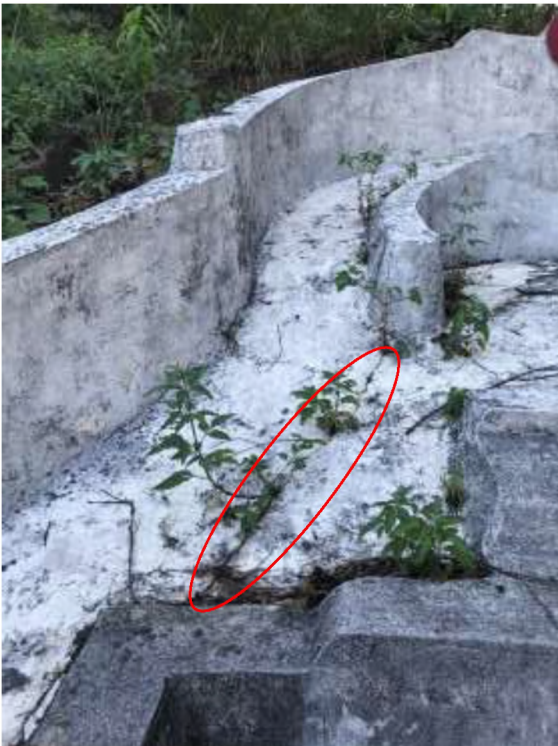
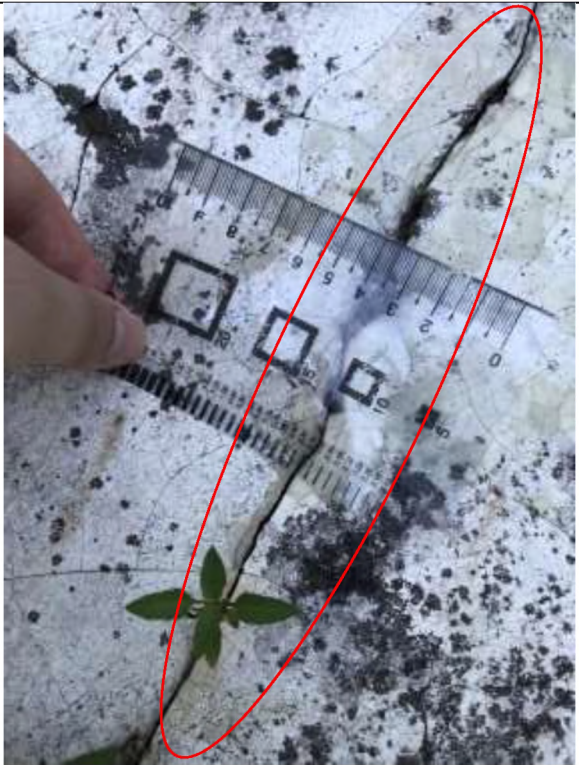
<p>6A-D2(1) - Fine Crack on Grave (General View)</p>	<p>6A-D2(2) – Fine Crack on Grave (Length:900mm/Width:0.50mm)</p>

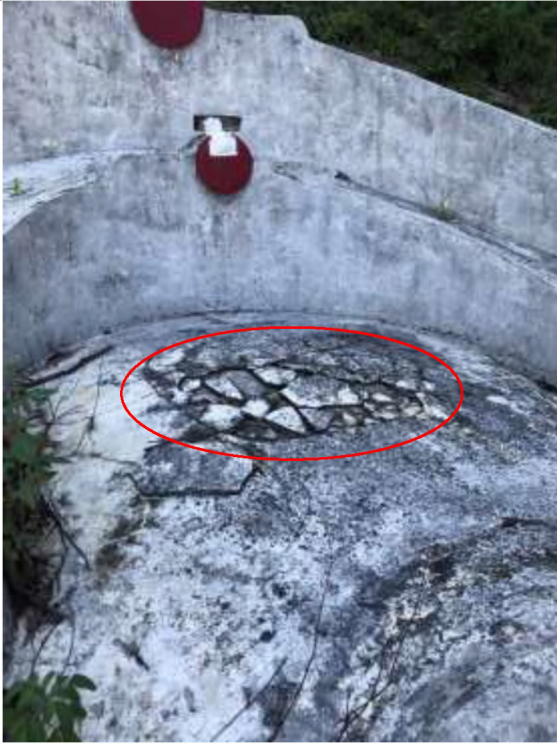
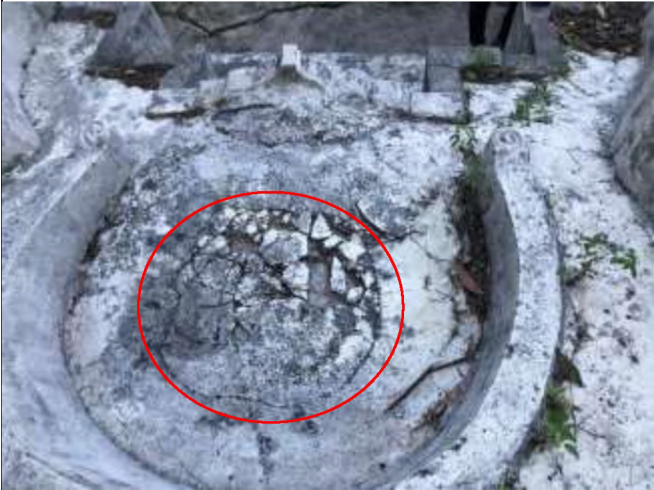
<p>6A-D3(1) - Broken Surface</p>	<p>6A-D3(2) - Broken Surface</p>

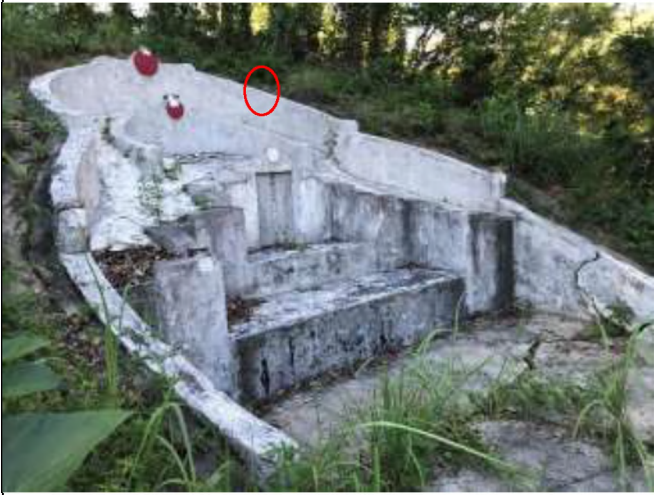
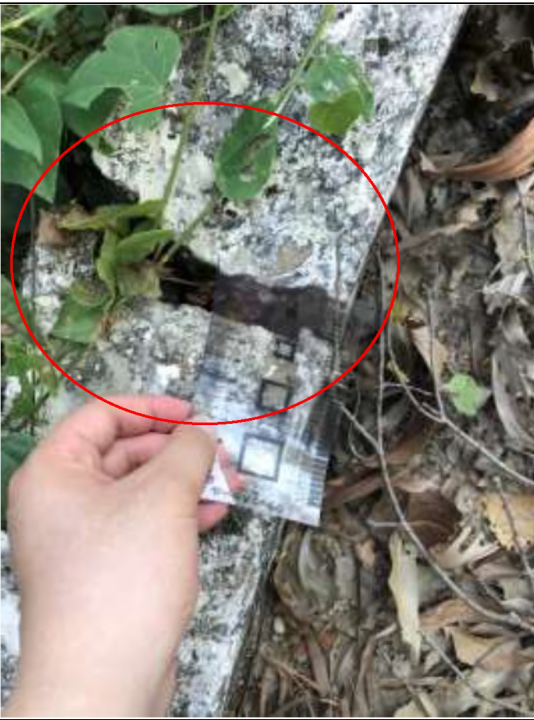
ITEM	PHOTO RECORD SERIES	CONCLUSION	CONDITION GRADING
(Part Plan E5)			
FL24 Grave (Part Plan E)	G1-G6, D1-D4	The grave (FL24) is in poor condition, with a volume of cracks on the structure	3 – poor

<p>6A-D4(1) - Wide Crack on Grave (General View)</p>	<p>6A-D4(2) - Wide Crack on Grave (Length:200mm/Width:20.00mm)</p>
