**Service Contract No. NDO 04/2019
Environmental Team for Environmental
Monitoring and Audit Works in
Construction Phase for the First Phase
Development of Kwu Tung North and
Fanling North New Development Areas**

**Monthly Environmental Monitoring and
Audit Report for December 2021**

Monthly Environmental Monitoring and Audit Report No. 26 (December 2021)

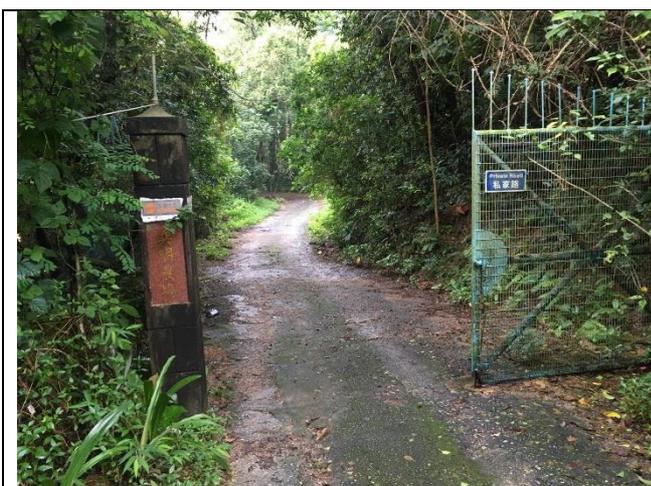
Photo 1. Inaccessible part of transect T5 located within private property.

- 9.47 For the monitoring conducted on 10th December 2021 on Transect T/5, a section of the transect route was found located within private property, and was not accessible. Another section on transect T5 was found blocked by new accumulation of fallen trees. The inaccessible part are shown in **Photo 1** and **Photo 2** below. The adjusted accessible transect route is shown in **Figure 11**.

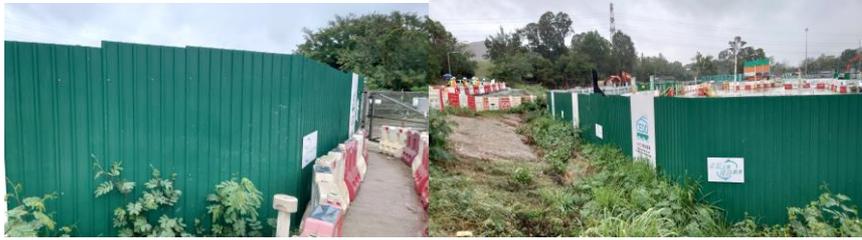
<p>To minimise adverse impacts on habitats of ecological importance in the vicinity of the Project, 2m high solid dull green site barrier fences shall be erected around all active works areas. (Figure 12)</p>	^ _[1]
<u>EP-468/2013/Δ</u>	2.11

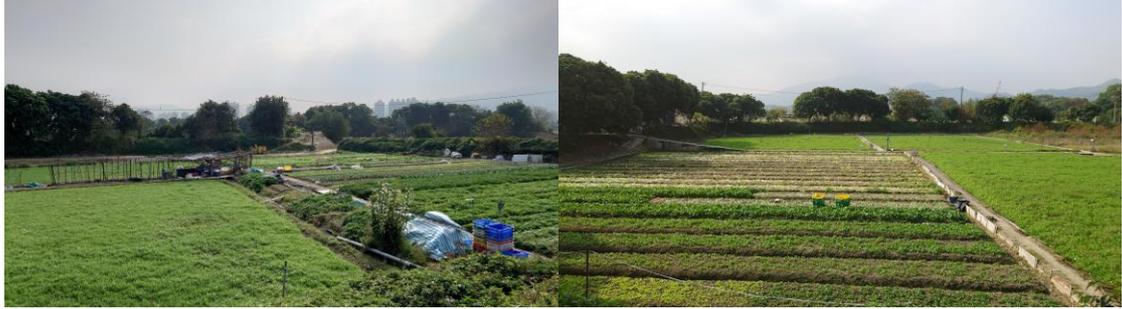
Table 10.5 Photographic Records of Site Activities in LVNP

<p>Agricultural practice are continued in existing farmland to maintain habitats in Long Valley</p>

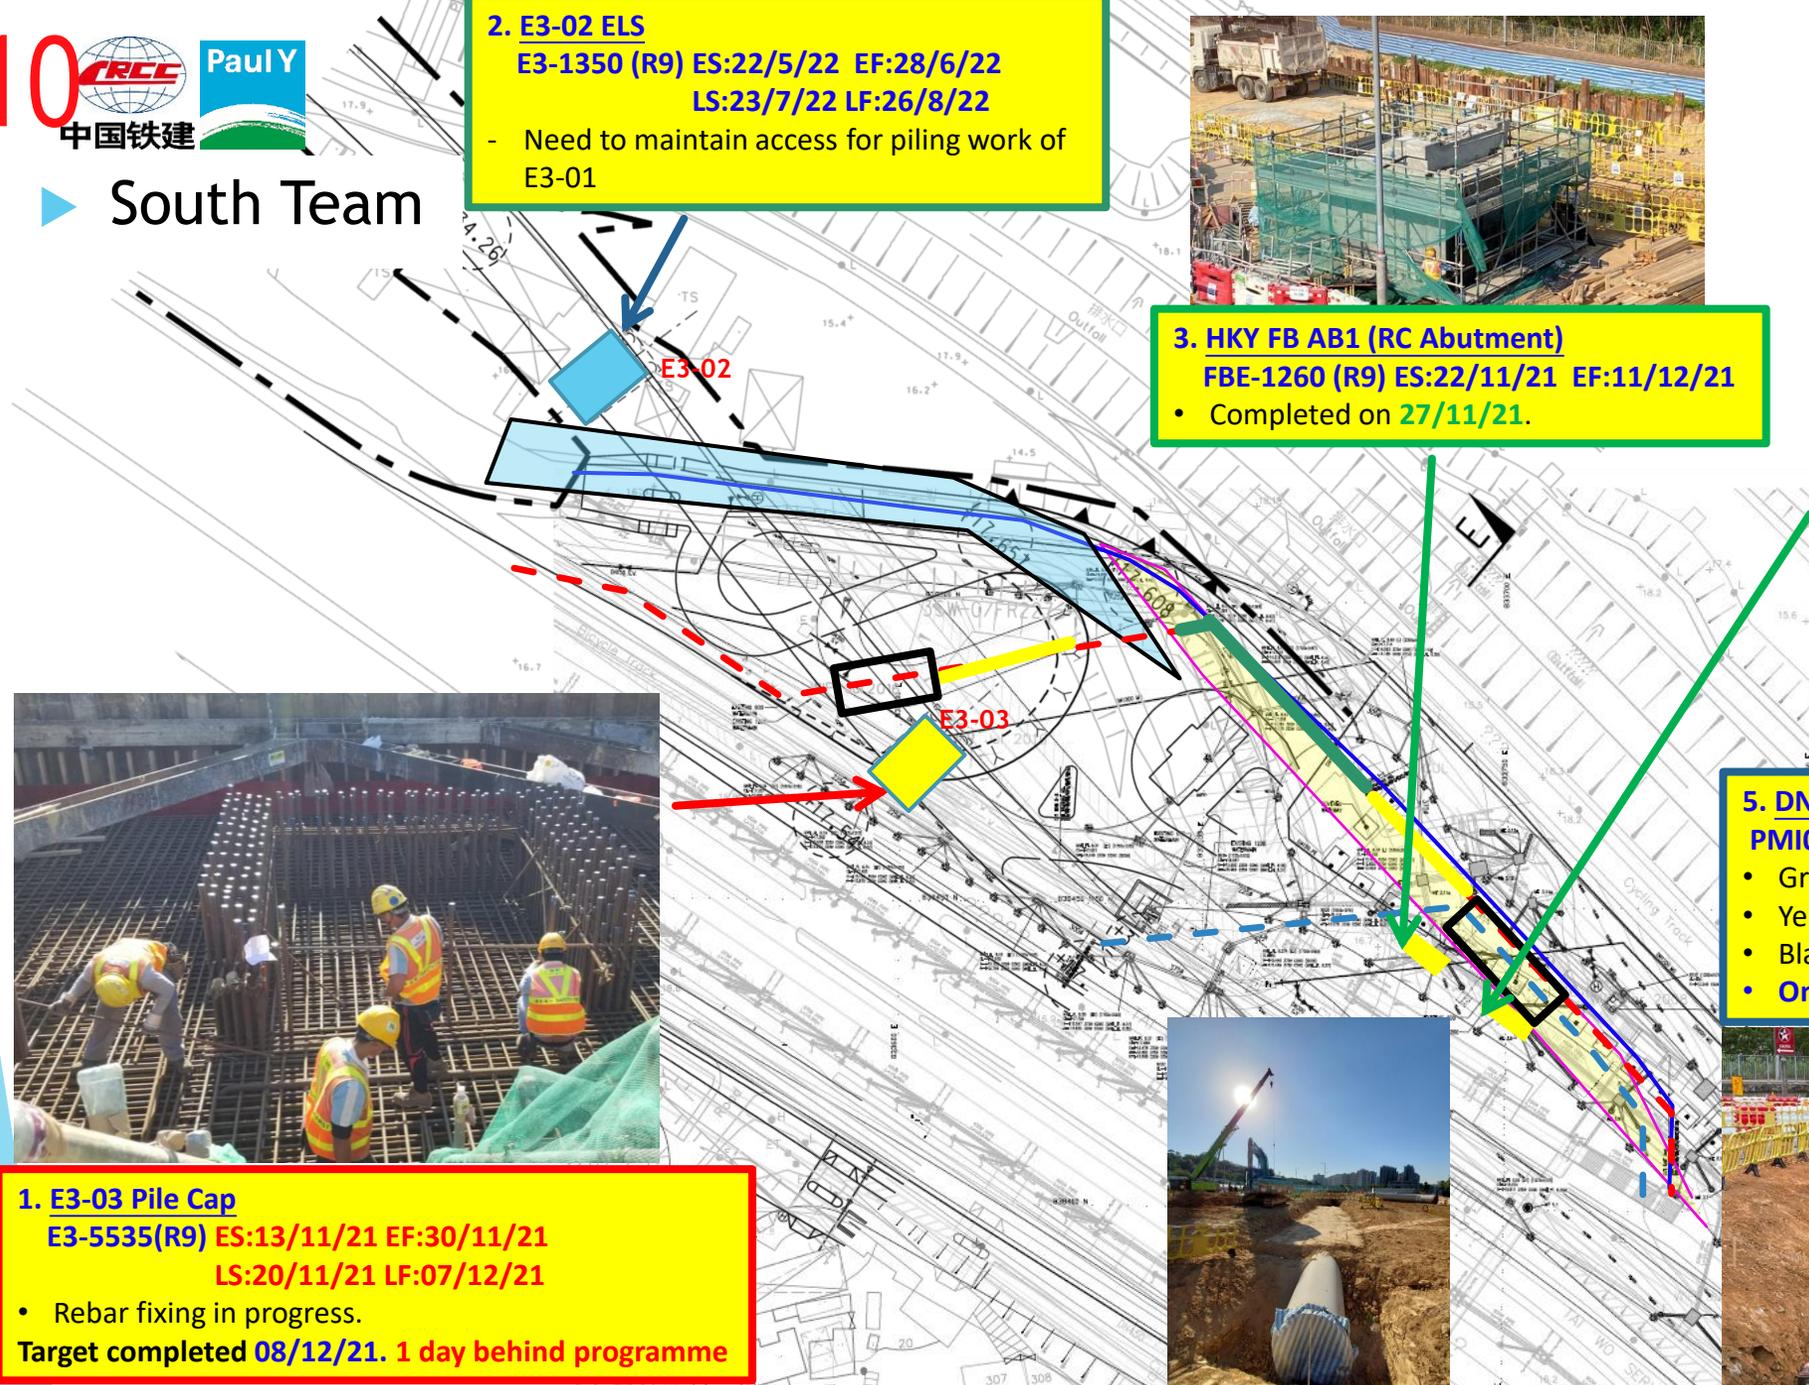
5. DN1200 and DN600 water main laying
 PMI027 (R9) ES:04/10/21 EF:25/03/22
 • Green line – completed
 • Yellow line – backfilling in progress
 • Black rectangle – next section
 • On Track

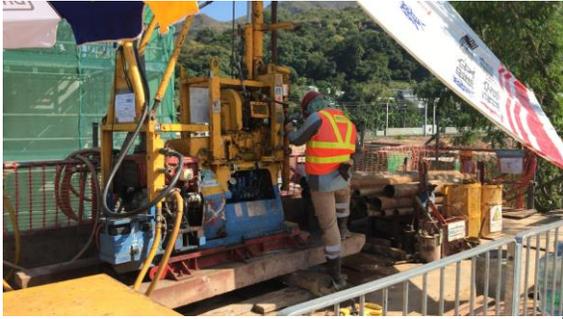
Predrilling for tower crane foundation next to E2-02

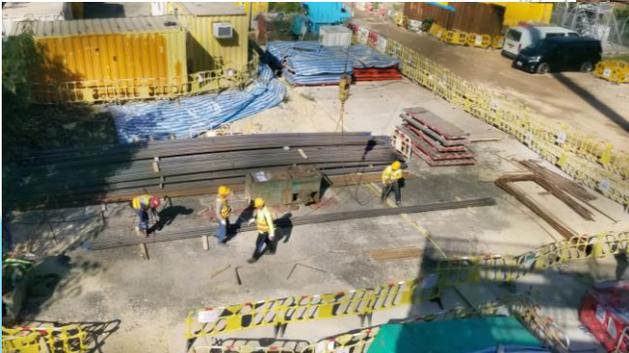
Rebar bending for pier head at E2-02
