**Service Contract No. NDO 04/2019
Environmental Team for Environmental
Monitoring and Audit Works in
Construction Phase for the First Phase
Development of Kwu Tung North and
Fanling North New Development Areas**

**Monthly Environmental Monitoring and
Audit Report for April 2022**

Monthly Environmental Monitoring and Audit Report No. 30 (April 2022)

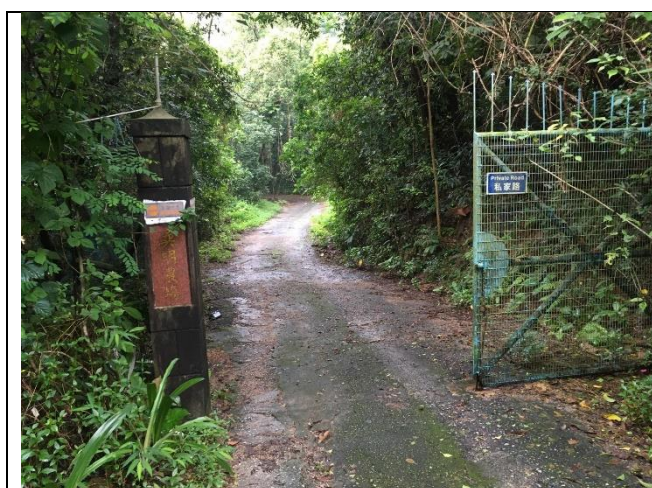
Photo 1. Inaccessible part of transect T5 located within private property.

- 9.48 For the monitoring conducted on 25th April 2022 on Transect T5, a section of the transect route was found located within private property, and was not accessible. Another section on transect T5 was found blocked by new accumulation of fallen trees. The inaccessible part are shown in **Photo 1** and **Photo 2** below. The adjusted accessible transect route is shown in **Figure 11**.

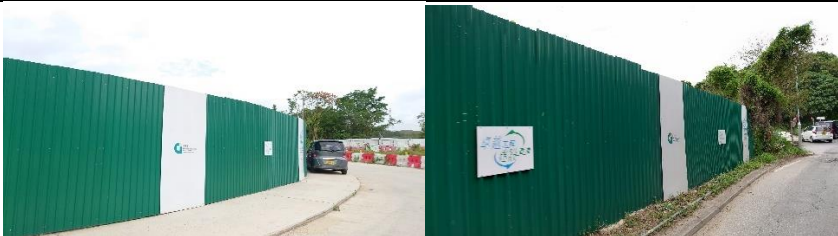
EP No.	Condition	Photographic Record	Implementation Status
<u>EP-466/2013</u>	2.9

<p>To minimise adverse impacts on habitats of ecological importance in the vicinity of the Project, 2m high solid dull green site barrier fences shall be erected around all active works areas.</p>	^ _[1]
<u>EP-468/2013/A</u>	2.11

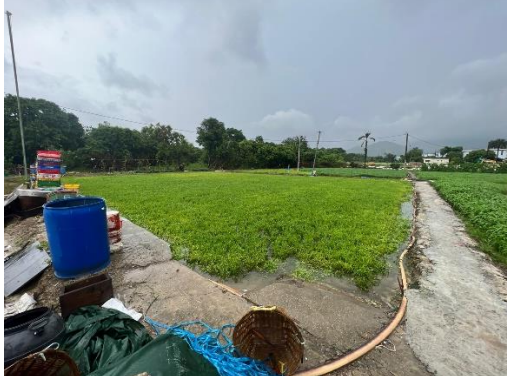
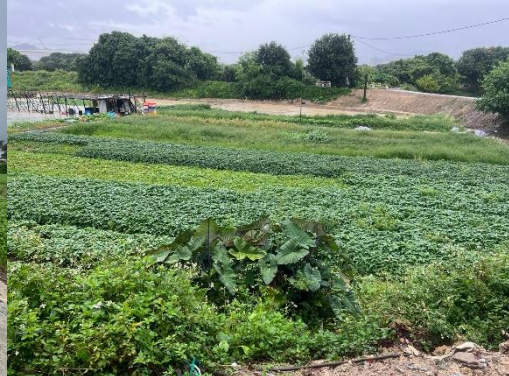
Table 10.5 Photographic Records of Site Activities in LVNP

Agricultural practice are continued in existing farmland to maintain habitats in Long Valley

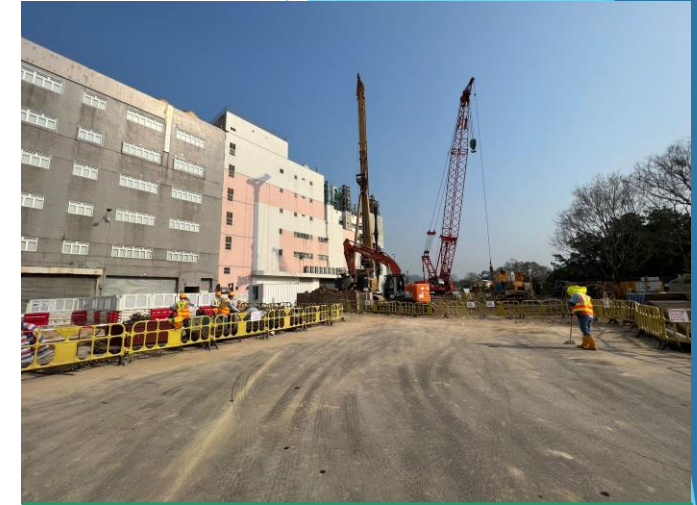
Bored pile works in C1-03
