**Service Contract No. NDO 04/2019  
Environmental Team for Environmental  
Monitoring and Audit Works in  
Construction Phase for the First Phase  
Development of Kwu Tung North and  
Fanling North New Development Areas**

**Monthly Environmental Monitoring and  
Audit Report for December 2022**

**Monthly Environmental Monitoring and Audit Report No. 38 (December 2022)**

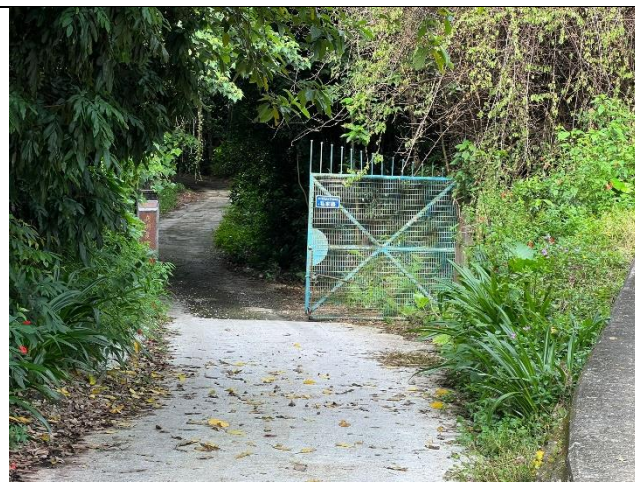
Photo 1. Inaccessible part of transect T5 located within a private property.

- 9.44 Odonata were recorded this month at all transects. No species recorded were of conservation importance. Transect T1 had the highest odonate species diversity among all transects.
- 9.45 Ecological sensitive receivers such as mammals, insects (butterflies and dragonflies), and herpetofauna monitoring during construction phase was conducted in the reporting month and the results are attached in **Appendices L2 to L5**.
- 9.46 For the monitoring conducted on 16 December 2022 at Transect T5, a section of the transect route was found located within a private property and hence not accessible. Another section of transect T5 was found blocked by a new accumulation of fallen trees. The inaccessible part are shown in **Photo 1** and **Photo 2** below. The adjusted accessible transect route is shown in **Figure 11**.

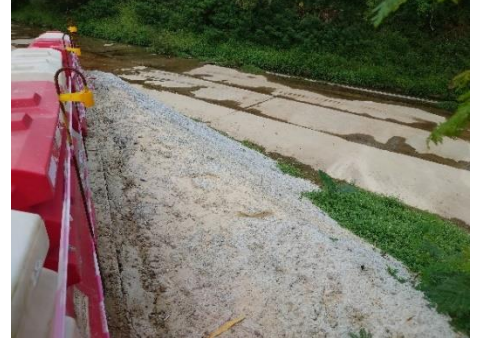
<p>Hard paved exposed slope surface</p>	  <p>Deployment of silt curtain around works area in Ng Tung River</p>

ND/2019/05	 	 
	Covering dusty stockpile	Provision of sand bags around works area
ND/2019/07	 	 
	Covering exposed slope surface with tarpaulin	De-silting waste water before discharge
<b>Water quality mitigation measures for site(s) in operation phase, remaining defect works</b>		
ND/2019/06	 	 
	Hard paved exposed haul road	Hard paved exposed haul road

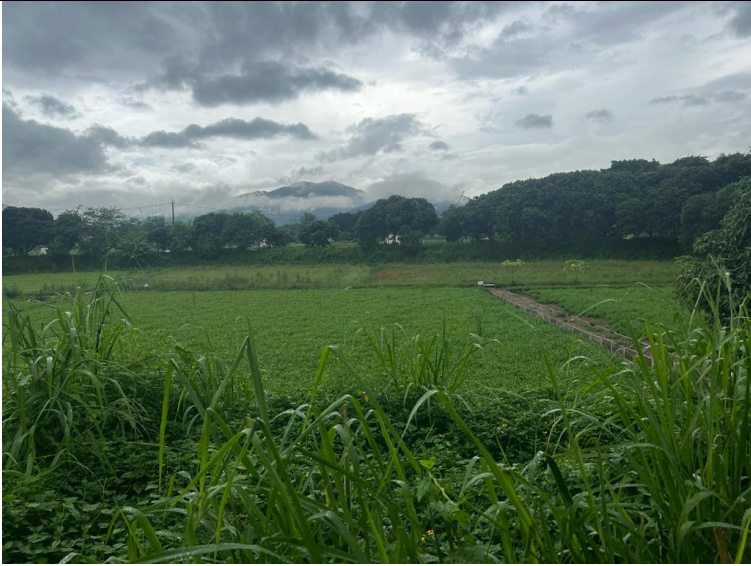
**Table 10.5 Photographic Records of Site Activities in LVNP**

Continuing agricultural practice in existing farmland to maintain habitats in Long Valley

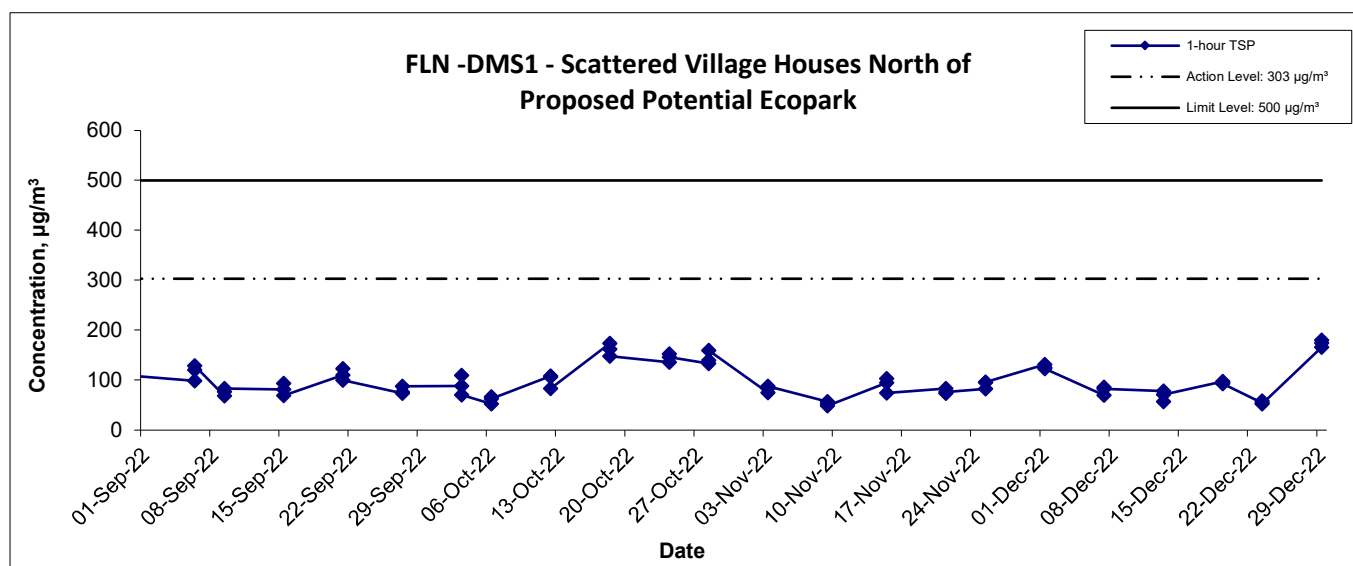
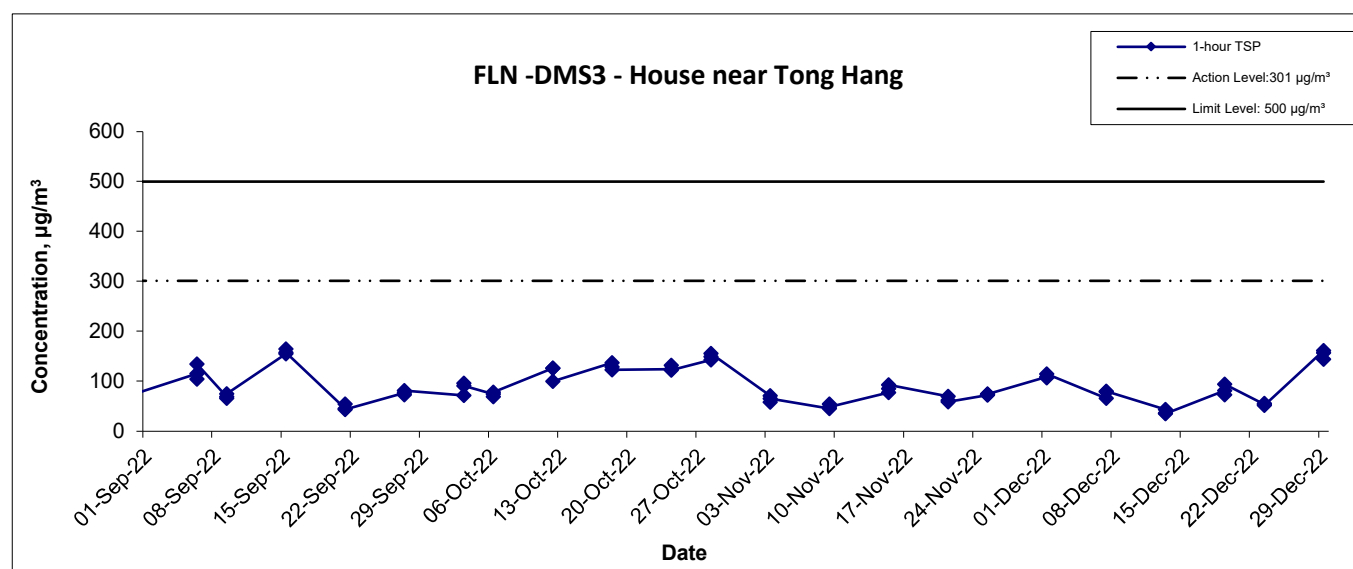
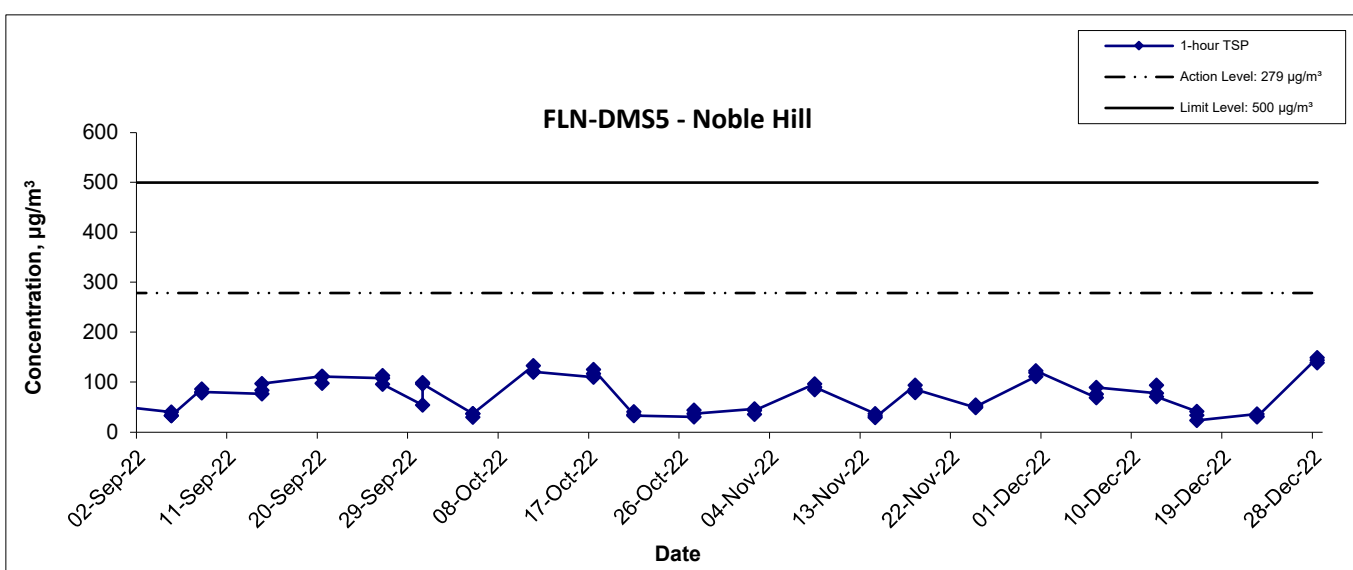
## 1-hr TSP Concentration Levels

Title	Service Contract No. NDO 04/2019		
	Environmental Team for Environmental Monitoring and Audit Works in Construction Phase for the First Phase Development of Kwu Tung North and Fanling North New Development Areas		
	Graphical Presentation of 1-hour TSP Monitoring Results		
Scale	N.T.S		Project No.
	Date		WMA20002
Dec 22		Appendix	E

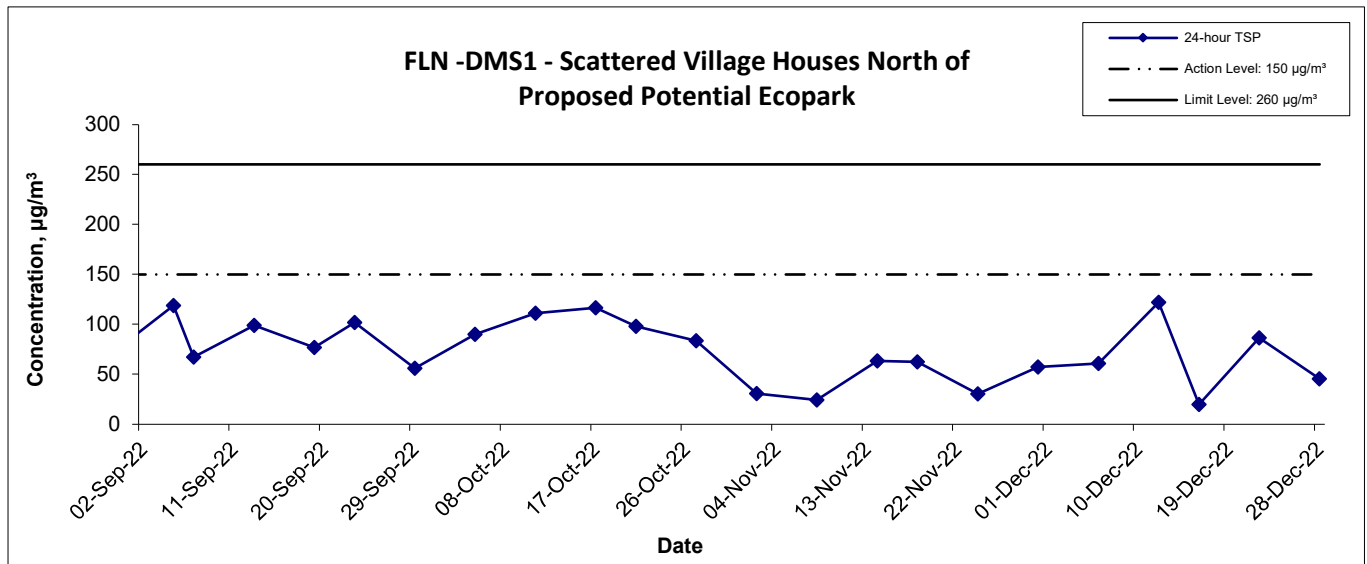
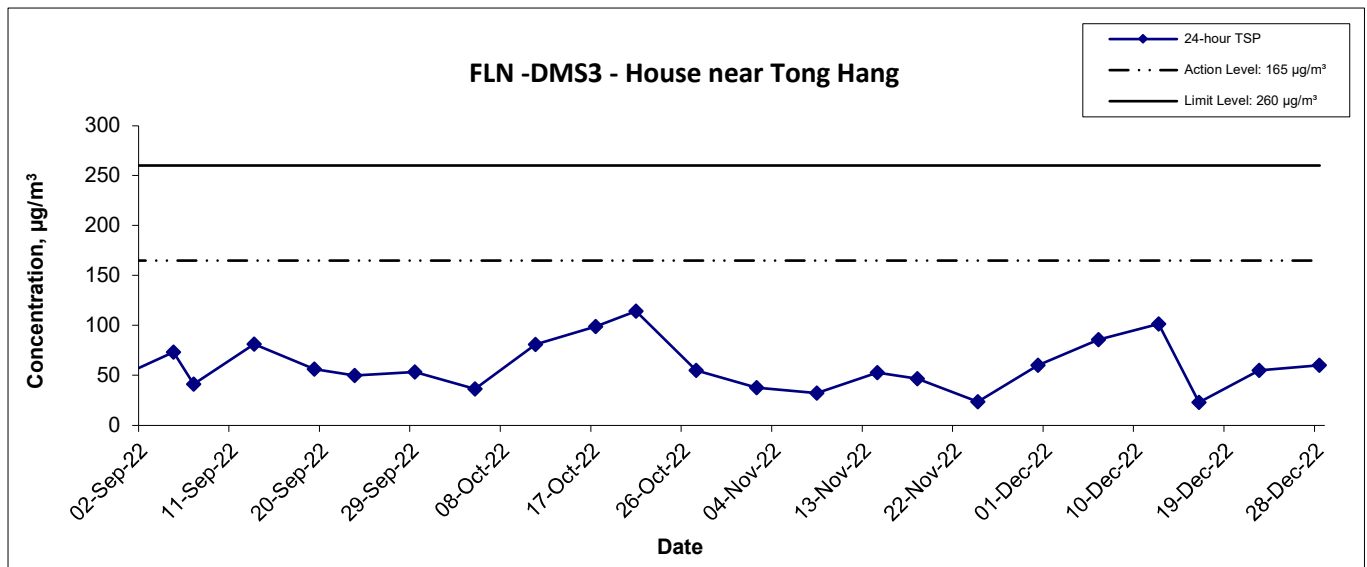
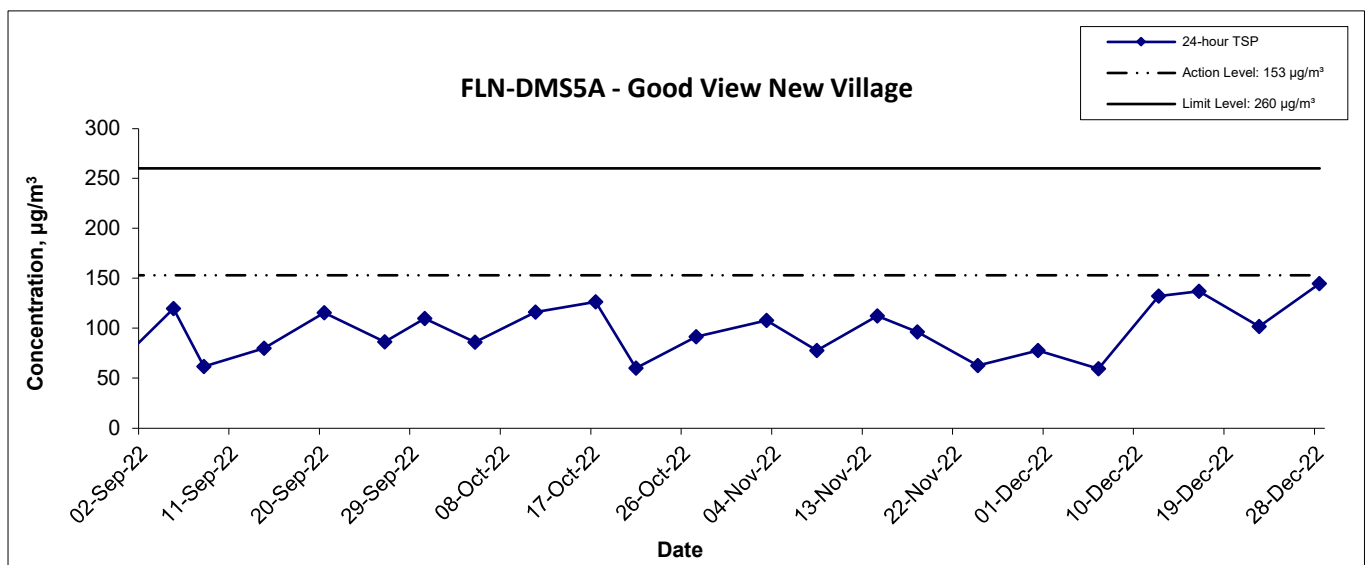
## 24-hr TSP Concentration Levels

<b>Title</b> Service Contract No. NDO 04/2019 Environmental Team for Environmental Monitoring and Audit Works in Construction Phase for the First Phase Development of Kwu Tung North and Fanling North New Development Areas Graphical Presentation of 24-hour TSP Monitoring Results	<b>Scale</b> N.T.S	<b>Project No.</b> WMA20002

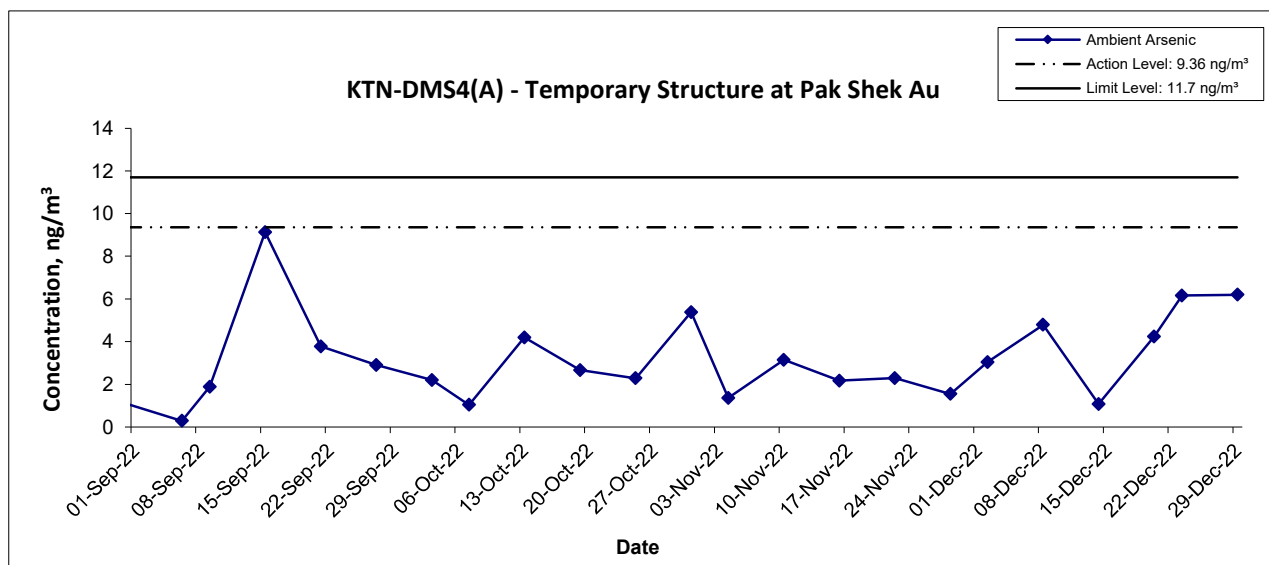
## Ambient Arsenic

<b>Title</b> Service Contract No. NDO 04/2019 Environmental Team for Environmental Monitoring and Audit Works in Construction Phase for the First Phase Development of Kwu Tung North and Fanling North New Development Areas  Graphical Presentation of Ambient Arsenic Monitoring Results	<b>Scale</b> N.T.S	<b>Project No.</b> WMA20002

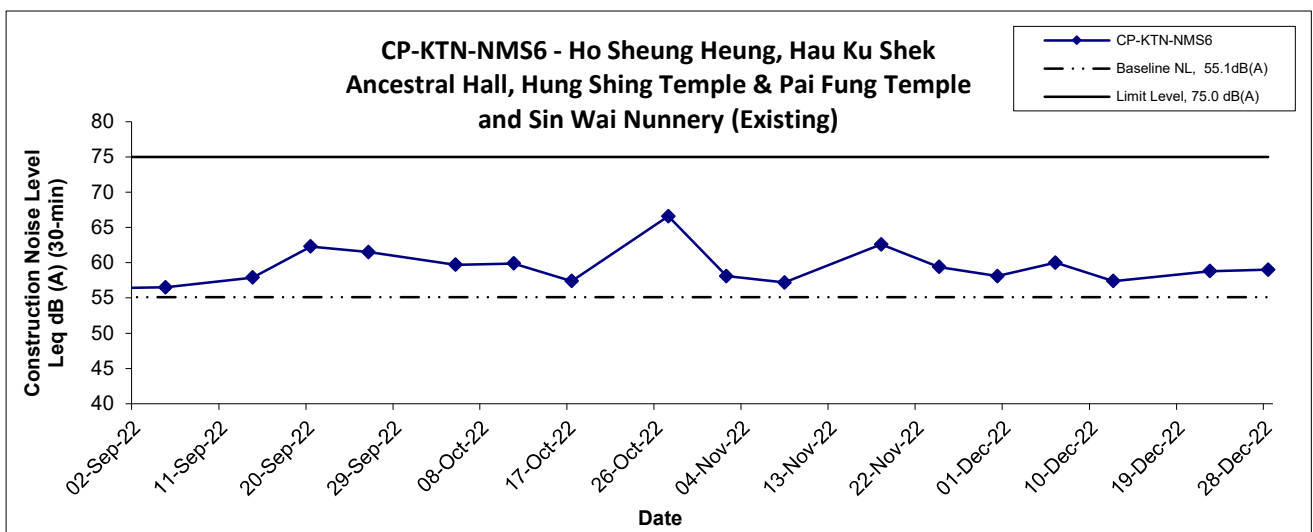
## Noise Levels

<b>Title</b> Service Contract No. NDO 04/2019 Environmental Team for Environmental Monitoring and Audit Works in Construction Phase for the First Phase Development of Kwu Tung North and Fanling North New Development Areas Graphical Presentation of Construction Noise Monitoring Results	<b>Scale</b> N.T.S	<b>Project No.</b> WMA20002

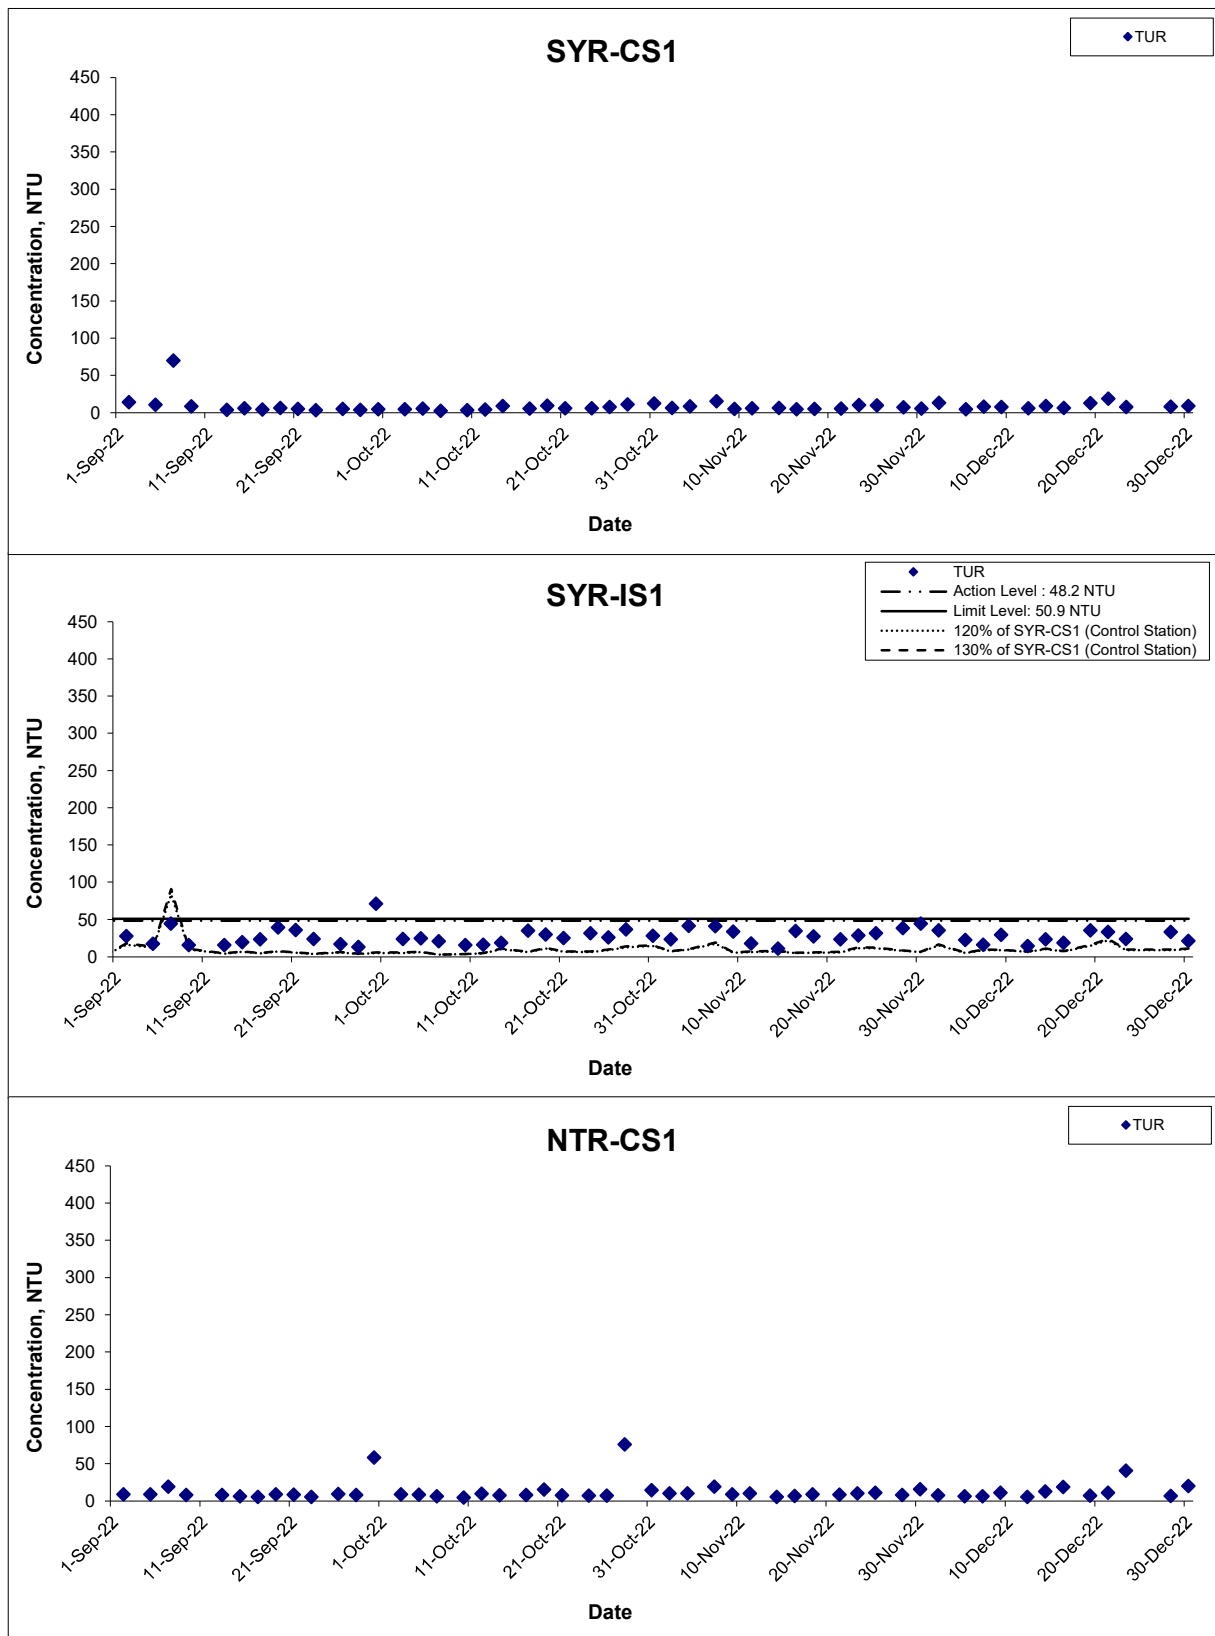
## Turbidity (Depth-averaged)

<b>Title</b> Contract No. NDO 04/2019 Advance and First Stage Works of Kwu Tung North and Fanling North New Development Areas Graphical Presentation of Water Quality Monitoring Results	<b>Scale</b> N.T.S	<b>Project No.</b> WMA20002	<b>WELLAB 匯力</b> consulting . testing . research
	<b>Date</b> Dec 22	<b>Appendix</b> G

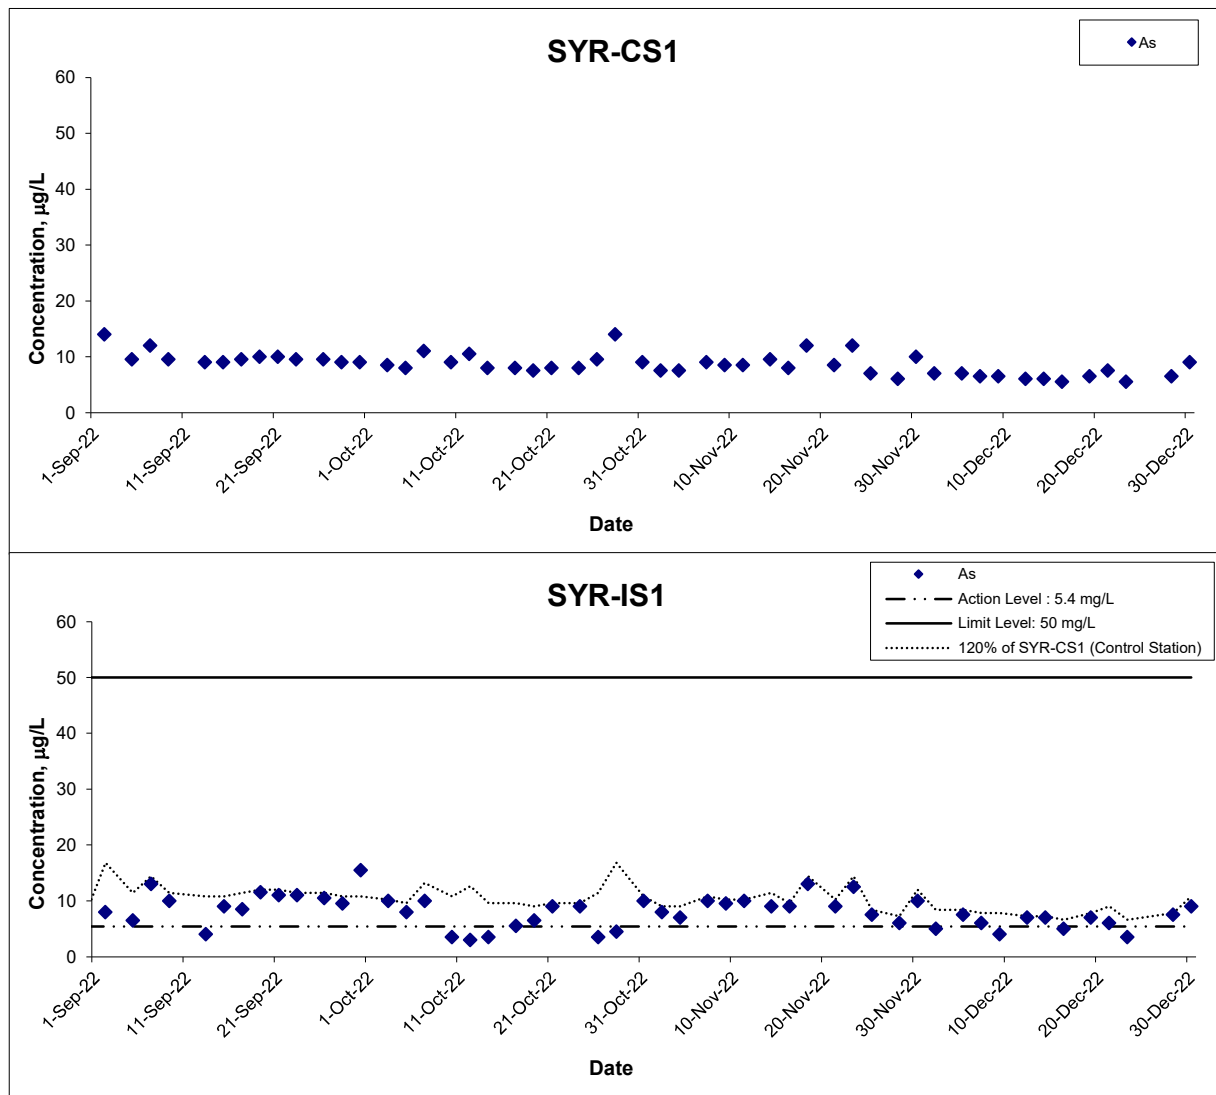
## Arsenic (Depth-averaged)

<b>Title</b> Contract No. NDO 04/2019 Advance and First Stage Works of Kwu Tung North and Fanling North New Development Areas Graphical Presentation of Water Quality Monitoring Results	<b>Scale</b> N.T.S	<b>Project No.</b> WMA20002
