**Service Contract No. NDO 04/2019  
Environmental Team for Environmental  
Monitoring and Audit Works in  
Construction Phase for the First Phase  
Development of Kwu Tung North and  
Fanling North New Development Areas**

**Monthly Environmental Monitoring and  
Audit Report for July 2022**

**Monthly Environmental Monitoring and Audit Report No. 33 (July 2022)**

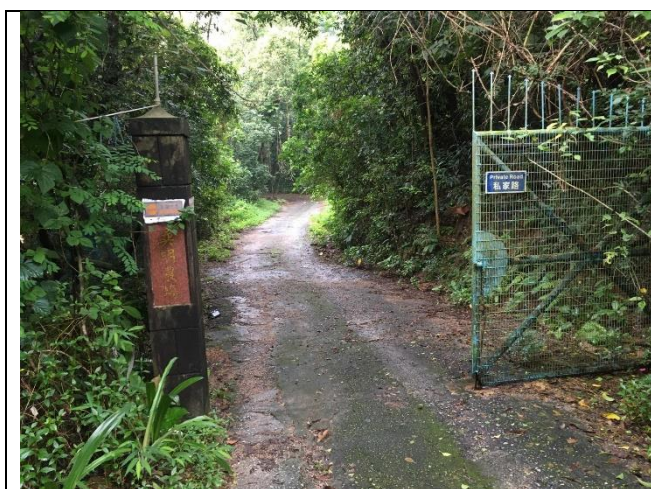
- 9.49 For the monitoring conducted on 13 July 2022 at Transect T5, a section of the transect route was found located within a private property and hence not accessible. Another section of transect T5 was found blocked by a new accumulation of fallen trees. The inaccessible part are shown in **Photo 1** and **Photo 2** below. The adjusted accessible transect route is shown in **Figure 11**.

Photo 1. Inaccessible part of transect T5 located within a private property.

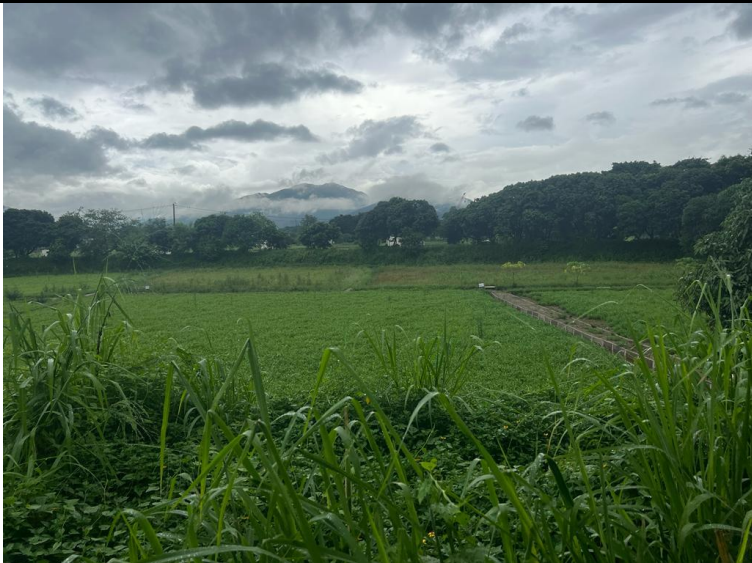
Continuing agricultural practice in existing farmland to maintain habitats in Long Valley

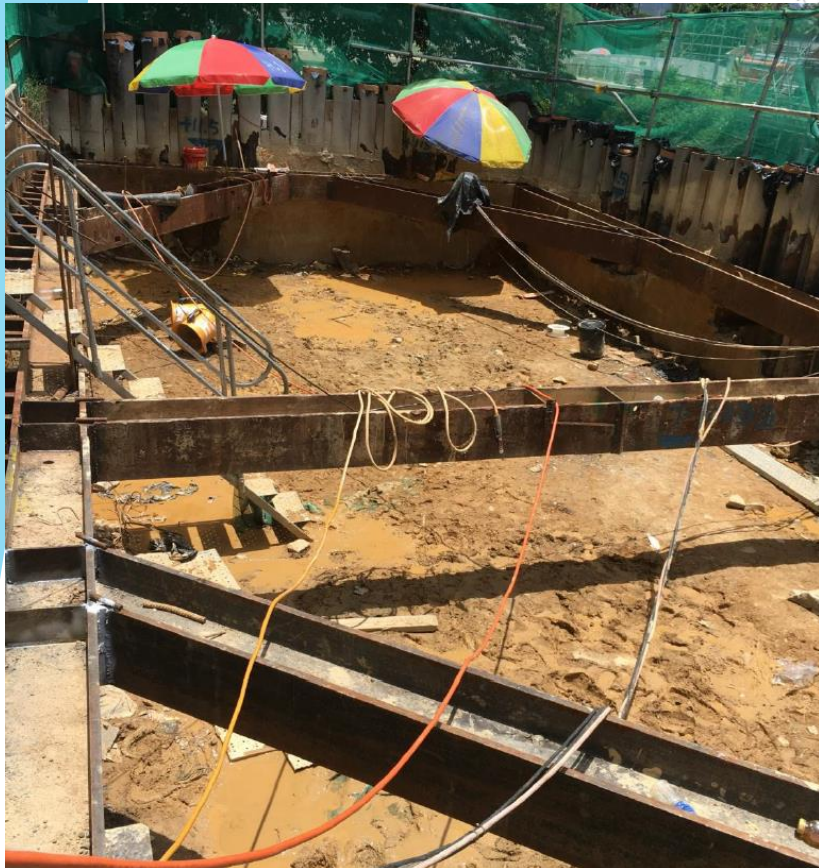
- 1<sup>st</sup> layer excavation completed
- Installation of 1<sup>st</sup> layer of waling and struts in progress
- ELS - ES: 26/10/22 EF: 29/11/22
- Ahead against R12

C1-01b 1<sup>st</sup> layer of ELS waling and struts Completed

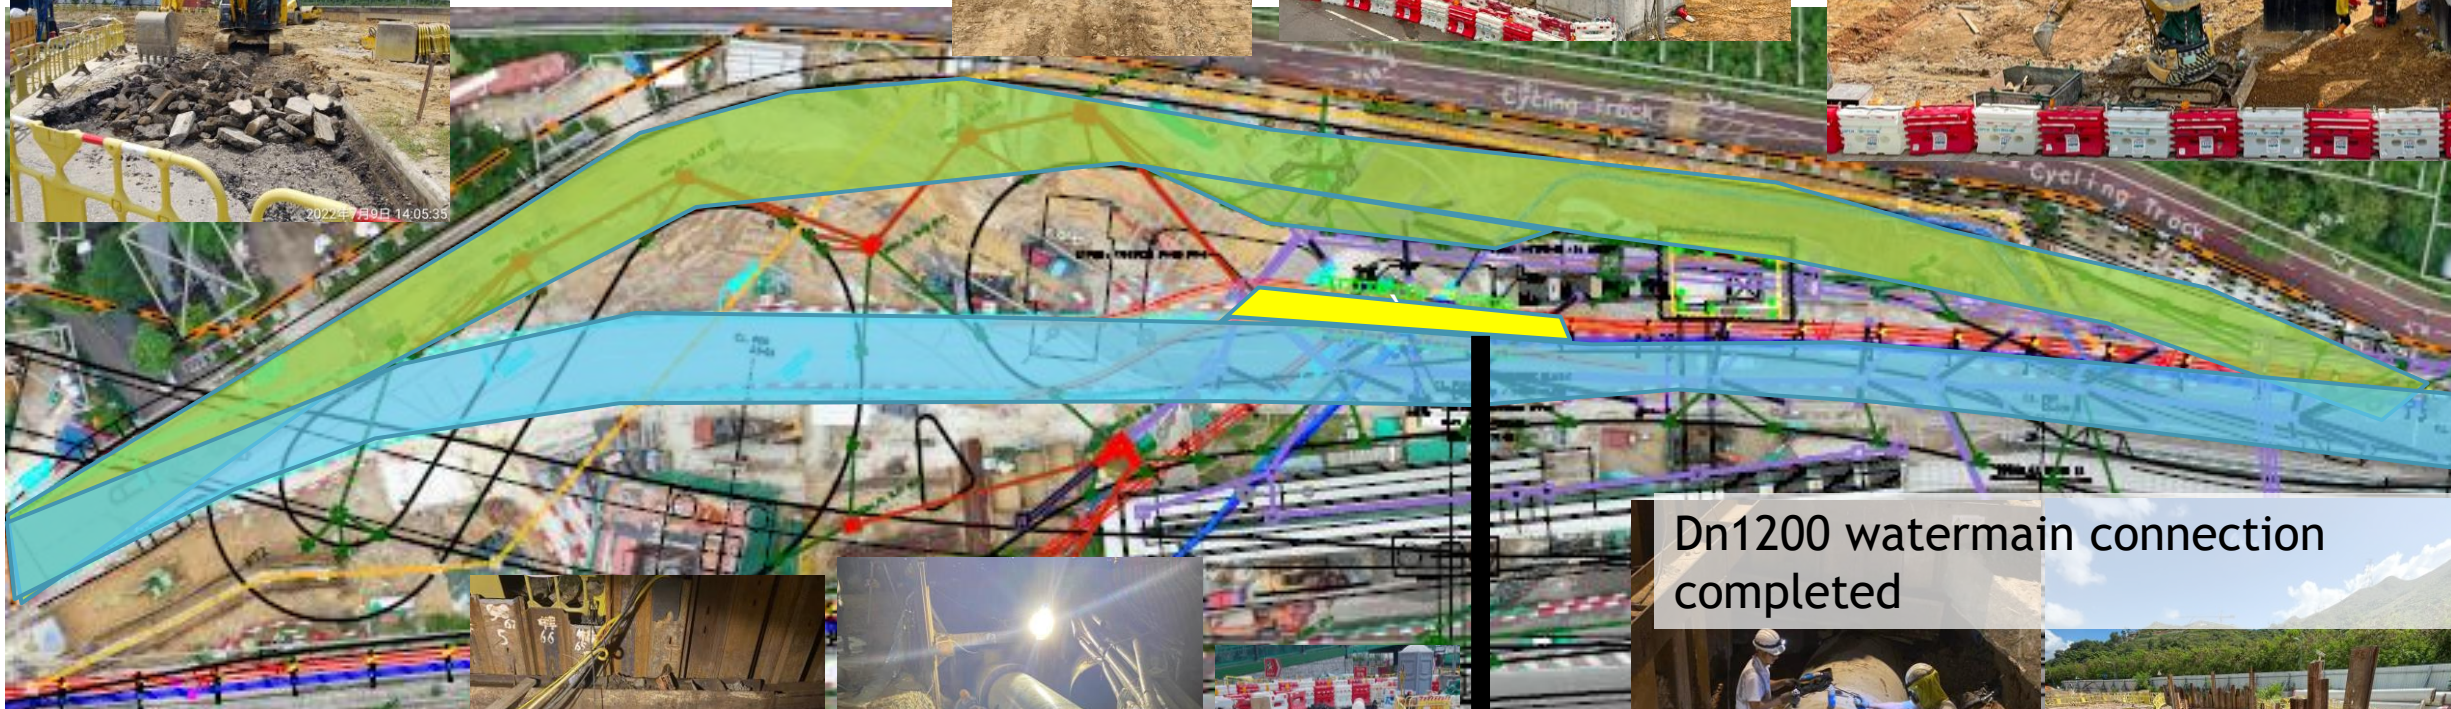
Dn1200 watermain connection completed
