**Service Contract No. NDO 04/2019
Environmental Team for Environmental
Monitoring and Audit Works in
Construction Phase for the First Phase
Development of Kwu Tung North and
Fanling North New Development Areas**

**Monthly Environmental Monitoring and
Audit Report for November 2022**

Monthly Environmental Monitoring and Audit Report No. 37 (November 2022)

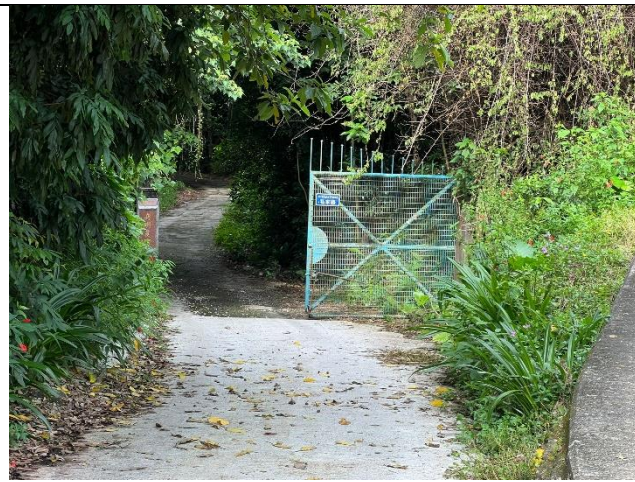
Photo 1. Inaccessible part of transect T5 located within a private property.

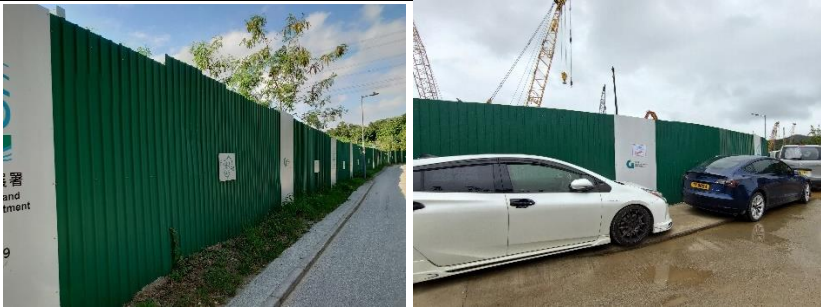
<p>To minimise adverse impacts on habitats of ecological importance in the vicinity of the Project, 2m high solid dull green site barrier fences shall be erected around all active works areas.</p>	^ _[1]
EP- 467/2013/ A	2.9

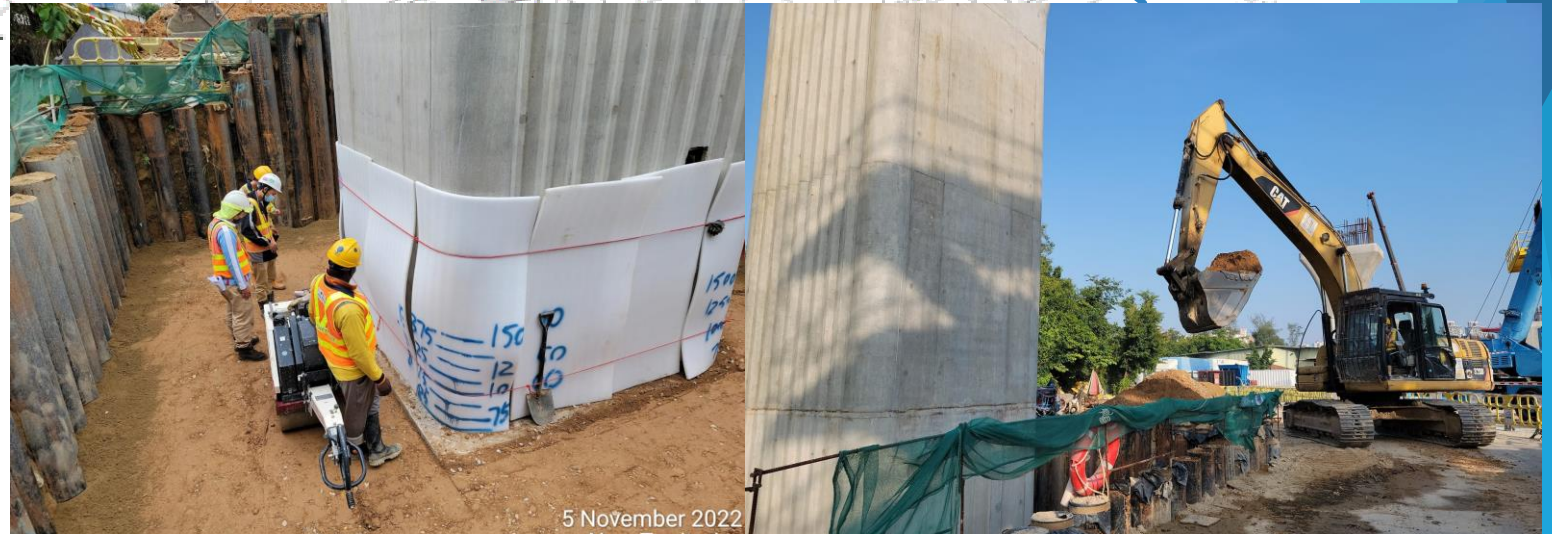
- Backfilling to EGL in progress
- Backfilling - ES:11/10/22 EF:24/10/22
 - LS:25/09/23 LF:10/10/23
- Slippage against R12A

D1-04 backfilling in progress.
