**Service Contract No. NDO 04/2019
Environmental Team for Environmental
Monitoring and Audit Works in
Construction Phase for the First Phase
Development of Kwu Tung North and
Fanling North New Development Areas**

**Monthly Environmental Monitoring and
Audit Report for October 2022**

Monthly Environmental Monitoring and Audit Report No. 36 (October 2022)

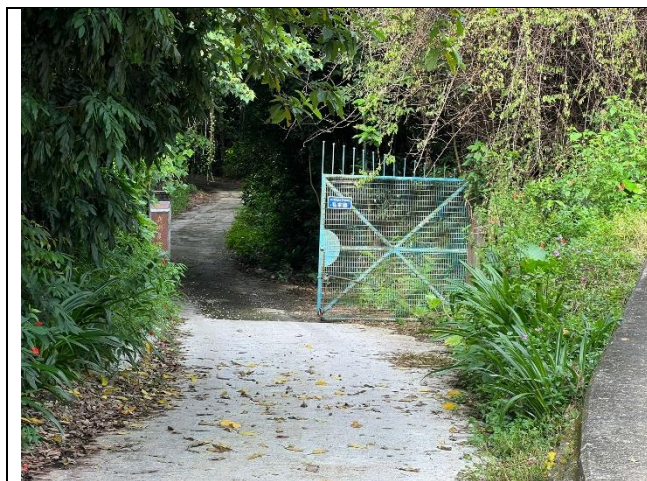
- 9.49 For the monitoring conducted on 26 October 2022 at Transect T5, a section of the transect route was found located within a private property and hence not accessible. Another section of transect T5 was found blocked by a new accumulation of fallen trees. The inaccessible part are shown in **Photo 1** and **Photo 2** below. The adjusted accessible transect route is shown in **Figure 11**.

Photo 1. Inaccessible part of transect T5 located within a private property.

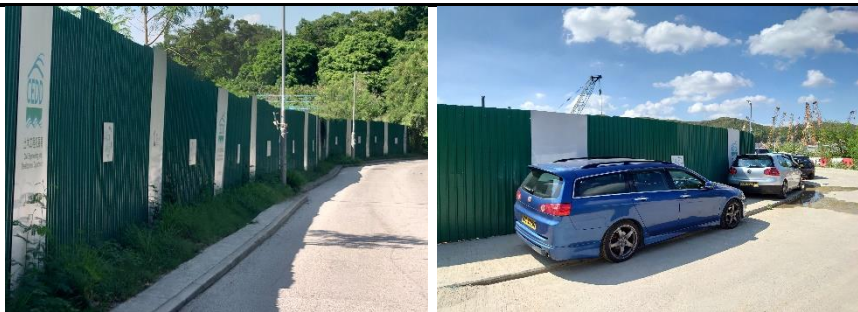
<p>To minimise adverse impacts on habitats of ecological importance in the vicinity of the Project, 2m high solid dull green site barrier fences shall be erected around all active works areas.</p>	^ _[1]
<u>EP-467/2013/A</u>	2.9

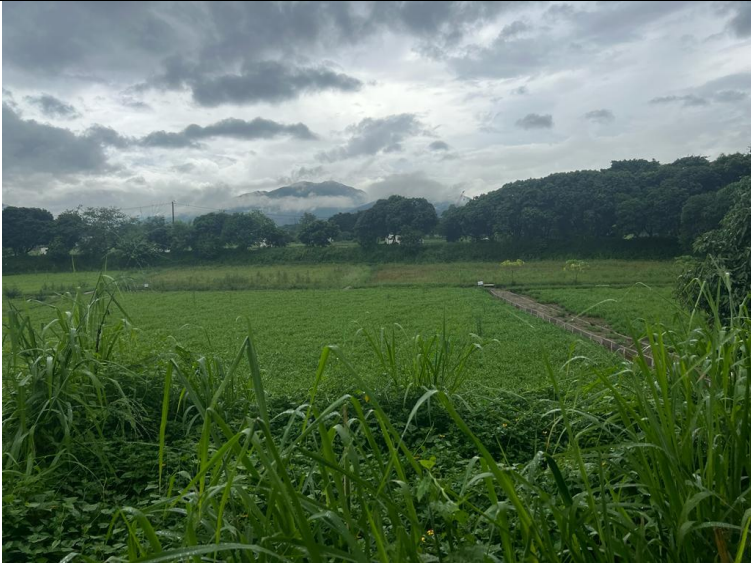
Table 10.5 Photographic Records of Site Activities in LVNP

<p>Continuing agricultural practice in existing farmland to maintain habitats in Long Valley</p>
