**Service Contract No. NDO 04/2019  
Environmental Team for Environmental  
Monitoring and Audit Works in  
Construction Phase for the First Phase  
Development of Kwu Tung North and  
Fanling North New Development Areas**

**Monthly Environmental Monitoring and  
Audit Report for April 2023**

**Monthly Environmental Monitoring and Audit Report No. 42 (April 2023)**

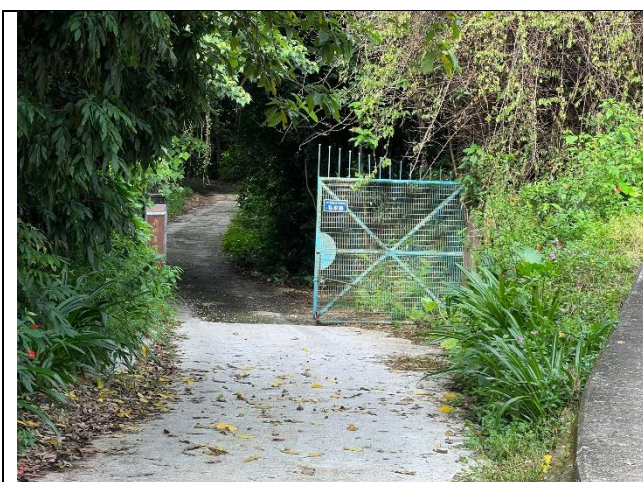
Photo 1. Inaccessible part of transect T5 located within a private property.

- 9.49 For the monitoring conducted on 26 April 2023 at Transect T5, a section of the transect route was found located within a private property and hence not accessible. Another section of transect T5 was found blocked by a new accumulation of fallen trees. The inaccessible part are shown in **Photo 1** and **Photo 2** below. The adjusted accessible transect route is shown in **Figure 11**.

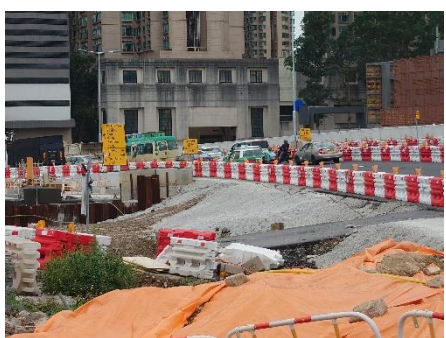
<p data-bbox="496 1664 826 1693">Hard paved exposed haul road</p>	  <p data-bbox="983 1641 1385 1700">Regular clearance of water for wheel washing facility</p>
ND/2019/04

<p data-bbox="475 2058 842 2087">Hard paved exposed slope surface</p>	  <p data-bbox="948 2040 1437 2098">Deployment of silt curtain around works area in Ng Tung River</p>

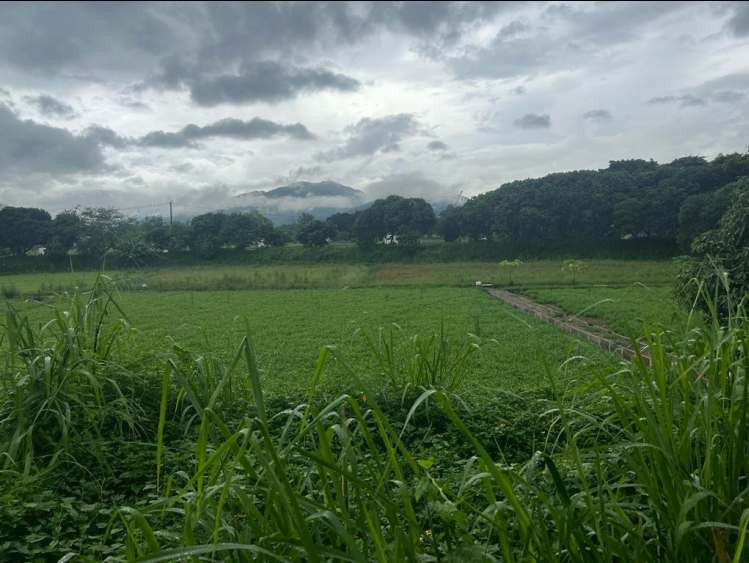
**Table 10.5 Photographic Records of Site Activities in LVNP**

<p>Continuing agricultural practice in existing farmland to maintain habitats in Long Valley</p>

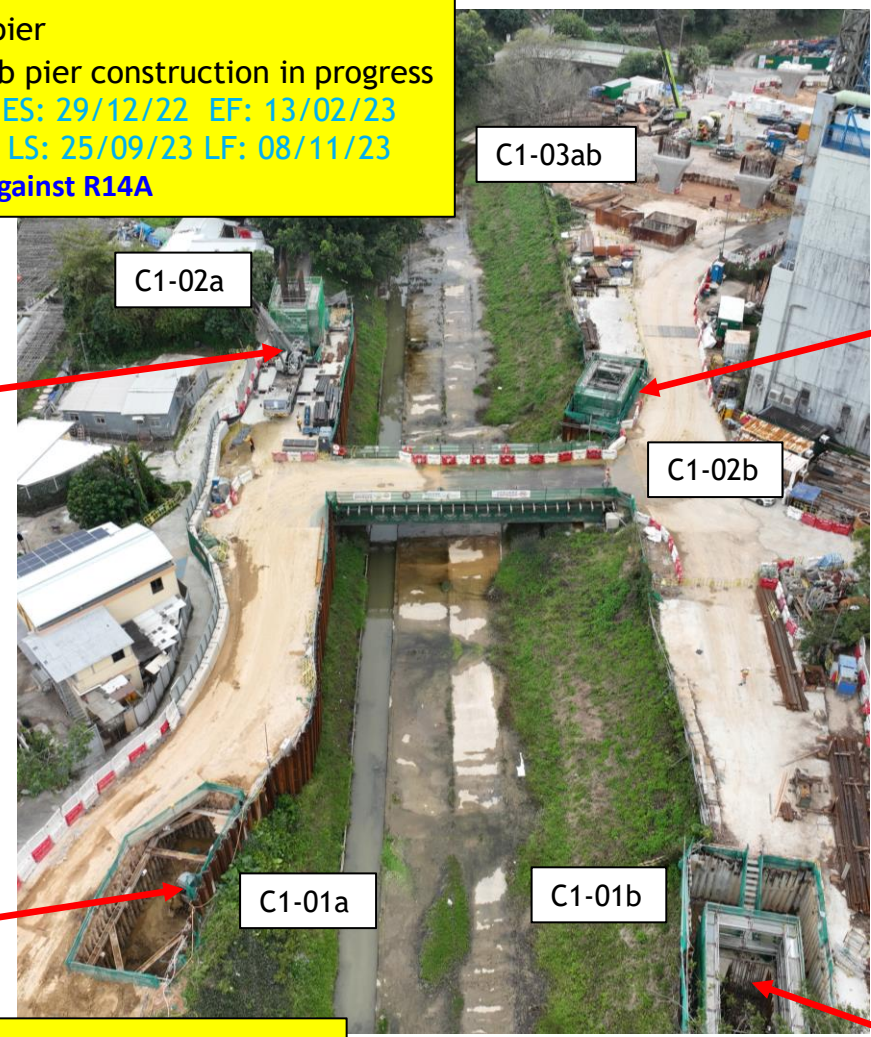
**C1-02a pier 1<sup>st</sup> & 2<sup>nd</sup> pour completed on 20/01/23 & 03/02/23 respectively**

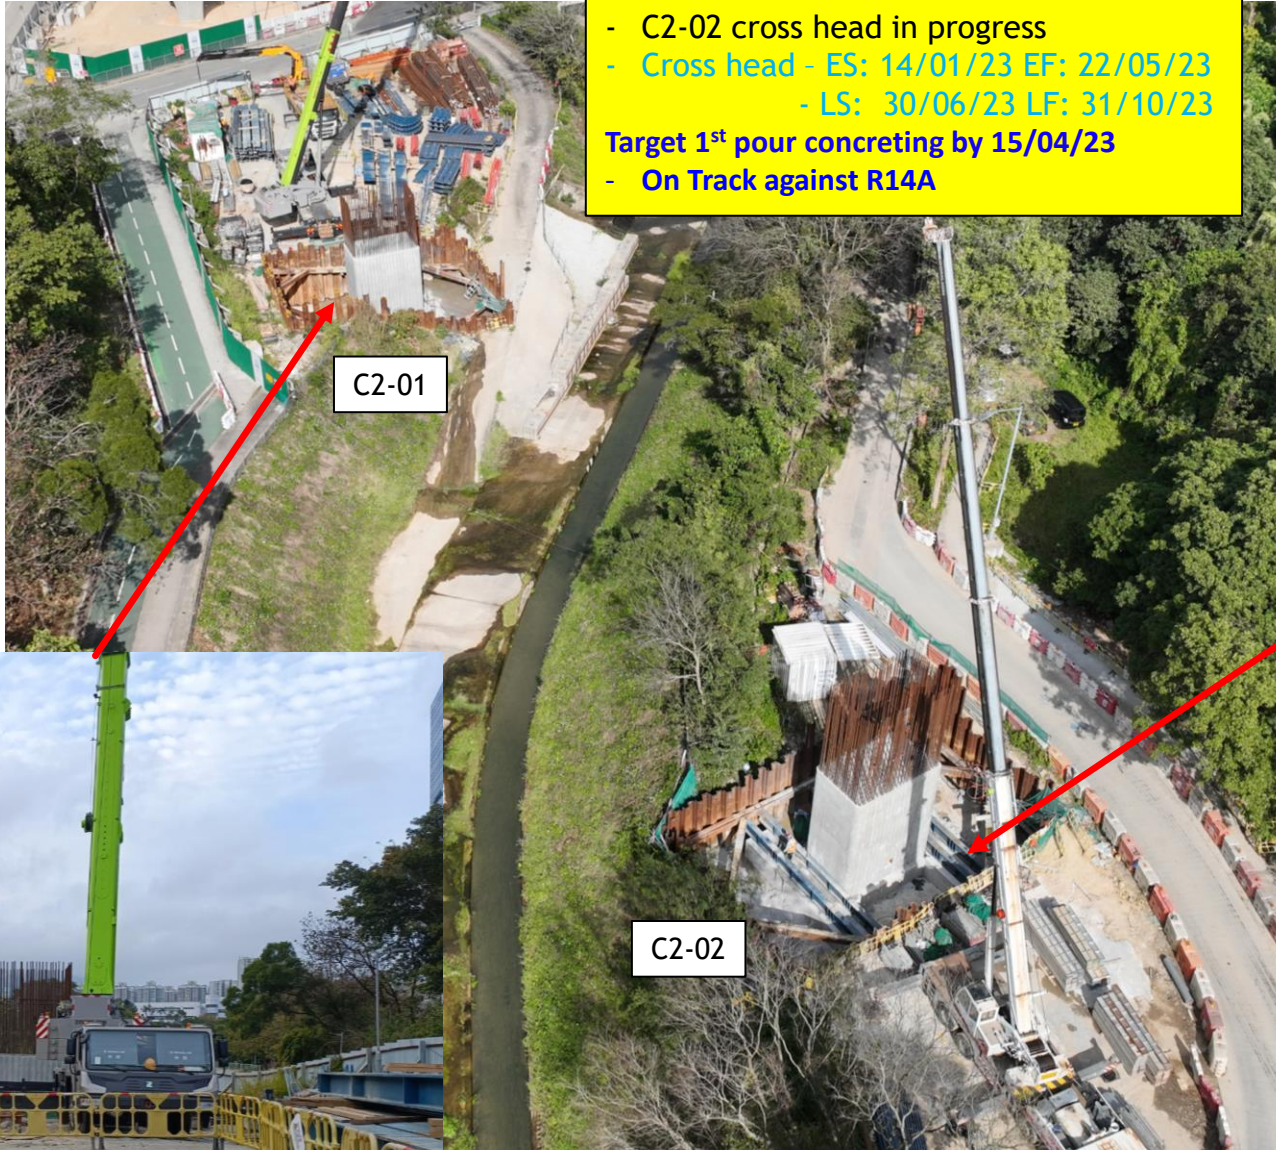
C2-02 cross head construction in progress

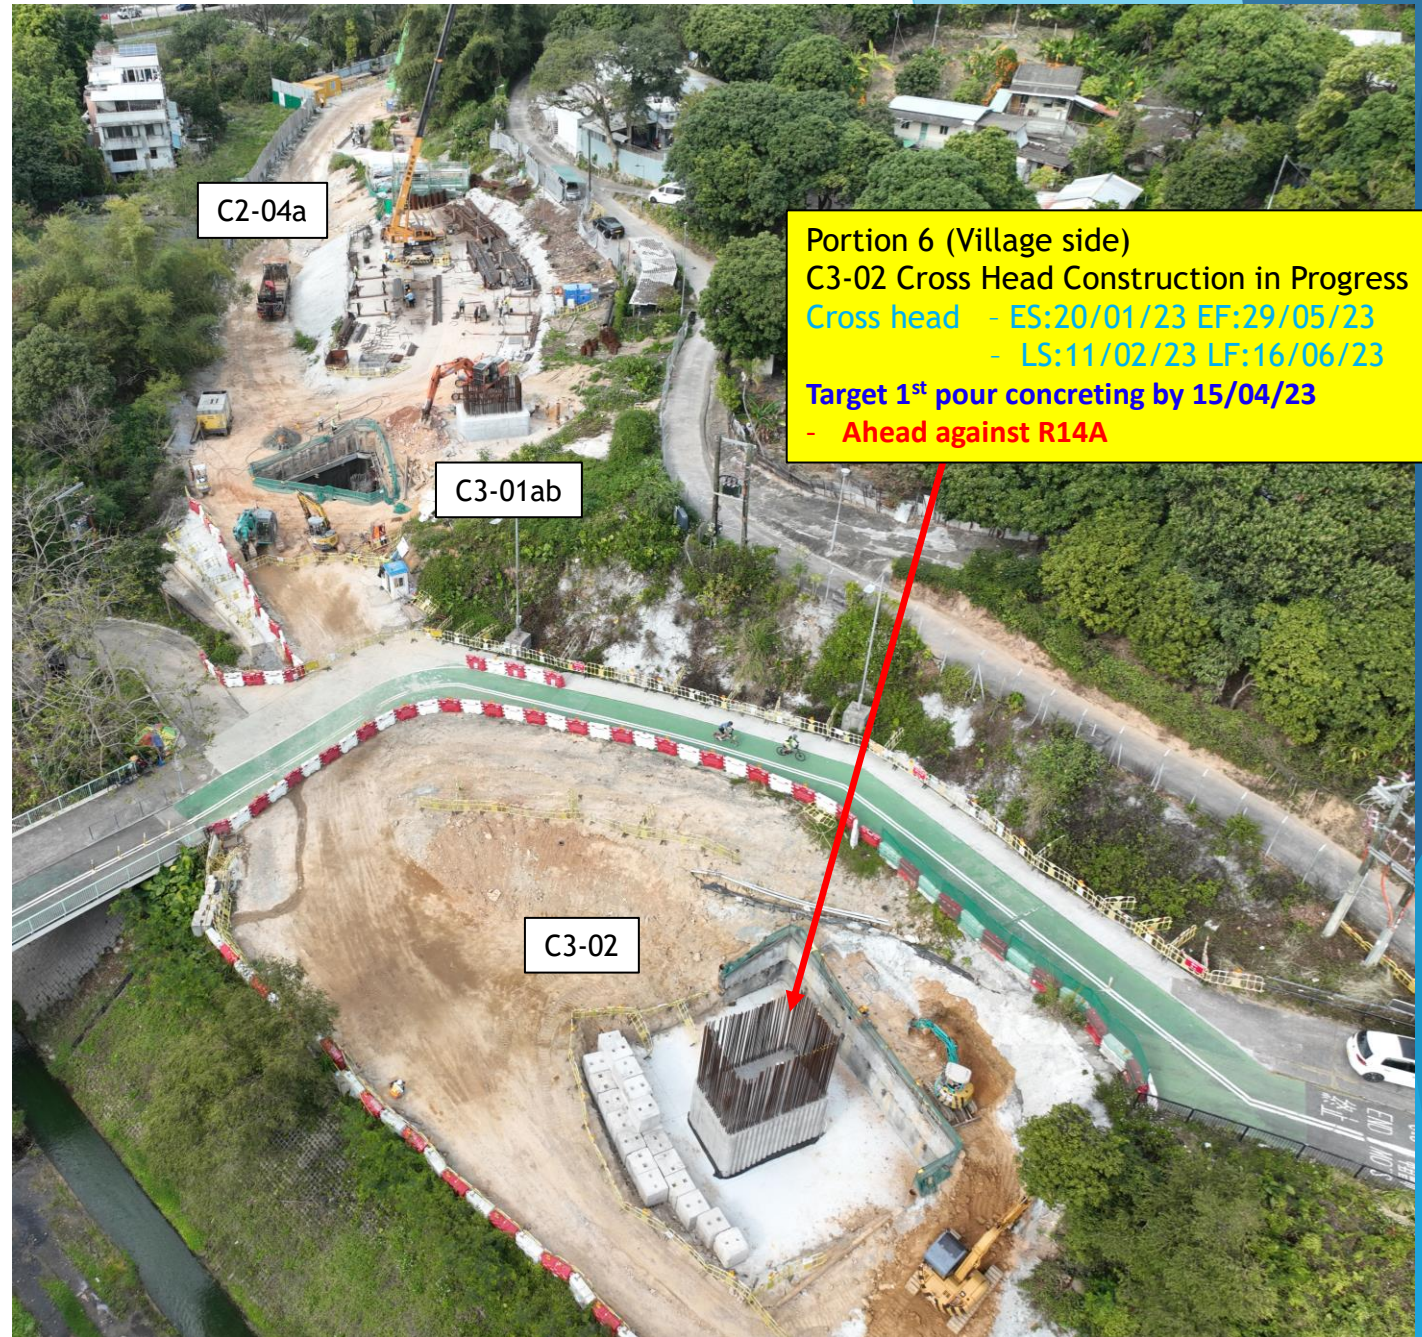
Portion 6 (Village side)  
C3-02 Cross Head Construction in Progress  
Cross head - ES:20/01/23 EF:29/05/23  
- LS:11/02/23 LF:16/06/23  
Target 1<sup>st</sup> pour concreting by 15/04/23  
- Ahead against R14A

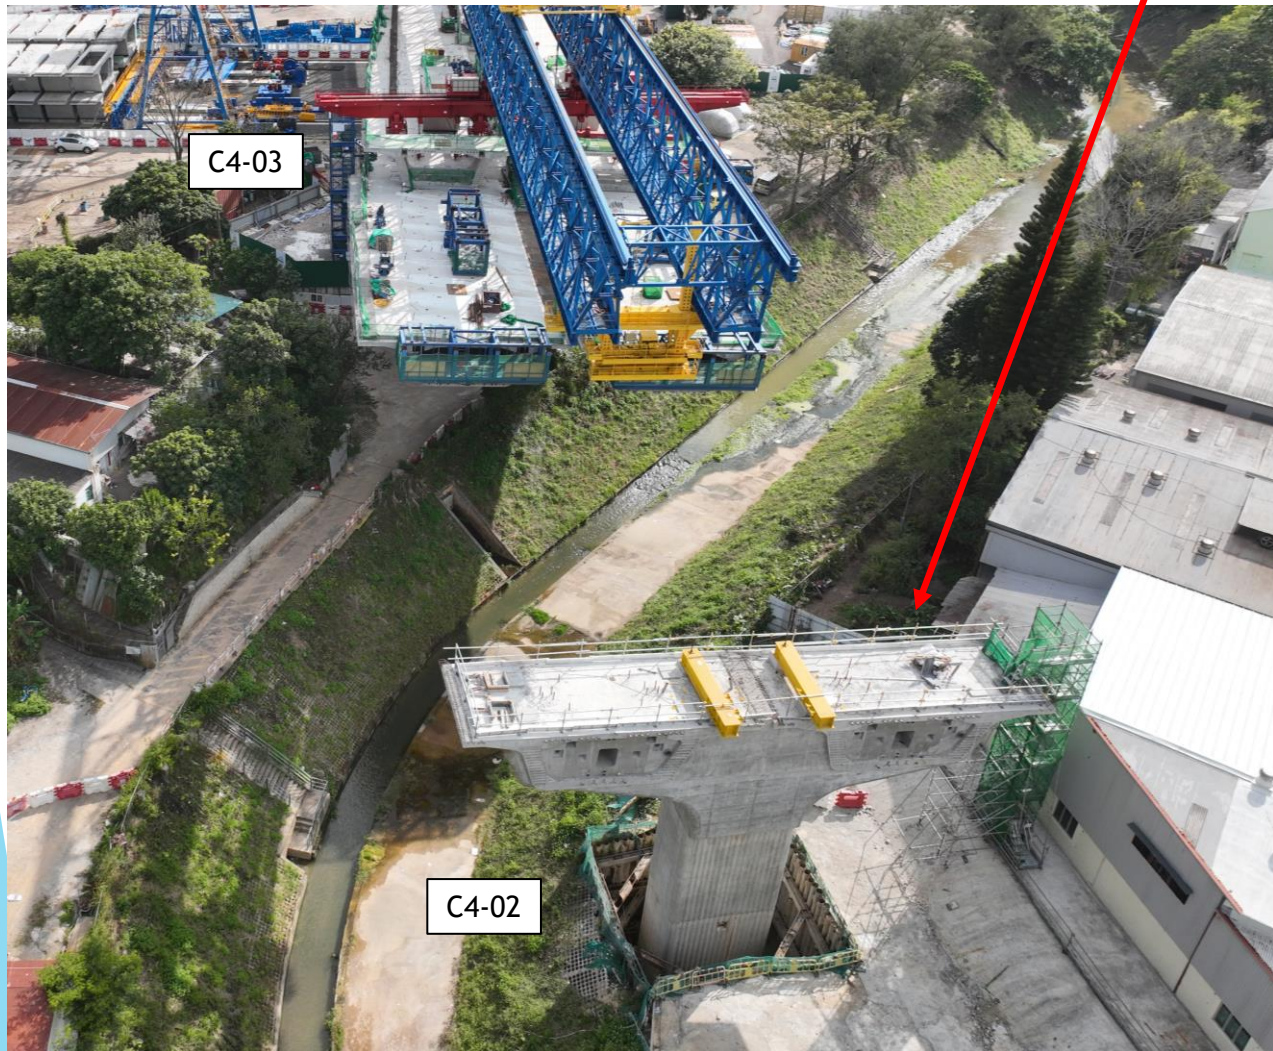
C4-02 Dismantling of temporary falsework completed on 13/01/23
