**Service Contract No. NDO 04/2019
Environmental Team for Environmental
Monitoring and Audit Works in
Construction Phase for the First Phase
Development of Kwu Tung North and
Fanling North New Development Areas**

**Monthly Environmental Monitoring and
Audit Report for June 2023**

Monthly Environmental Monitoring and Audit Report No. 44 (June 2023)

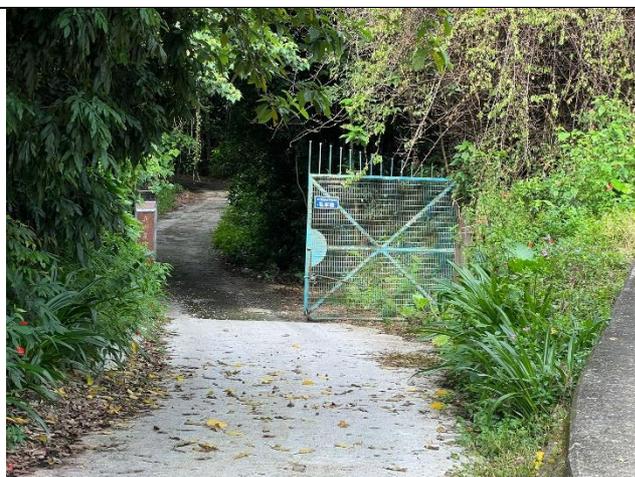
Photo 1. Inaccessible part of transect T5 located within a private property.

9.59 For the monitoring conducted on 23 June 2023 at Transect T5, a section of the transect route was found located within a private property and hence not accessible. Another section of transect T5 was found blocked by a new accumulation of fallen trees. The inaccessible part are shown in **Photo 1** and **Photo 2** below. The adjusted accessible transect route is shown in **Figure 11**.

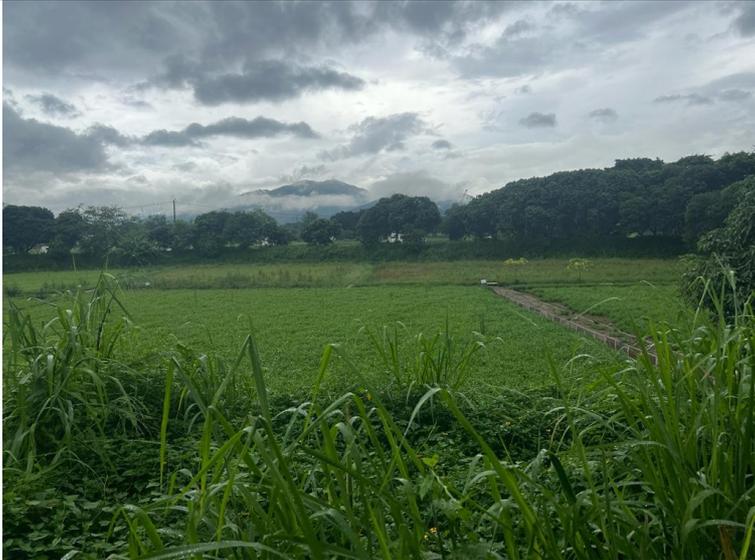
Table 10.5 Photographic Records of Site Activities in LVNP

<p>Continuing agricultural practice in existing farmland to maintain habitats in Long Valley</p>

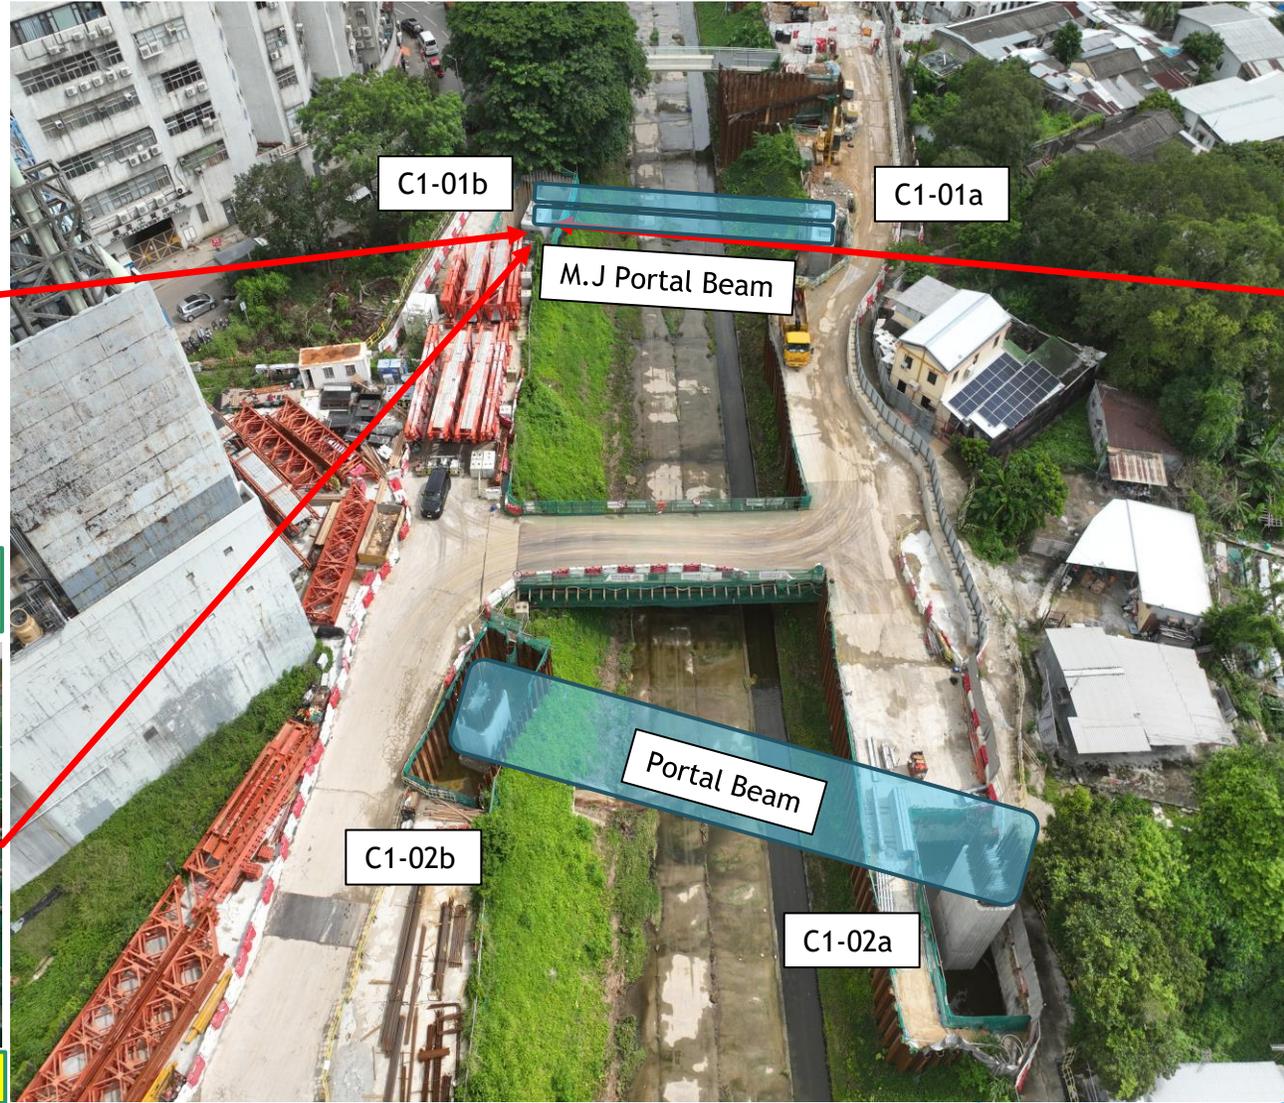
C1-01a bearing completed on 25/05/23

C1-01b bearing plinth completed on 20/05/23

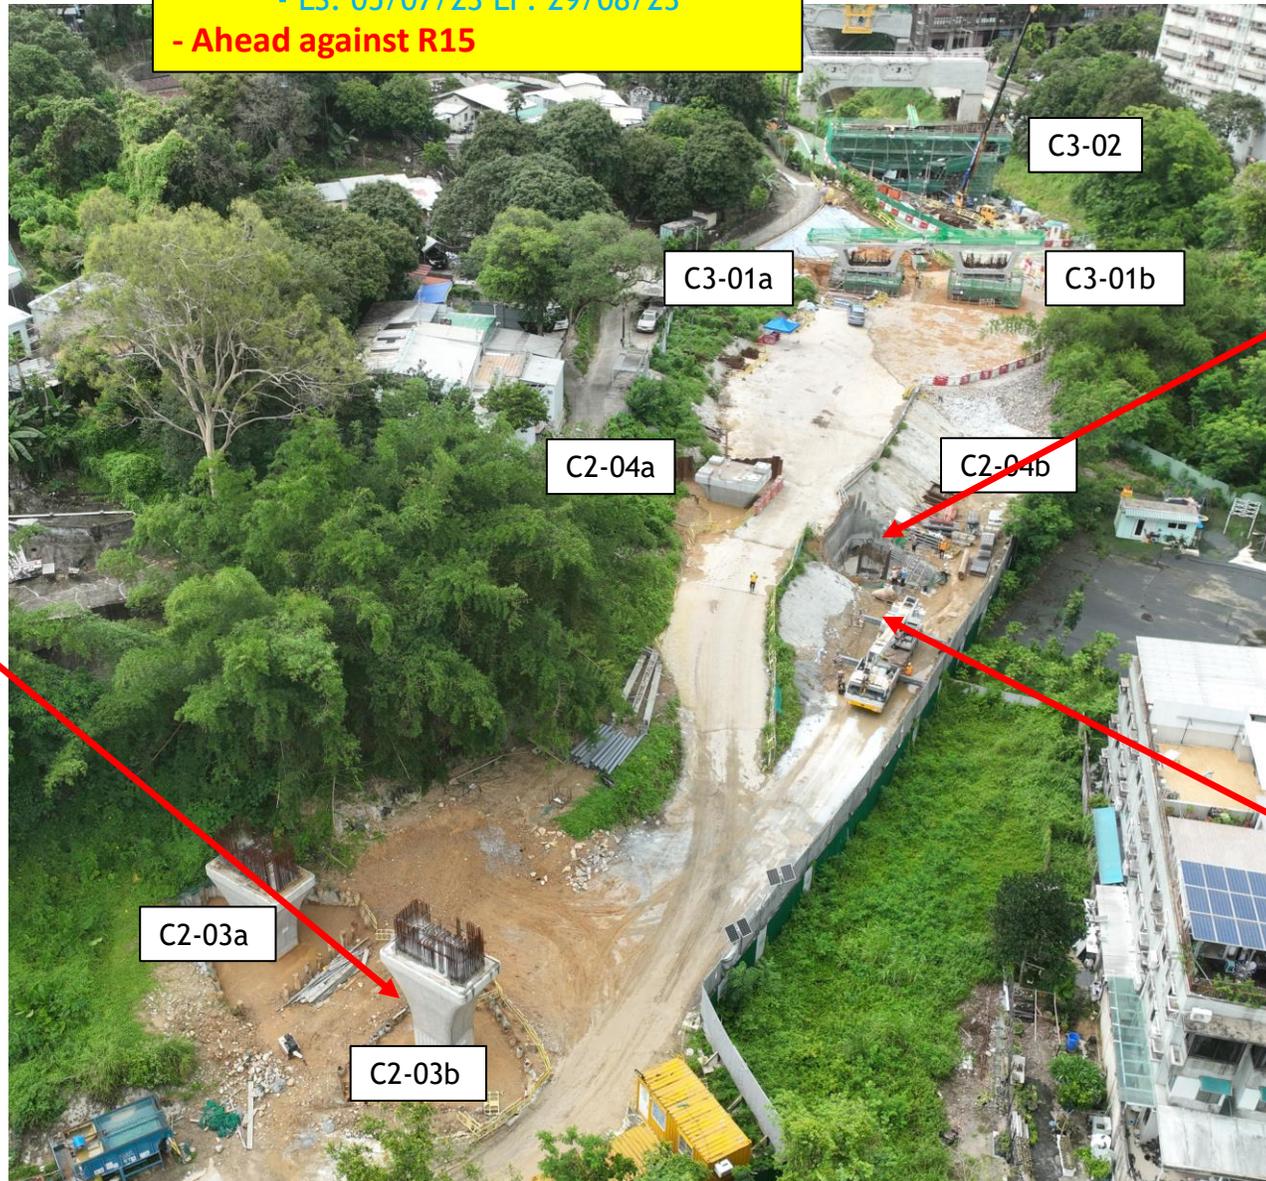
C2-03b hand over to backfilling works on 22/05/23

C2-04b pier construction in progress

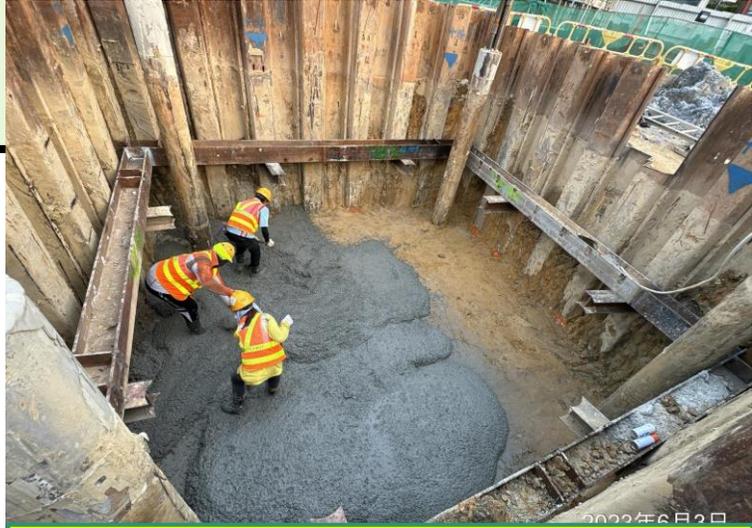
E2-01 Tower Crane Pile Cap rebar fixing in progress.

E2-01 Tower Crane foundation ELS and blinding layer completed on 03/06/23

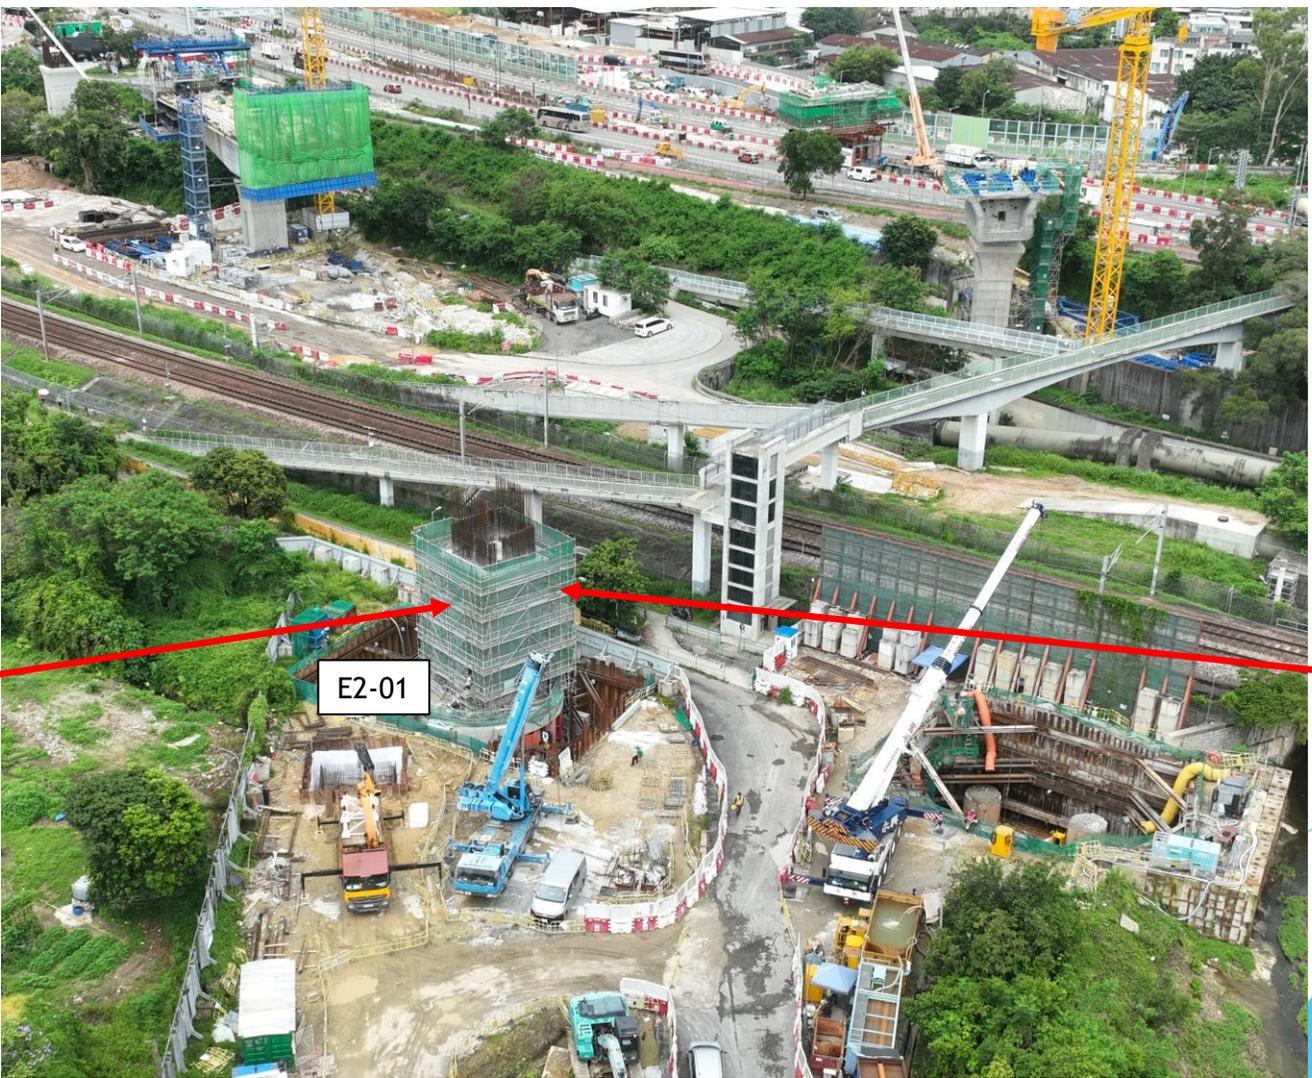
Rotation Bridge at Pier E2-01
 Pier head Construction in Progress
 - Pier head - ES: 12/04/23 EF:23/06/23
 LS: 24/05/23 LF:29/06/23
 Pier head (2nd pour) concreting completed on 01/06/23
 - **Ahead against R15**

E2-01 pier head (2st pour) concreting completed on 01/06/23

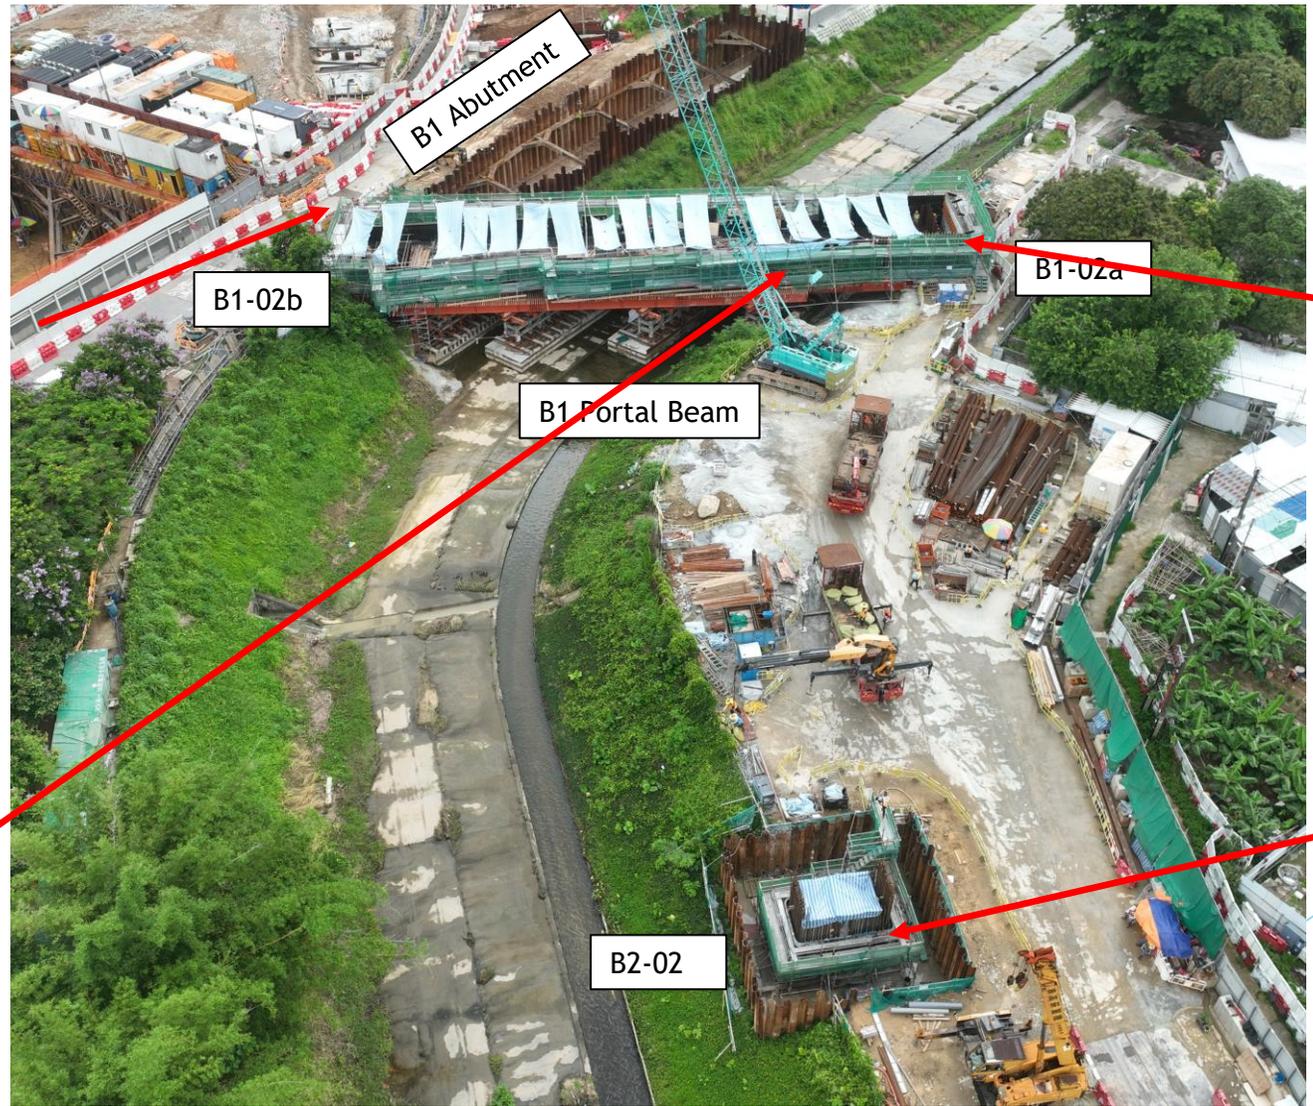
Segment kicker formwork at B1-02 portal beam in progress

Soffit formwork at B1-02 portal beam completed on 01/06/23

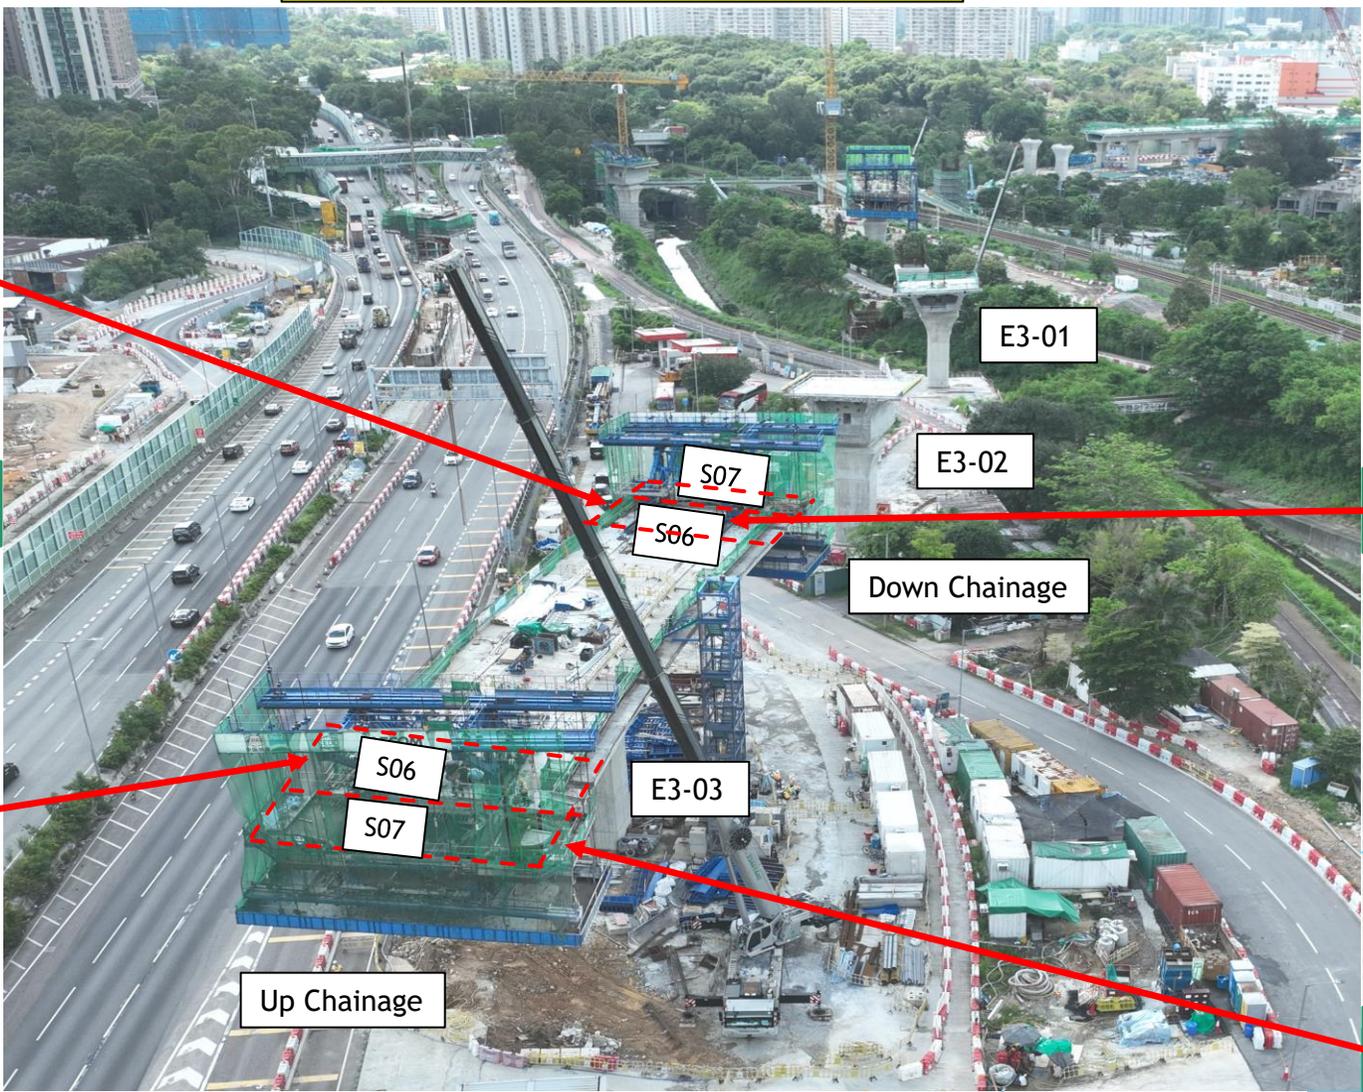
S06 segment (up Chainage) completed on 31/05/23

Rebar fixing at S07 segment (Lower Chainage) in progress

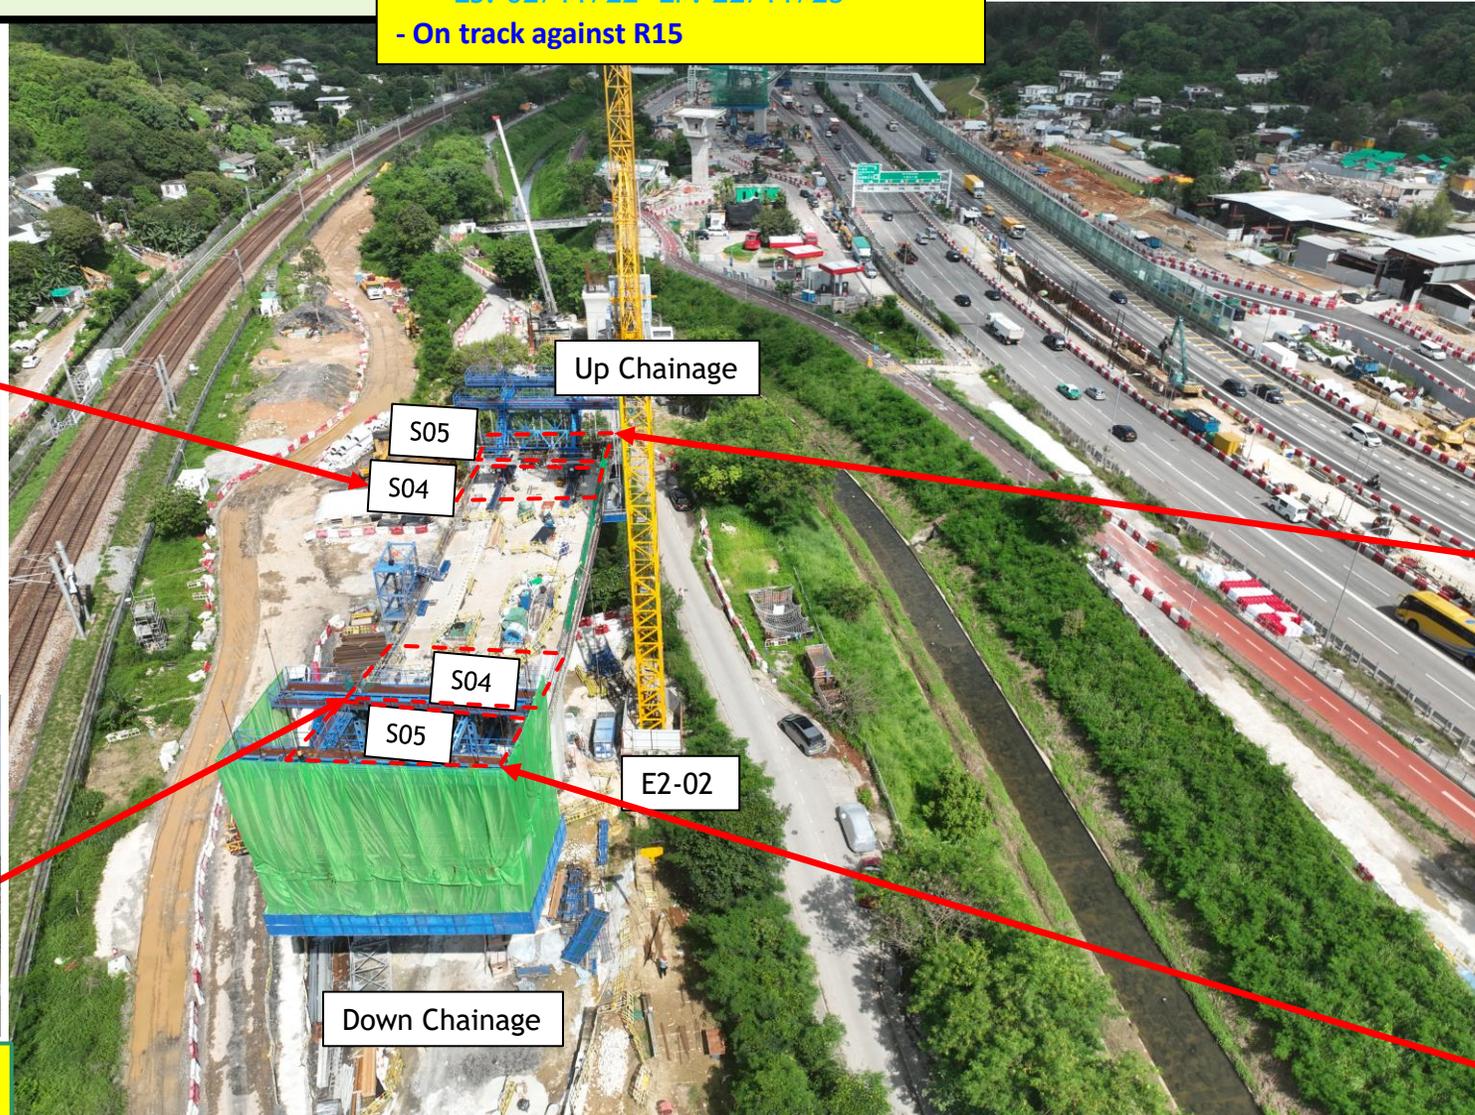
S04 segment (Down Chainage) completed on 17/05/23

Rebar fixing at S05 segment (Up Chainage) in progress

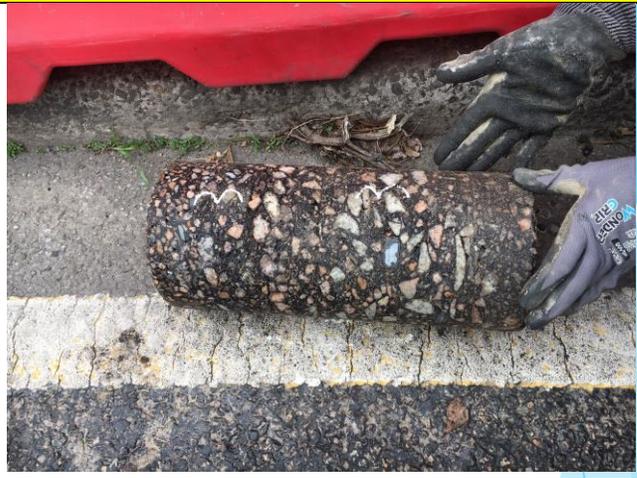
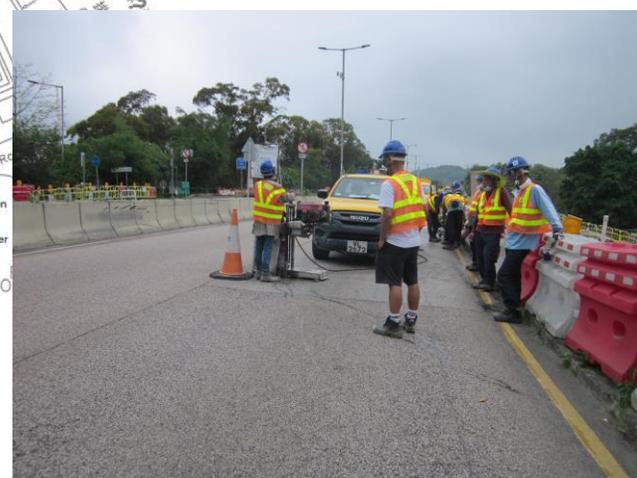
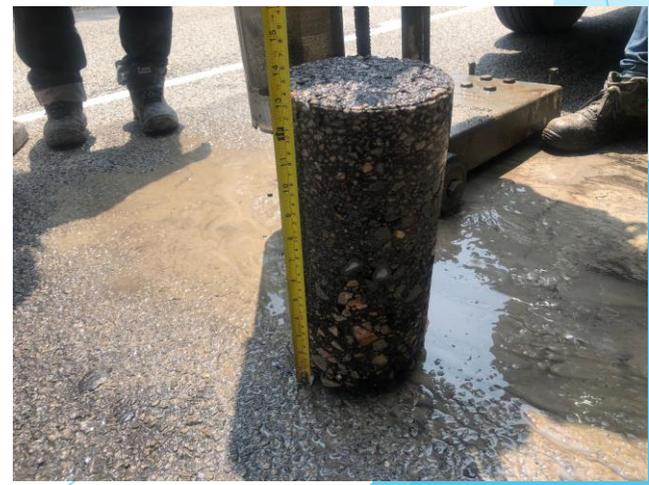
Jockey Club Road - CSD (Northbound)
Core sample of existing carriageway to verify the existing road condition for CSD of road re-construction to road re-surfacing.
