Service Contract No. NDO 04/2019 Environmental Team for Environmental Monitoring and Audit Works in Construction Phase for the First Phase Development of Kwu Tung North and Fanling North New Development Areas

Monthly Environmental Monitoring and Audit Report for May 2023

Monthly Environmental Monitoring and Audit Report No. 43 (May 2023)

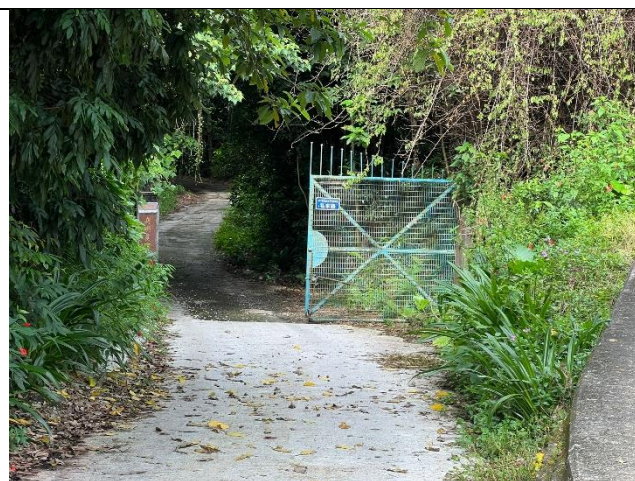
Photo 1. Inaccessible part of transect T5 located within a private property.

9.59 For the monitoring conducted on 8 May 2023 at Transect T5, a section of the transect route was found located within a private property and hence not accessible. Another section of transect T5 was found blocked by a new accumulation of fallen trees. The inaccessible part are shown in **Photo 1** and **Photo 2** below. The adjusted accessible transect route is shown in **Figure 11**.

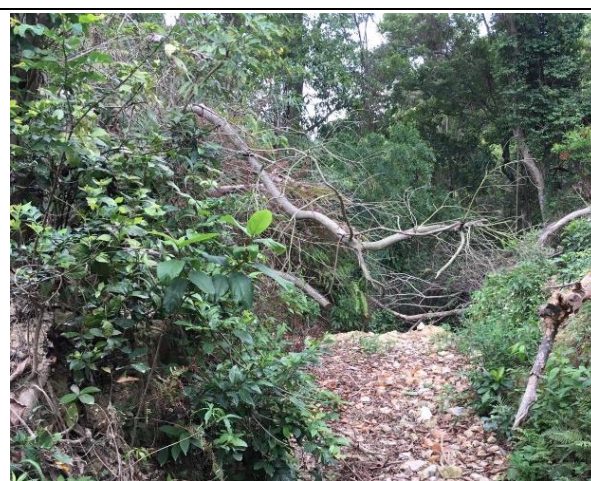
Photo 2. Inaccessible part of transect T5 blocked by fallen trees.

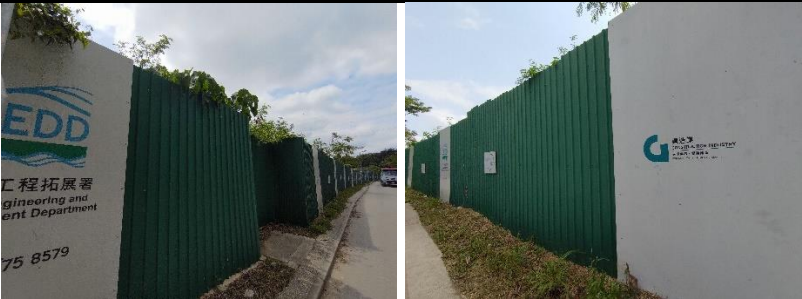
<p>To minimise adverse impacts on habitats of ecological importance in the vicinity of the Project, 2m high solid dull green site barrier fences shall be erected around all active works areas.</p>	Λ _[1]
EP- 467/2013/ A	2.9

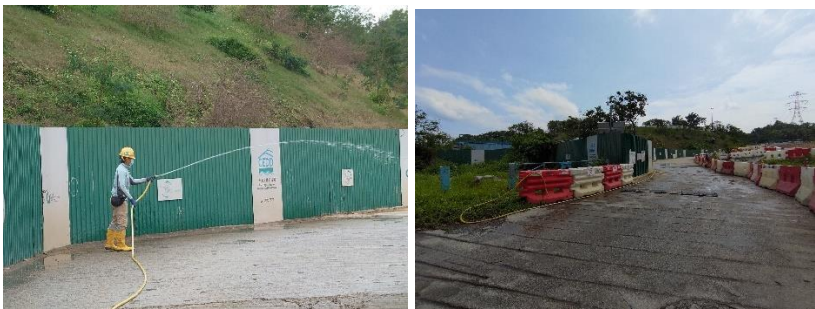
<p>To minimise adverse impacts on habitats of ecological importance in the vicinity of the Project, 2m high solid dull green site barrier fences shall be erected around all active works areas.</p>	Λ _[1]
EP- 468/2013/ A	2.11

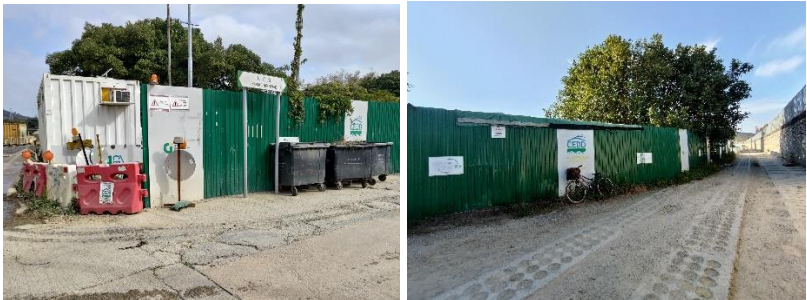
<p>To minimise adverse impacts on habitats of ecological importance in the vicinity of the Project, 2m high solid dull green site barrier fences shall be erected around all active works areas.</p>	Λ _[1]
EP- 469/2013	2.7

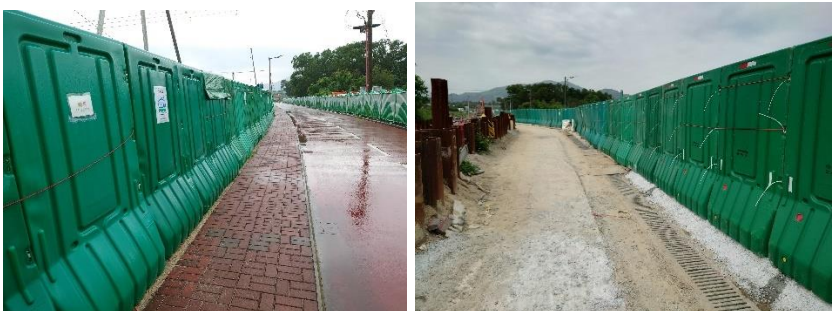
<p>To minimise adverse impacts on habitats of ecological importance in the vicinity of the Project, 2m high solid dull green site barrier fences shall be erected around all active works areas.</p>	Λ _[1]

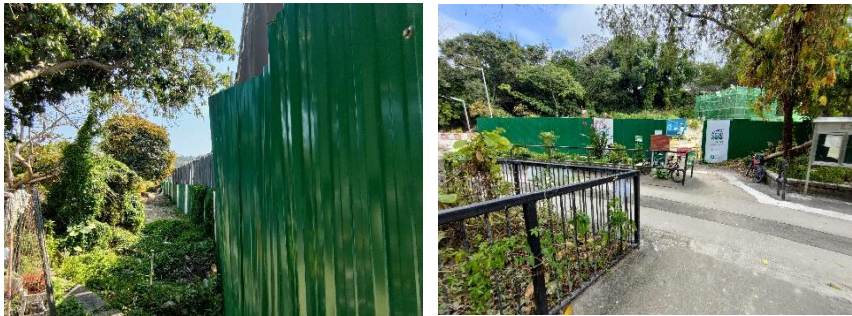
<p>EP- 473/2013/ A</p>	<p>2.13</p>

<p>To minimise adverse impacts on habitats of ecological importance in the vicinity of the Project, 2m high solid dull green site barrier fences shall be erected around all active works areas.</p>	<p>^_[1]</p>
<p>EP- 475/2013/ A</p>	<p>2.7</p>

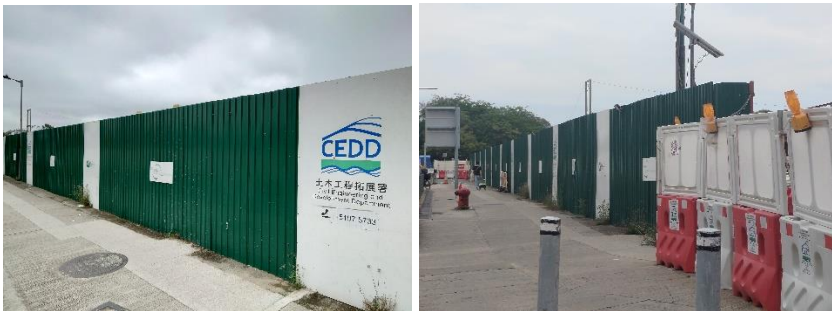
<p>To minimise adverse impacts on habitats of ecological importance in the vicinity of the Project, 2m high solid dull green site barrier fences shall be erected around all active works areas.</p>	<p>^_[1]</p>
<p>Implementation status:</p>	<p>^ Mitigation measure was fully implemented * Observation/reminder was made during site audit but improved/rectified by the contractor # Observation/reminder was made during site audit but not yet improved/ rectified by the contractor X Non-compliance of mitigation measure • Non-compliance but rectified by the contractor N/A Not Applicable at this stage as no such site activities were conducted in the reporting period</p>

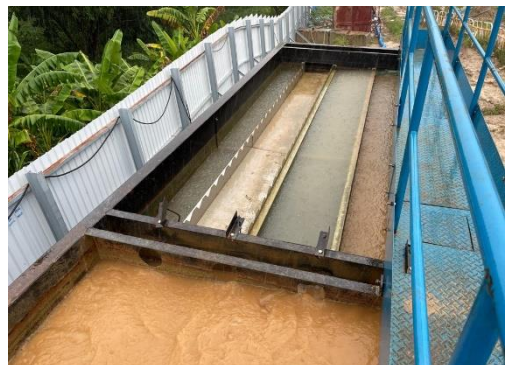
Covering dusty stockpile	Provision of sand bags around works area
ND/2019/07

Covering exposed slope surface with tarpaulin	De-silting waste water before discharge
Water quality mitigation measures for site(s) in operation phase, remaining defect works		
ND/2019/06	 	 
	Hard paved exposed haul road	Hard paved exposed haul road

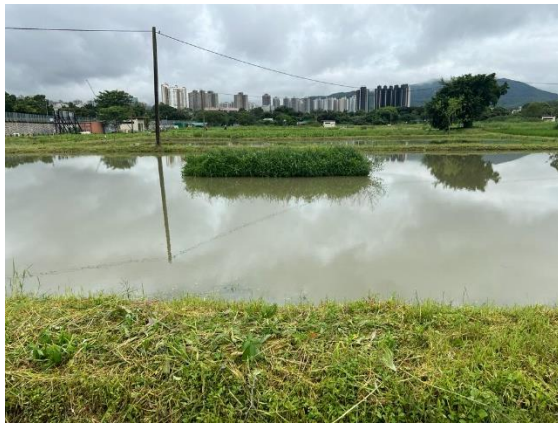
Enhancement of irrigation channel to provide reliable water source for farmland in Long Valley

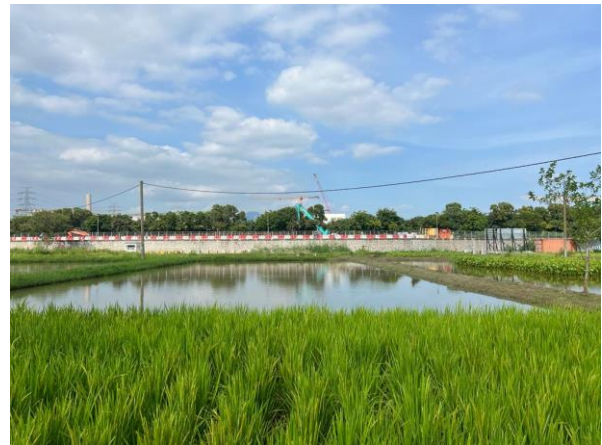
Provision of bird island (hidden area)

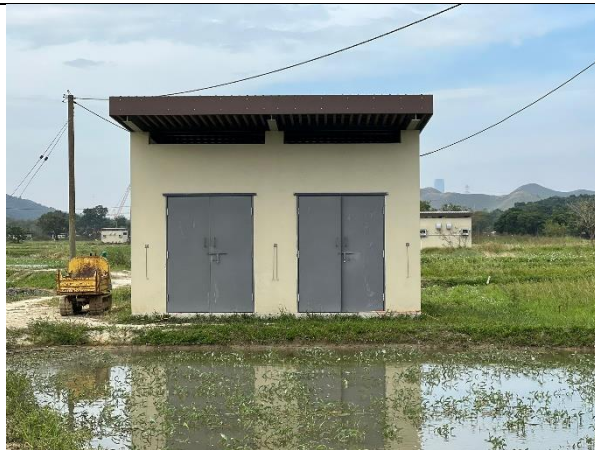
Restoring of water flea pond to provide food source to water birds

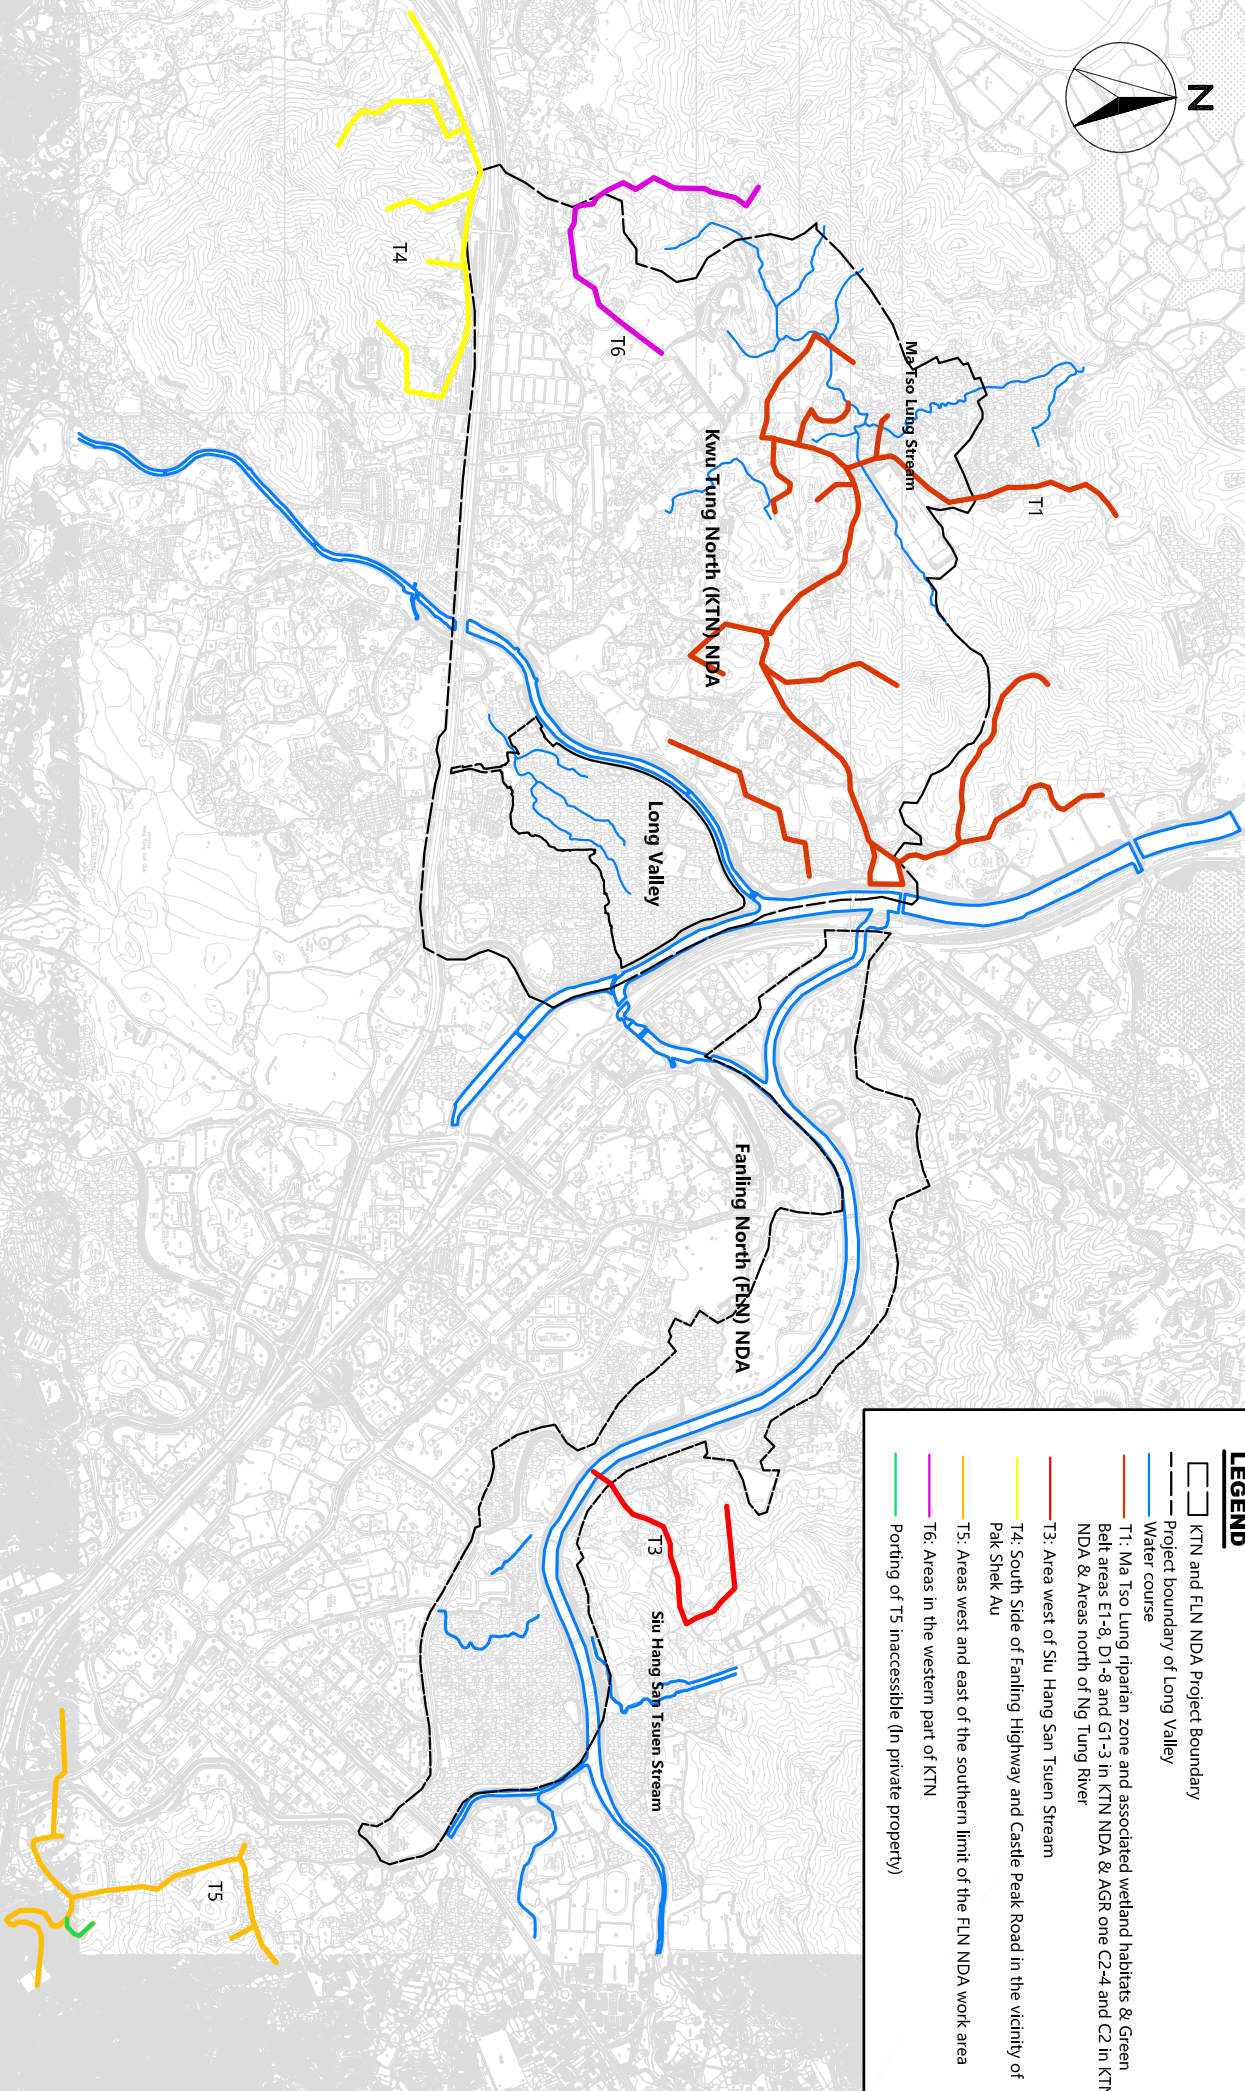
SCALE	A4 @ 1:70000	DATE	JUL 2021
CHECK	KL	DRAWN	ML
PROJECT No.	WMA20002	FIGURE NO.	11
		REV	—

Service Contract No. NDO 04/2019 Environmental Team for EM&A Works in Construction
Phase for the First Phase Development of KTN and FLN NDAs
Location of Transect Route of Ecological Sensitive Habitats
(Non-Aquatic Fauna) Transects (T1, T3-T6)

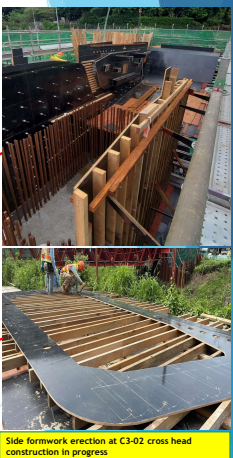
Portion 6 (Village side)
C3-02 Cross Head Construction In Progress
Cross head - ES: 01/02/23 EF: 29/06/23
LS: 01/06/23 LF: 23/08/23
Target 1st pour concreting by 29/05/23
On track against R15

Erection of soffit at C3-02 cross head construction completed on 06/05/23

Side formwork erection at C3-02 cross head construction in progress

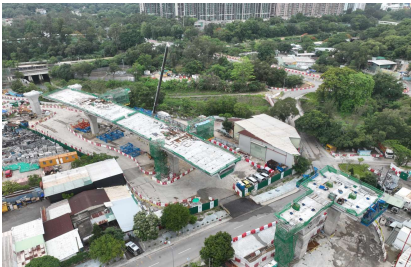
- T-span segments at pier D1-01 in progress
- Precast shell on D1-02 and D1-03, Rebar fixing is in progress

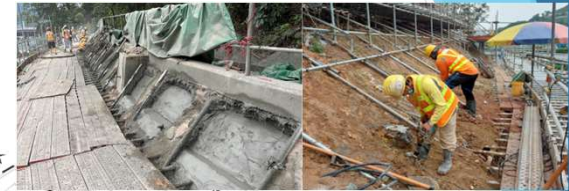
Row	Completed
Row B	Digging in Progress
Row C	Digging in Progress
Row D	Target 25/5/2023
Row E	Target 19/5/2023
Row F	Completed (15/5/2023)
Row G	Completed (9/5/2023)

1. FS 04 - Soil Nail
TSW 1138 (R15) ES: 01/11/22 EF: 04/05/23
LS: 19/05/23 LF: 16/06/23
• Digging work of soil nail head in progress
• Concreting of soil nail head in progress

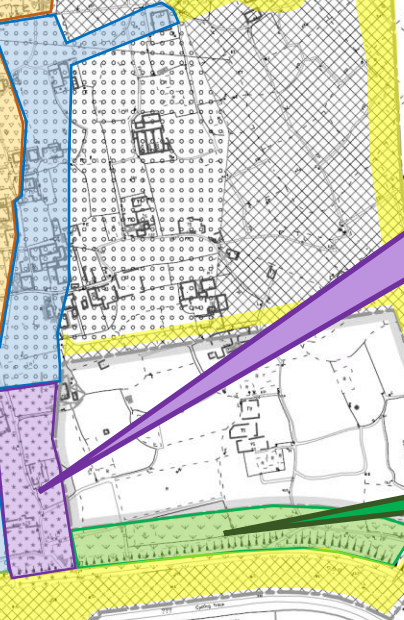
PORTION V

- C&D waste disposal
- Construction of noise barrier
- Construction of site haul road
- Drainage works
- Sewerage works
- Road works

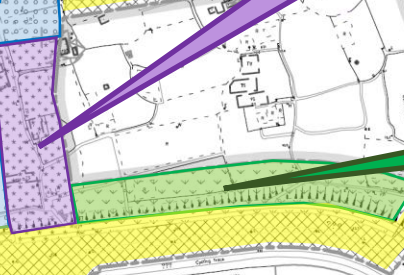
PORTION III

- Drainage works
- Sewerage works

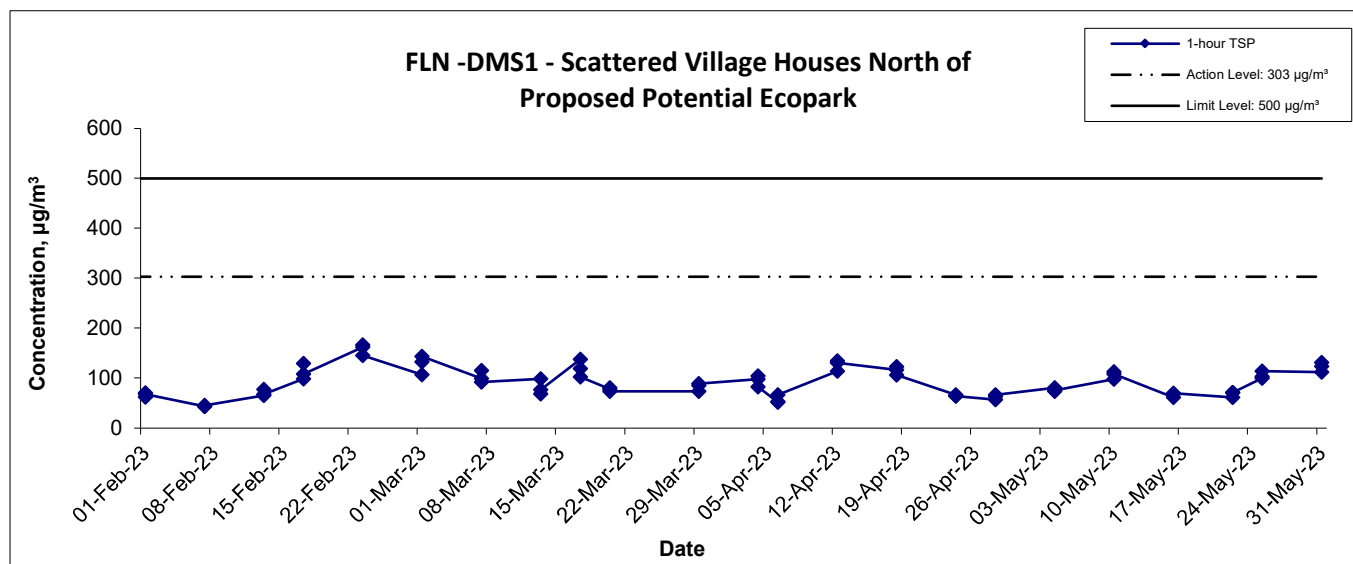
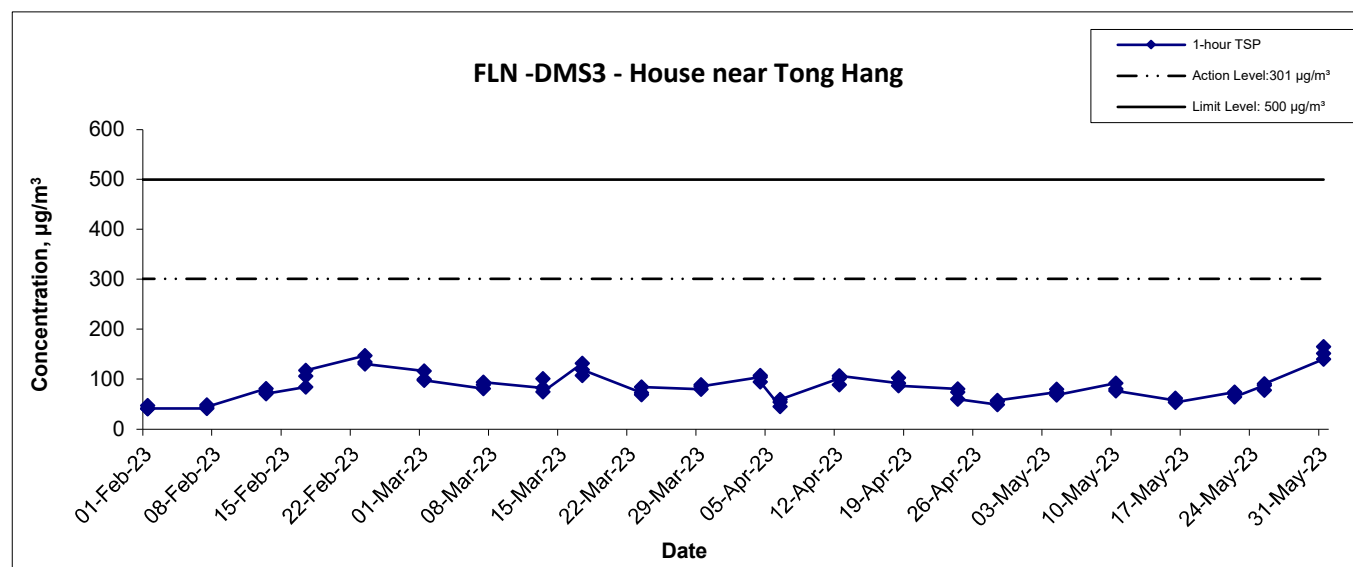
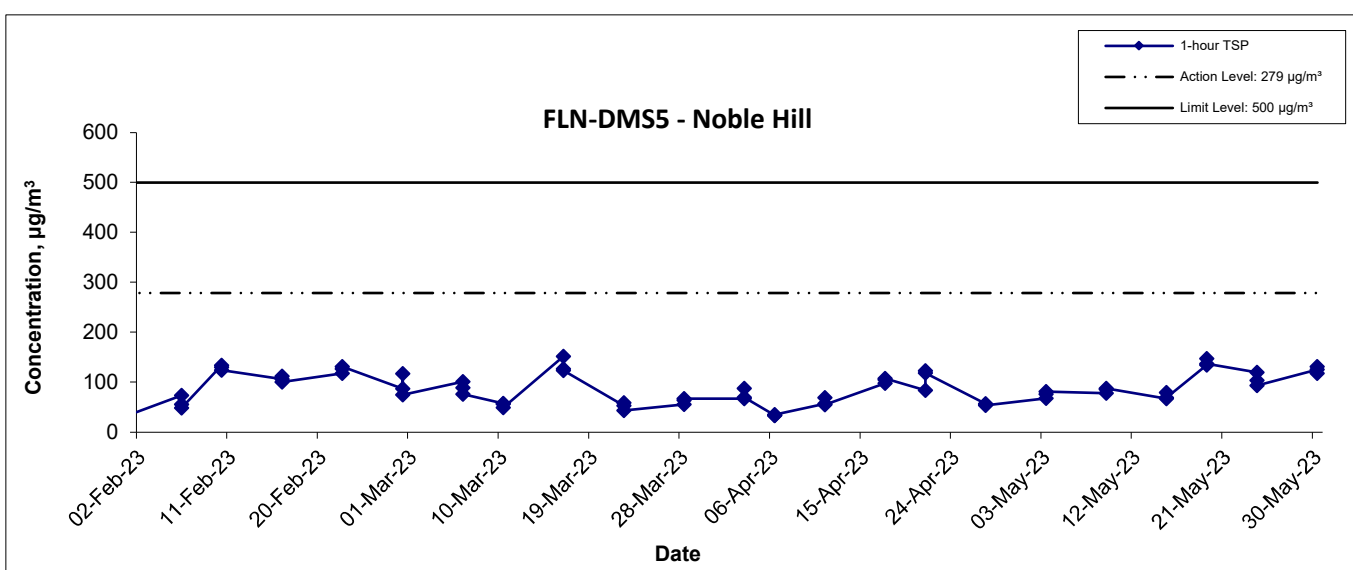
1-hr TSP Concentration Levels

Title	Service Contract No. NDO 04/2019		
	Environmental Team for Environmental Monitoring and Audit Works in Construction Phase for the First Phase Development of Kwu Tung North and Fanling North New Development Areas		
	Graphical Presentation of 1-hour TSP Monitoring Results		
Scale	N.T.S		Project No.
	Date		WMA20002
May 23		Appendix	E

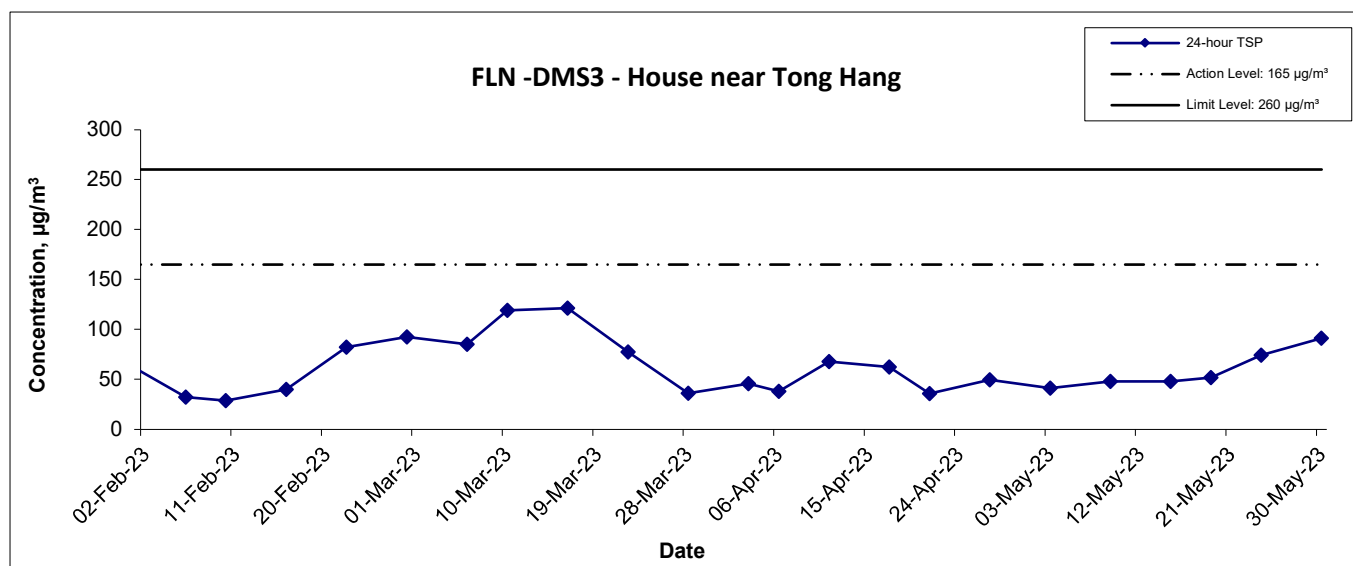
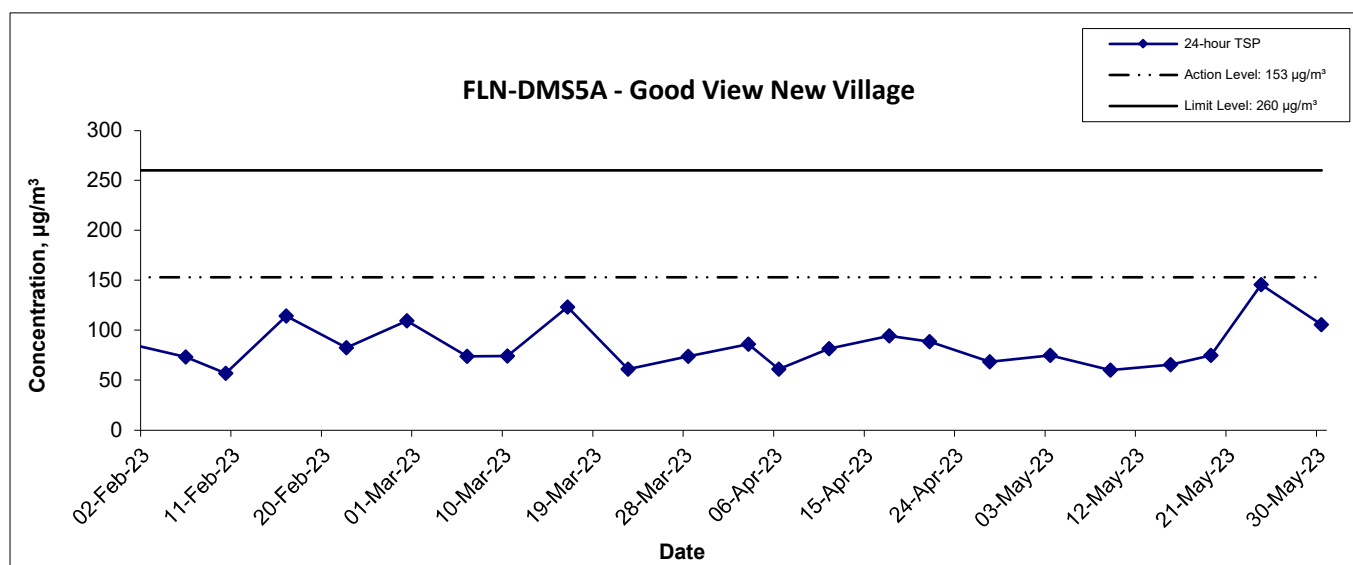
24-hr TSP Concentration Levels

Title Service Contract No. NDO 04/2019 Environmental Team for Environmental Monitoring and Audit Works in Construction Phase for the First Phase Development of Kwu Tung North and Fanling North New Development Areas Graphical Presentation of 24-hour TSP Monitoring Results	Scale	Project No.

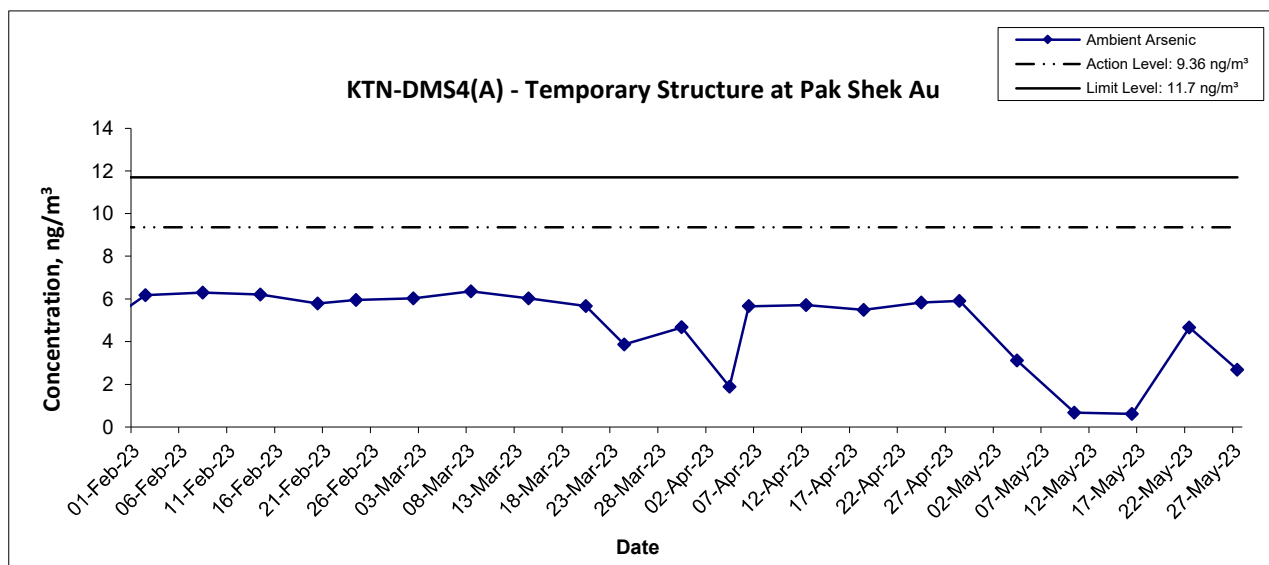
Title Service Contract No. NDO 04/2019 Environmental Team for Environmental Monitoring and Audit Works in Construction Phase for the First Phase Development of Kwu Tung North and Fanling North New Development Areas Graphical Presentation of Ambient Arsenic Monitoring Results	Scale N.T.S	Project No. WMA20002

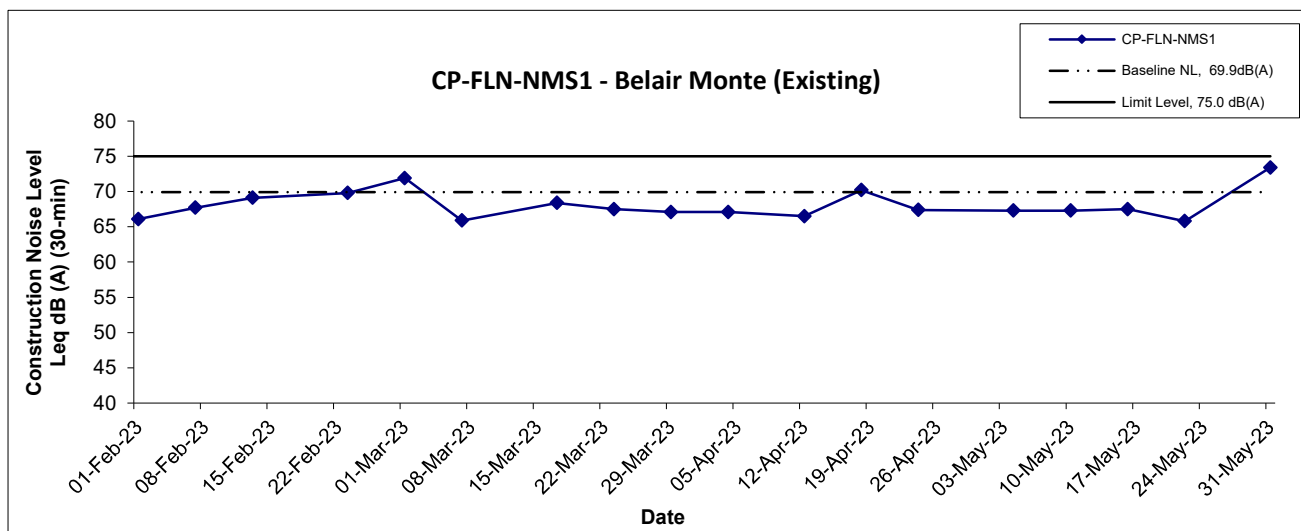
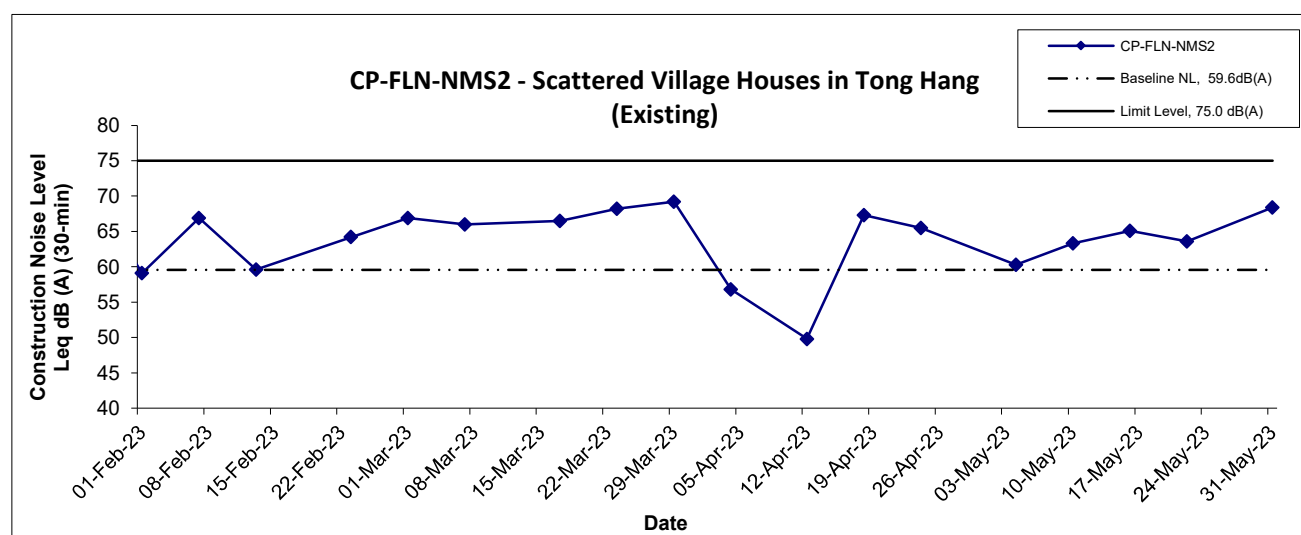
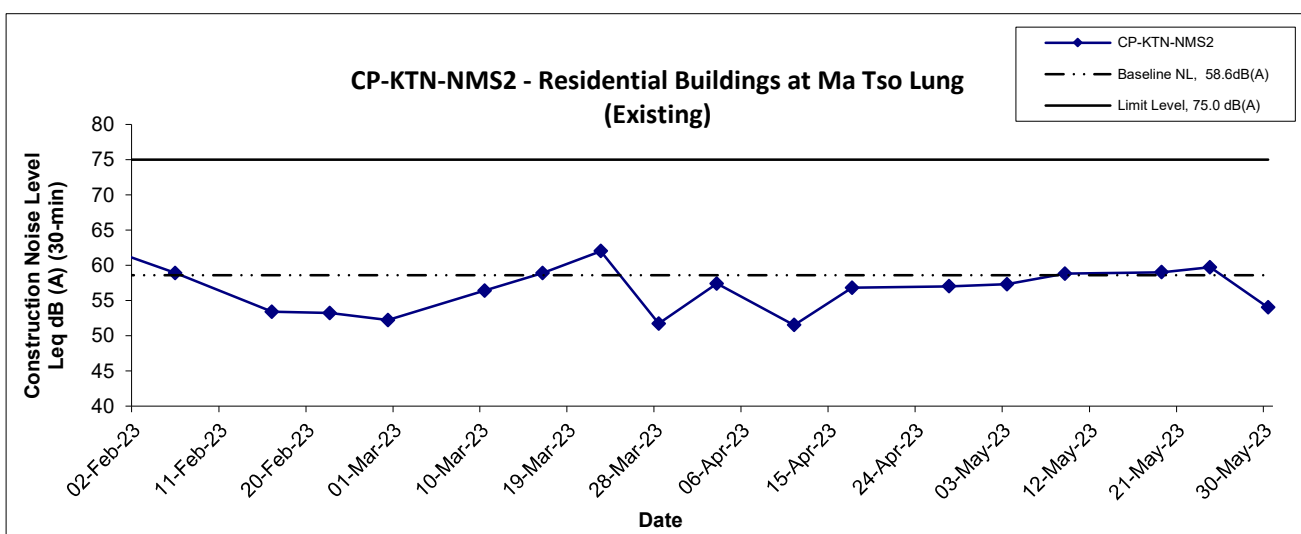
Noise Levels

Title Service Contract No. NDO 04/2019 Environmental Team for Environmental Monitoring and Audit Works in Construction Phase for the First Phase Development of Kwu Tung North and Fanling North New Development Areas Graphical Presentation of Construction Noise Monitoring Results	Scale N.T.S	Project No. WMA20002

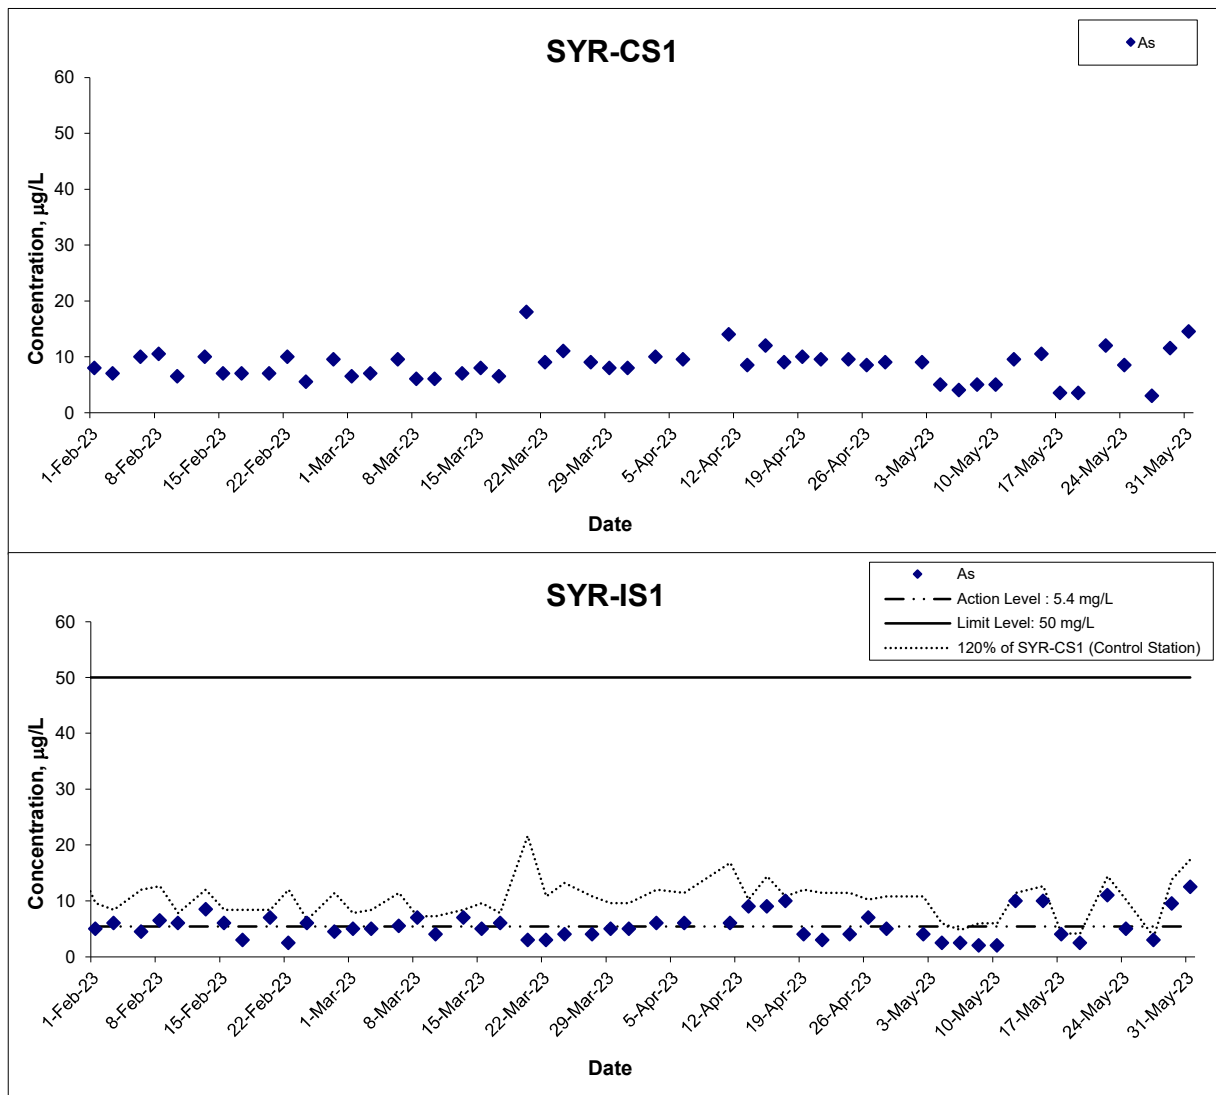
Arsenic (Depth-averaged)

Title Contract No. NDO 04/2019 Advance and First Stage Works of Kwu Tung North and Fanling North New Development Areas Graphical Presentation of Water Quality Monitoring Results	Scale N.T.S	Project No. WMA20002
