Service Contract No. NDO 04/2019
Environmental Team for Environmental
Monitoring and Audit Works in
Construction Phase for the First Phase
Development of Kwu Tung North and
Fanling North New Development Areas

Monthly Environmental Monitoring and Audit Report for November 2023

Monthly Environmental Monitoring and Audit Report No. 49 (November 2023)

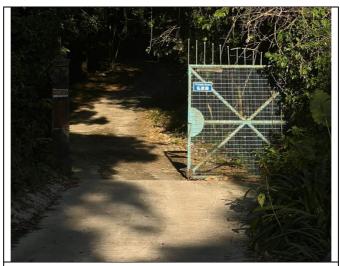
Photo 1. Inaccessible part of transect T5 located within a private property.

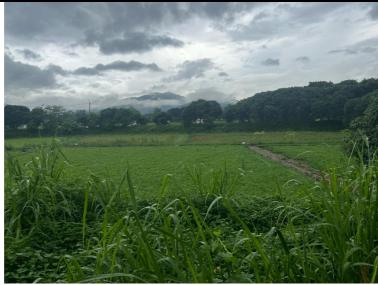
Table 10.6 Photographic Records of Site Activities in LVNP

Continuing agricultural practice in existing farmland to maintain habitats in Long Valley

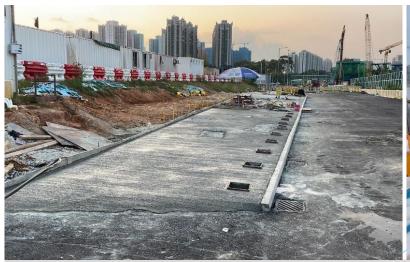
Preparation Works Before TTA 325

- 1. Light poles and Type 2 Railings installation
- 2. Remedial work for Defects in Stormwater Manholes
- 3. CCTV inspection for new drainage system

- 4. Concrete Footpath
- 5. Bituminous pavement (HKY Entrance)
