# **Civil Engineering and Development Department**

## **Service Contract No. NDO 04/2019 Environmental Team for Environmental Monitoring and Audit Works in Construction Phase for the First Phase Development of Kwu Tung North and Fanling North New Development Areas**

### **Monthly Environmental Monitoring and Audit Report for June 2024**

**Monthly Environmental Monitoring and Audit Report No. 56 (June 2024)**

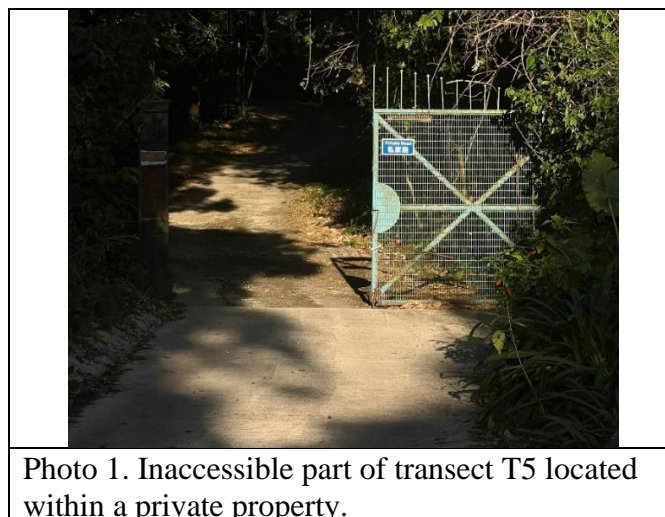
9.59 For the monitoring conducted on 6 June 2024 at Transect T5, a section of the transect route was found located within a private property and hence not accessible. The inaccessible part are shown in **Photo 1** below. The adjusted accessible transect route is shown in **Figure 11**.

Photo 1. Inaccessible part of transect T5 located within a private property.

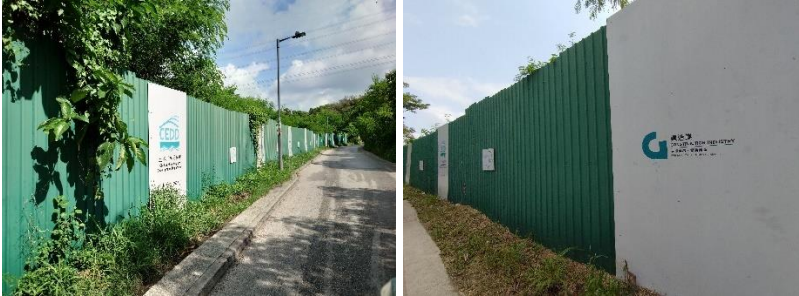
EP No.	Condition	Photographic Record	Implementation Status
<u>EP-466/2013/</u> <u>A</u>	2.9

<p>To minimise adverse impacts on habitats of ecological importance in the vicinity of the Project, 2m high solid dull green site barrier fences shall be erected around all active works areas.</p>	^ <sub>[1]</sub>
<u>EP-467/2013/</u> <u>A</u>	2.9

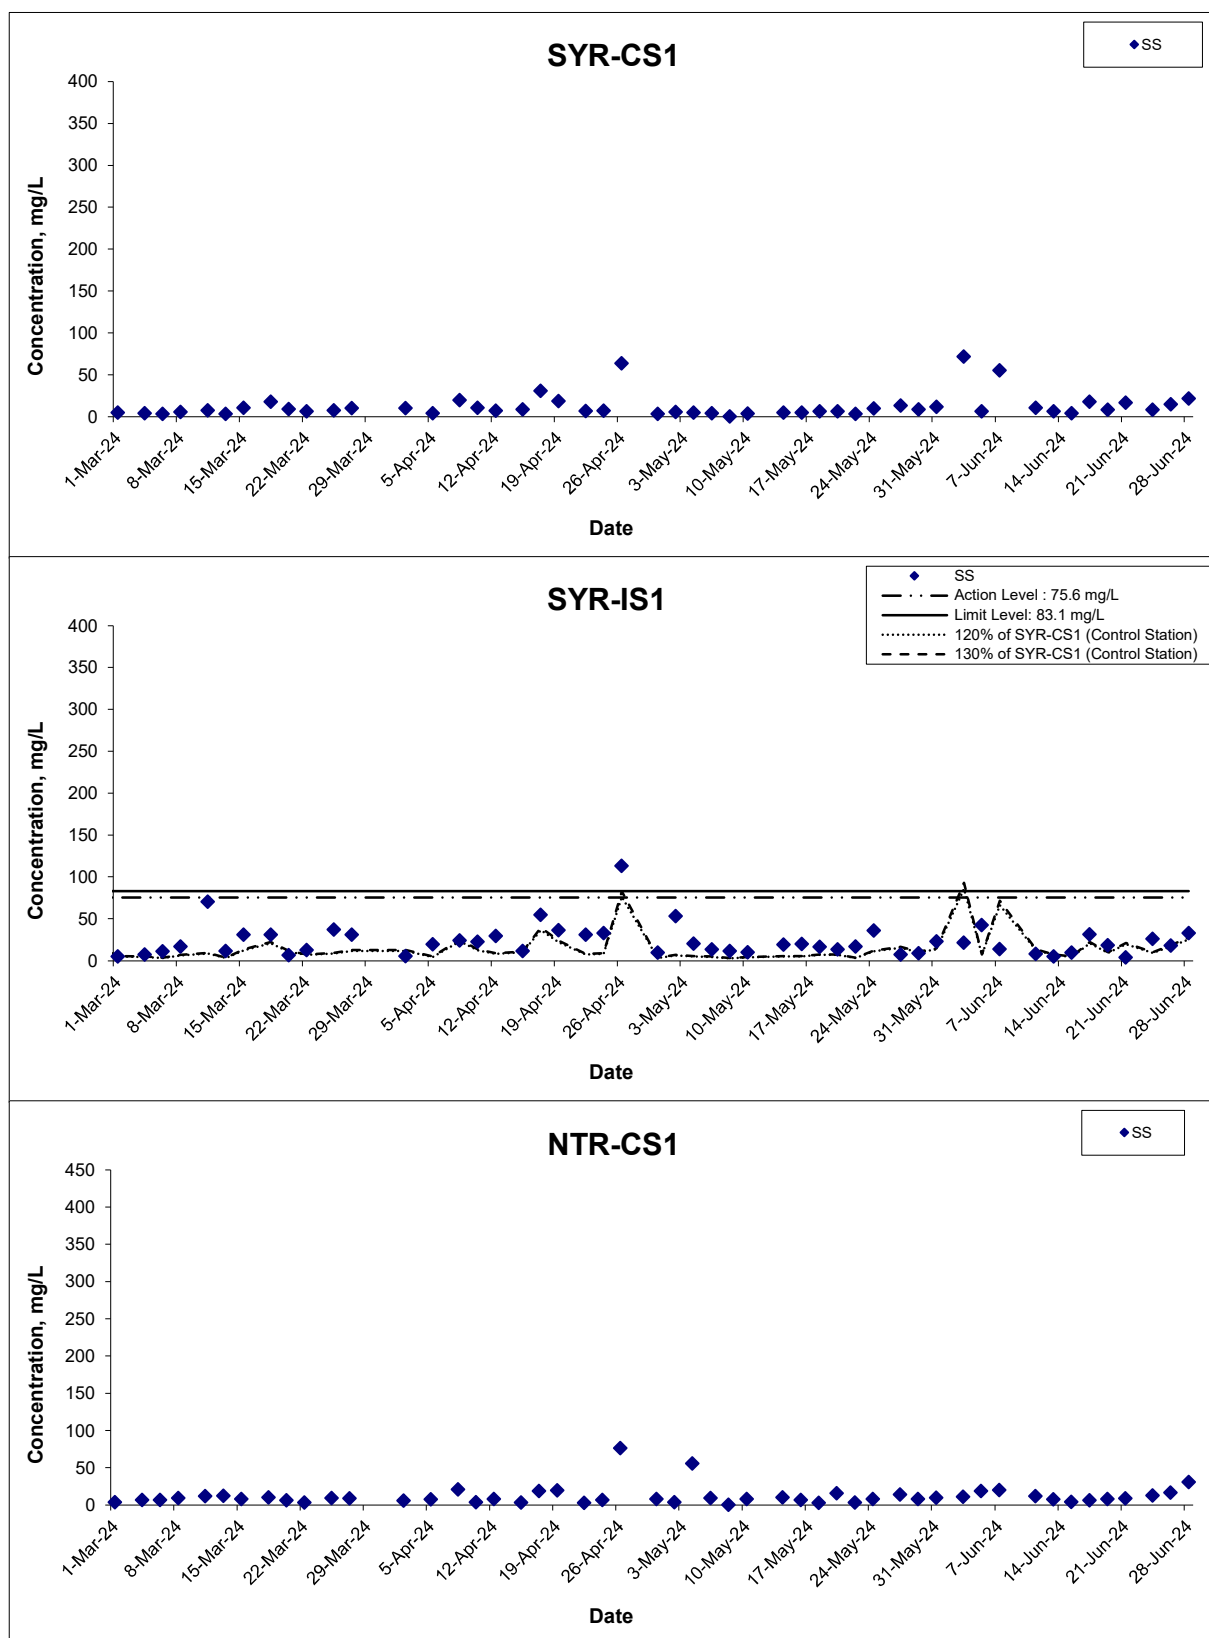
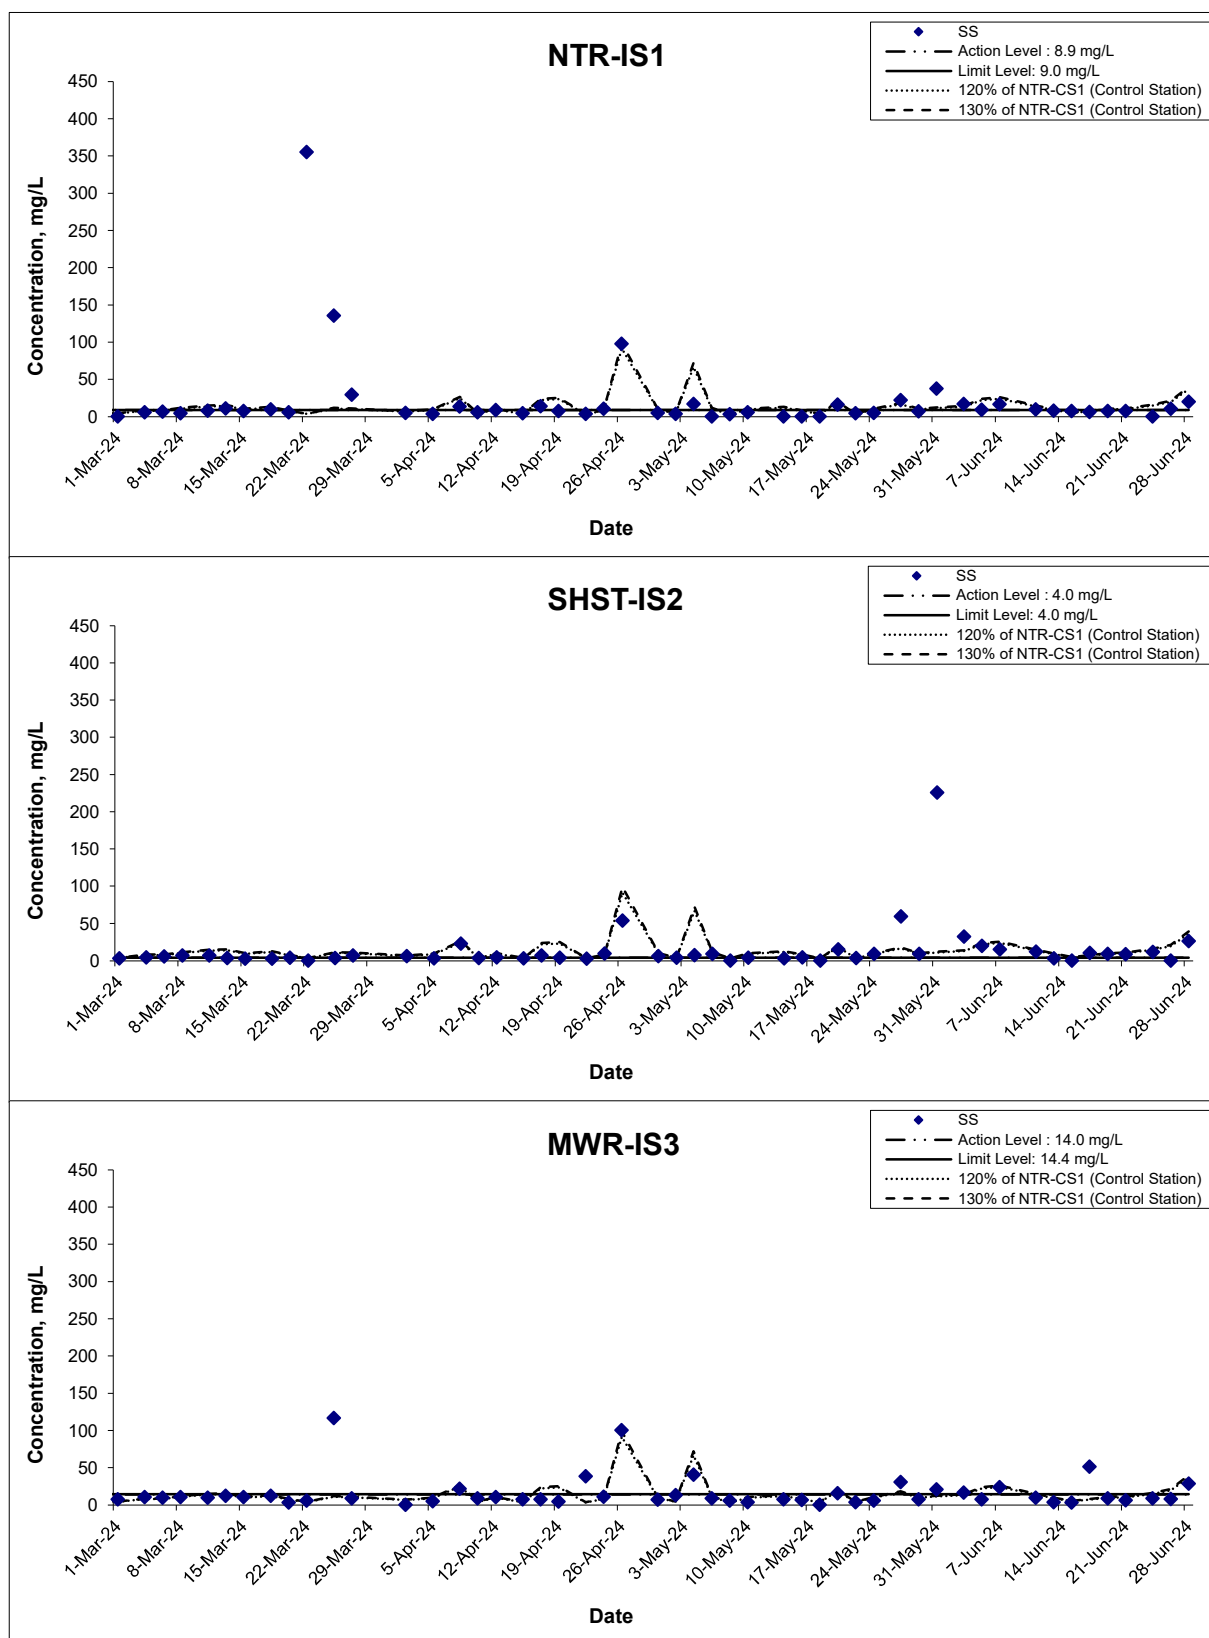
## Suspended Solids (Depth-averaged)

Remark: The graphical point at zero concentration is presented as <2.5 mg/L
