**Service Contract No. NDO 04/2019
Environmental Team for Environmental
Monitoring and Audit Works in
Construction Phase for the First Phase
Development of Kwu Tung North and
Fanling North New Development Areas**

**Monthly Environmental Monitoring and
Audit Report for September 2024**

Monthly Environmental Monitoring and Audit Report No. 59 (September 2024)

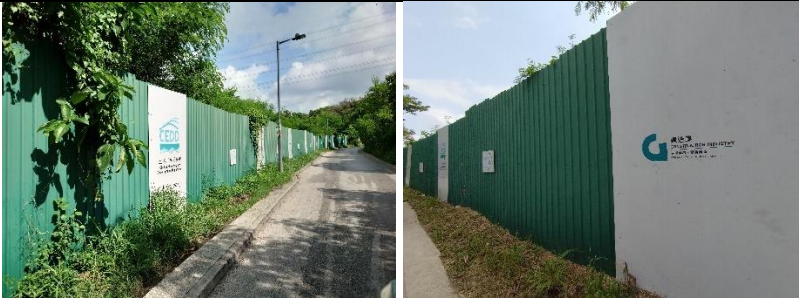
EP No.	Condition	Photographic Record	Implementation Status
<u>EP-466/2013/A</u>	2.9

<p>To minimise adverse impacts on habitats of ecological importance in the vicinity of the Project, 2m high solid dull green site barrier fences shall be erected around all active works areas.</p>	^ _[1]
<u>EP-467/2013/A</u>	2.9
