**Service Contract No. NDO 04/2019
Environmental Team for Environmental
Monitoring and Audit Works in
Construction Phase for the First Phase
Development of Kwu Tung North and
Fanling North New Development Areas**

**Monthly Environmental Monitoring and
Audit Report for May 2025**

Monthly Environmental Monitoring and Audit Report No. 67 (May 2025)

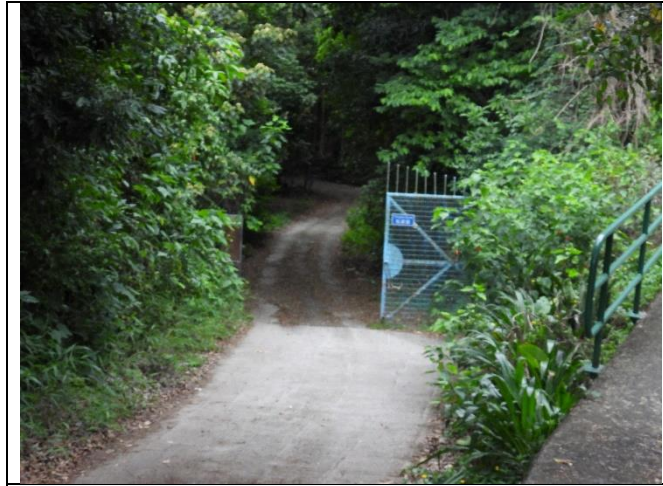
- 9.59 For the monitoring conducted on 20th May 2025 at Transect T5, a section of the transect route was found located within a private property and hence not accessible. The inaccessible part are shown in **Photo 1** below. The adjusted accessible transect route is shown in **Figure 11**.

Photo 1. Inaccessible part of transect T5 located within a private property.

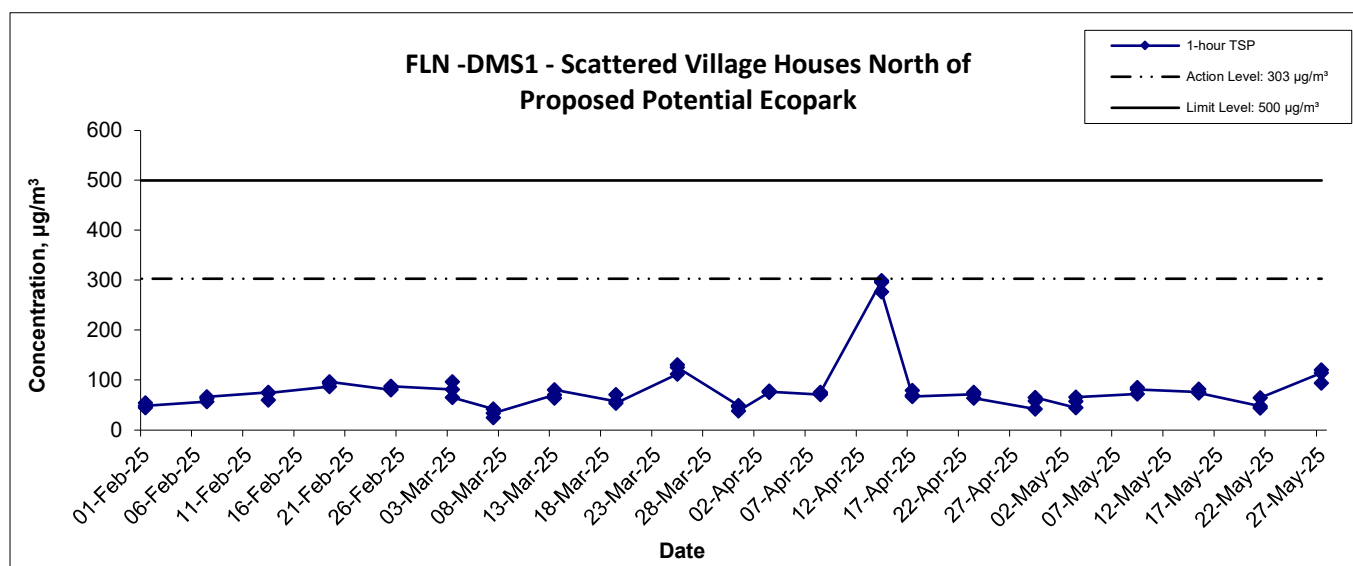
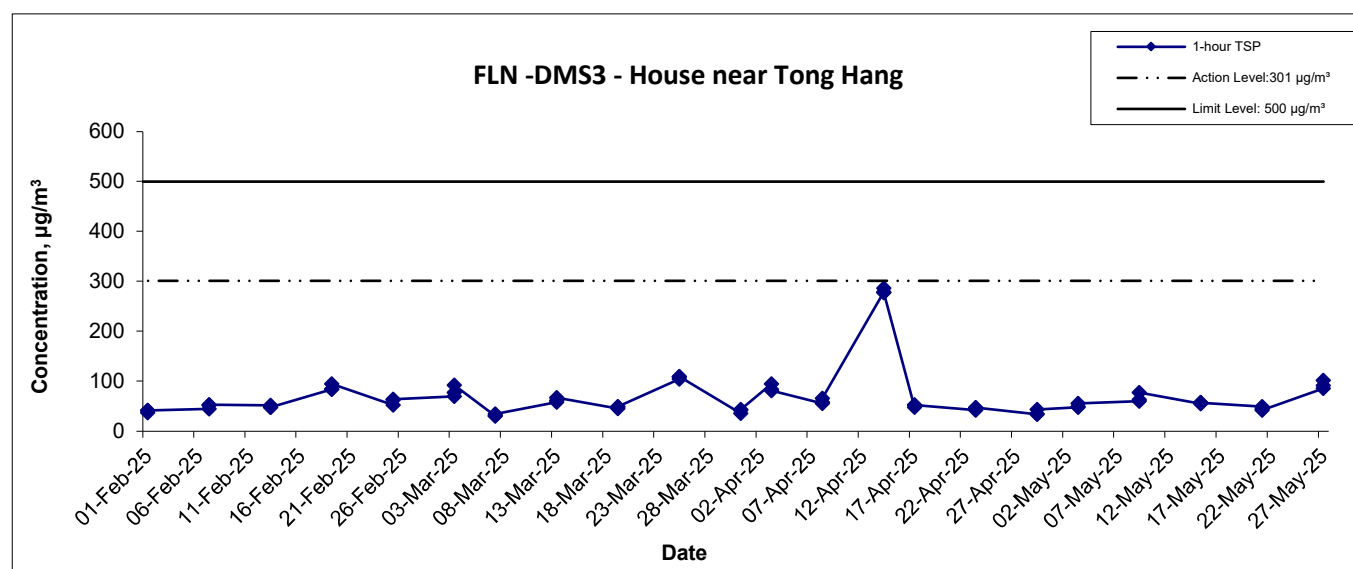
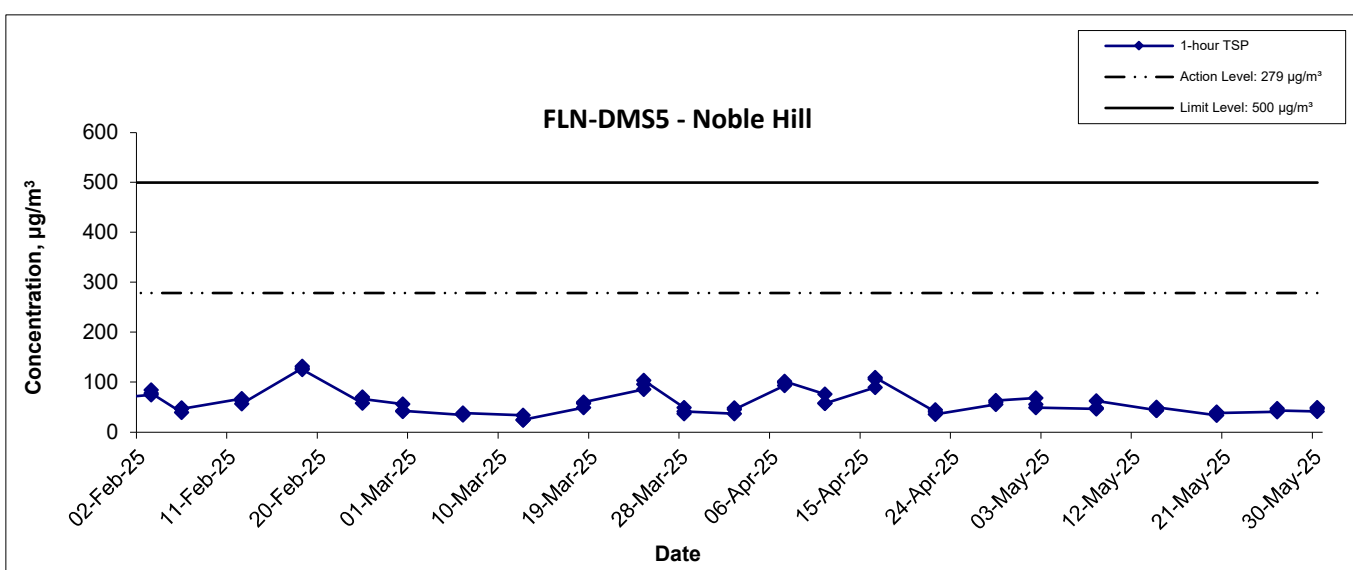
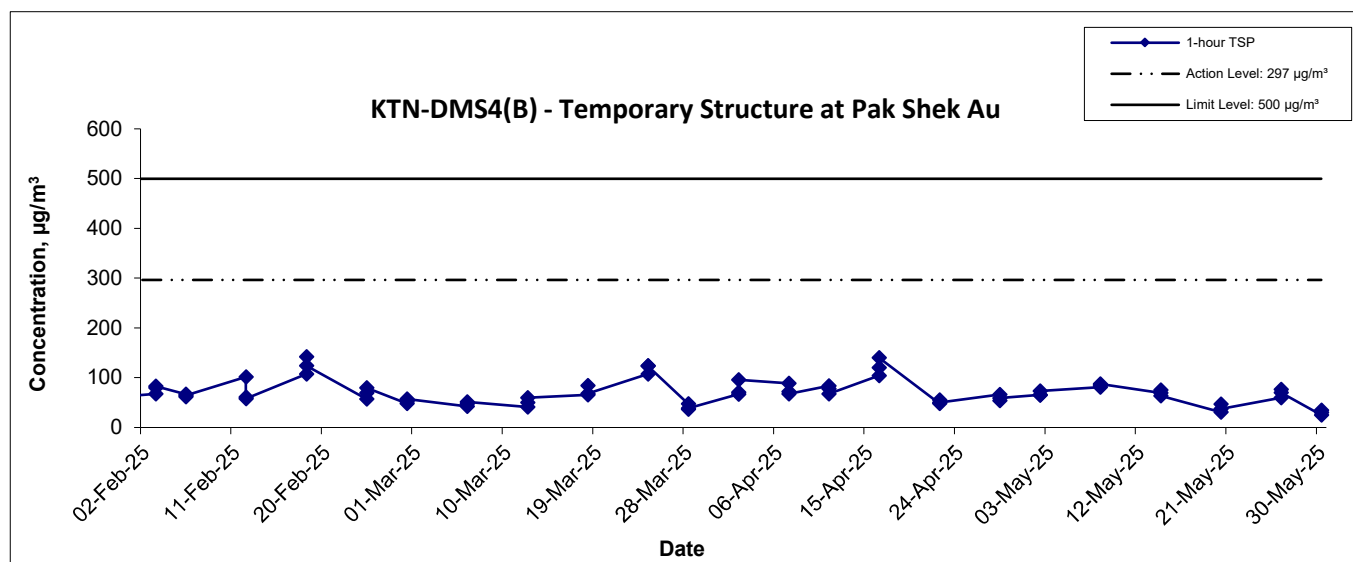
1-hr TSP Concentration Levels

Title	Service Contract No. NDO 04/2019		Scale	Project No.
	Environmental Team for Environmental Monitoring and Audit Works in Construction Phase for the First Phase Development of Kwu Tung North and Fanling North New Development Areas		N.T.S	WMA20002
	Graphical Presentation of 1-hour TSP Monitoring Results		Date	Appendix
			May 25	E

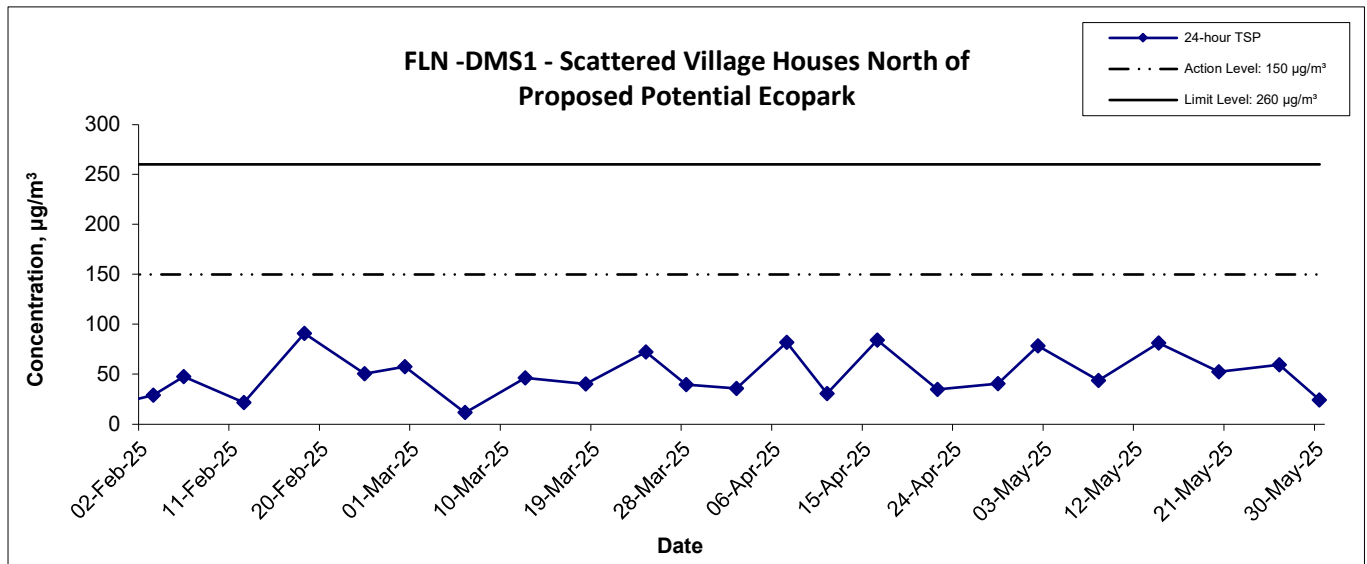
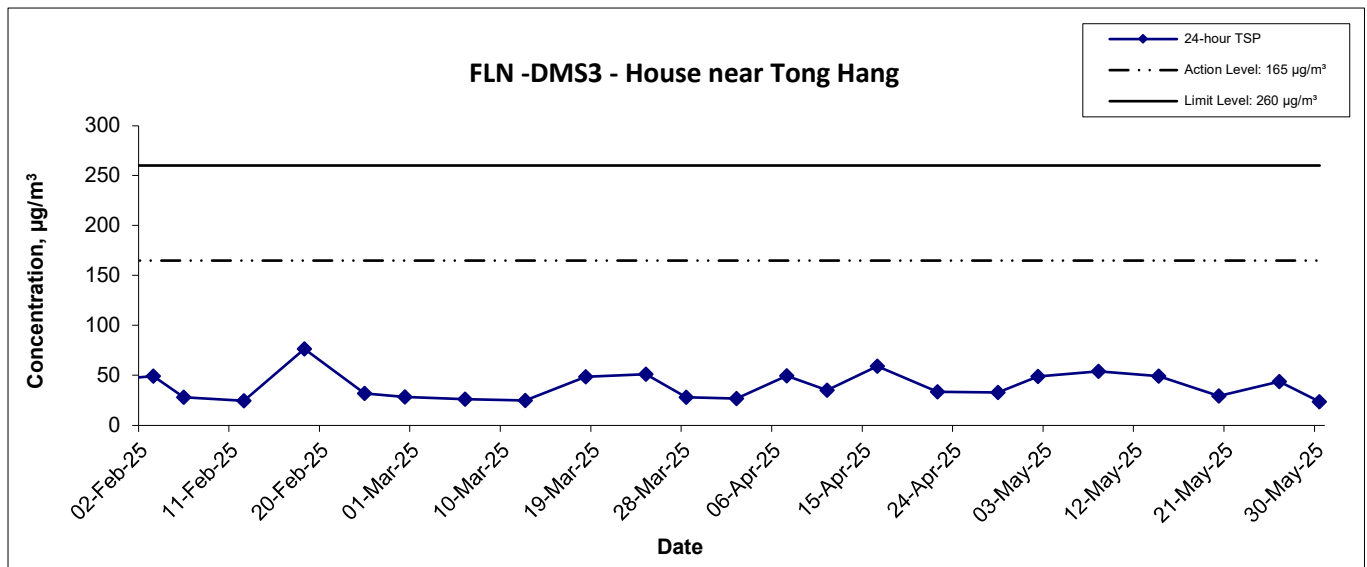
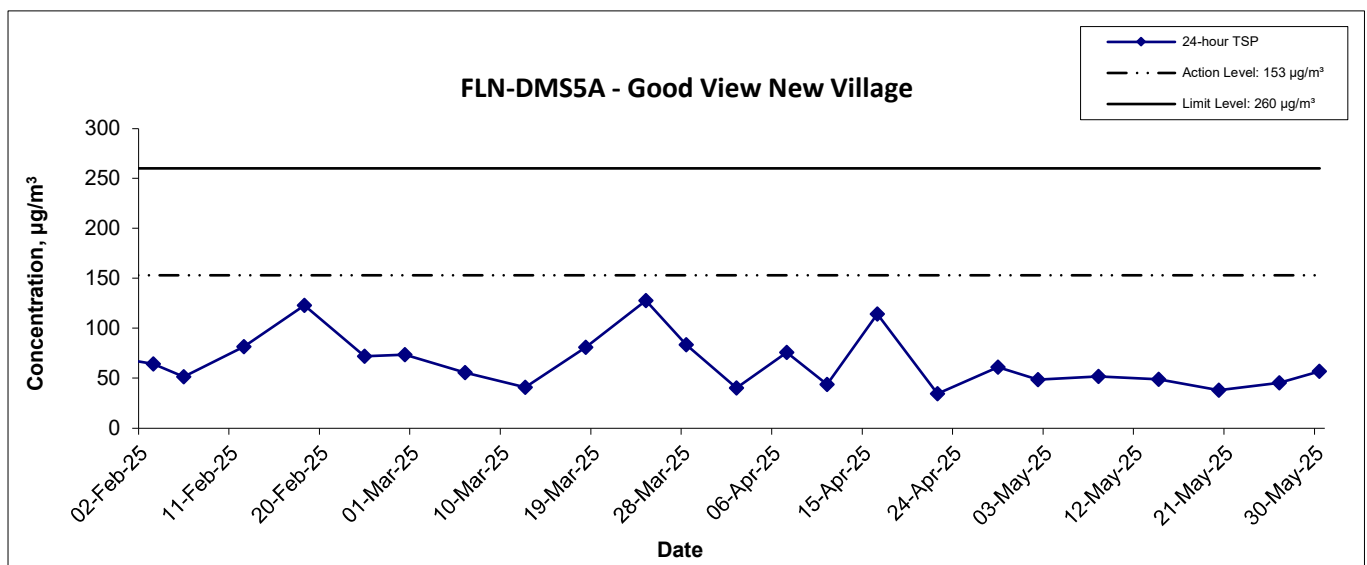
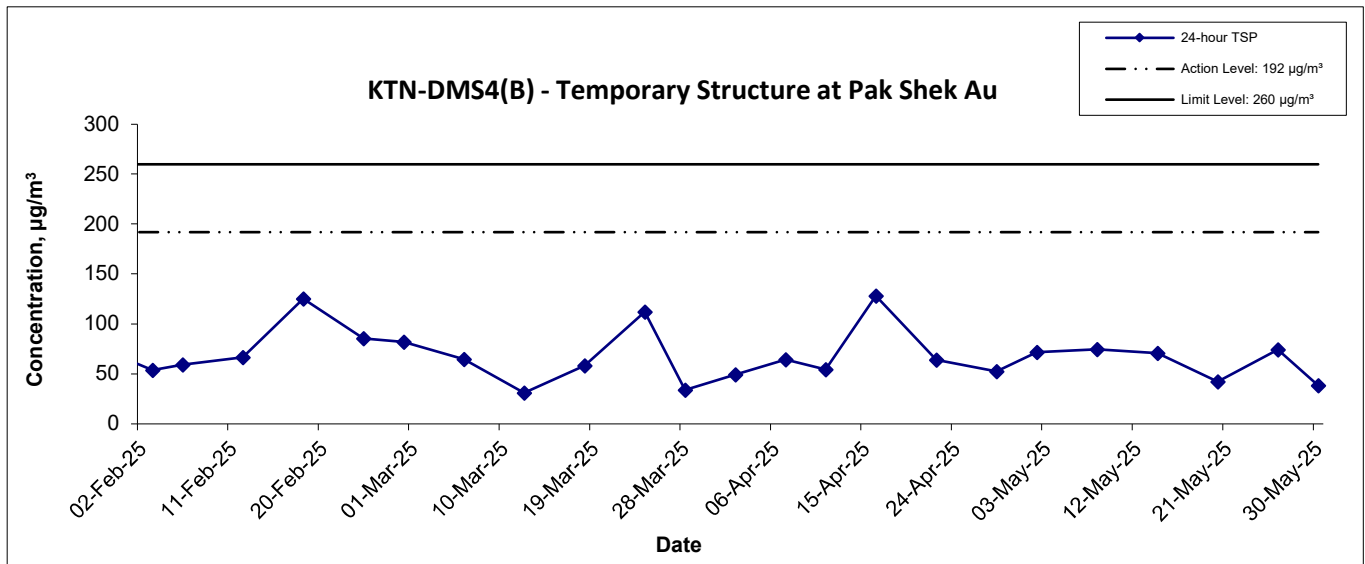
24-hr TSP Concentration Levels

Title	Service Contract No. NDO 04/2019		Scale	Project No.
	Environmental Team for Environmental Monitoring and Audit Works in Construction Phase for the First Phase Development of Kwu Tung North and Fanling North New Development Areas		N.T.S	WMA20002
	Graphical Presentation of 24-hour TSP Monitoring Results		Date	Appendix
			May 25	E

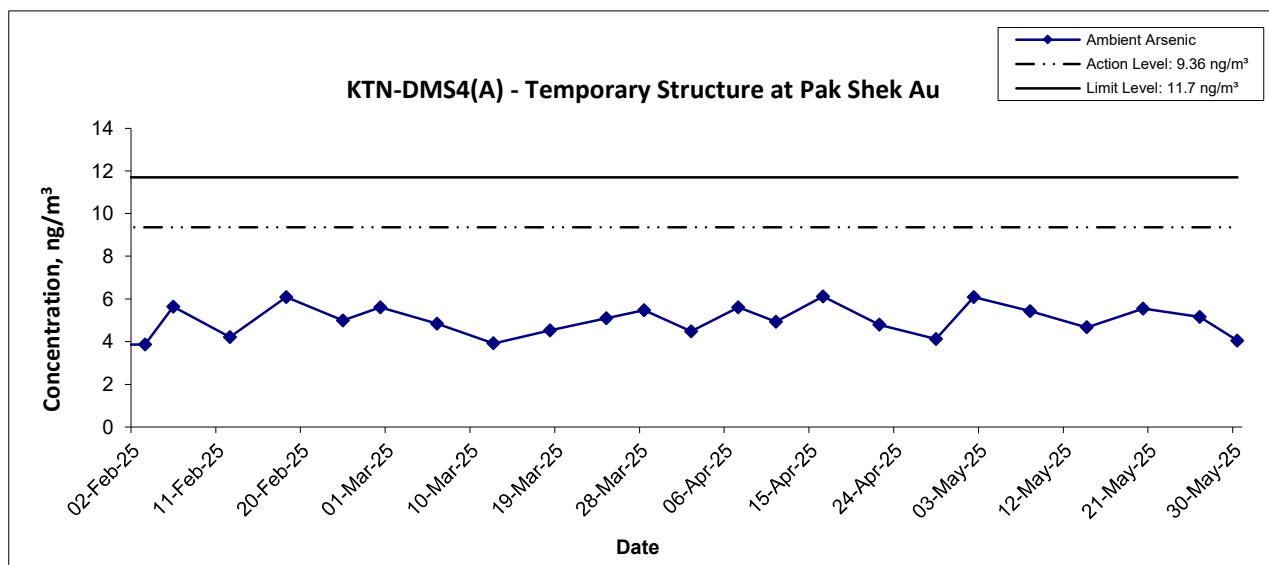
Title Service Contract No. NDO 04/2019 Environmental Team for Environmental Monitoring and Audit Works in Construction Phase for the First Phase Development of Kwu Tung North and Fanling North New Development Areas Graphical Presentation of Ambient Arsenic Monitoring Results	Scale N.T.S	Project No. WMA20002

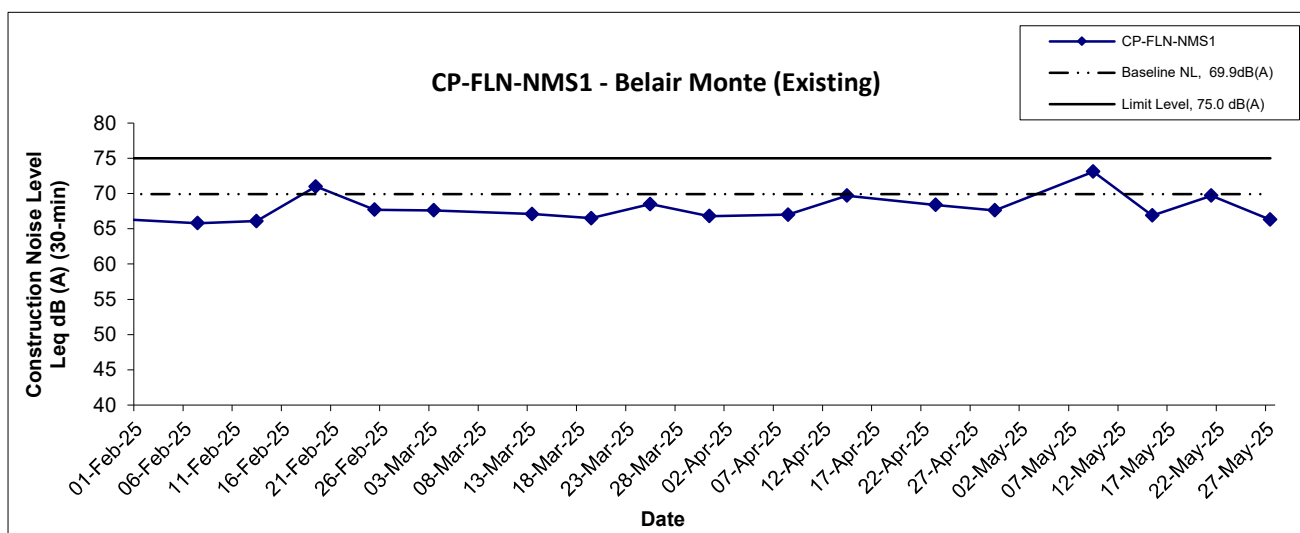
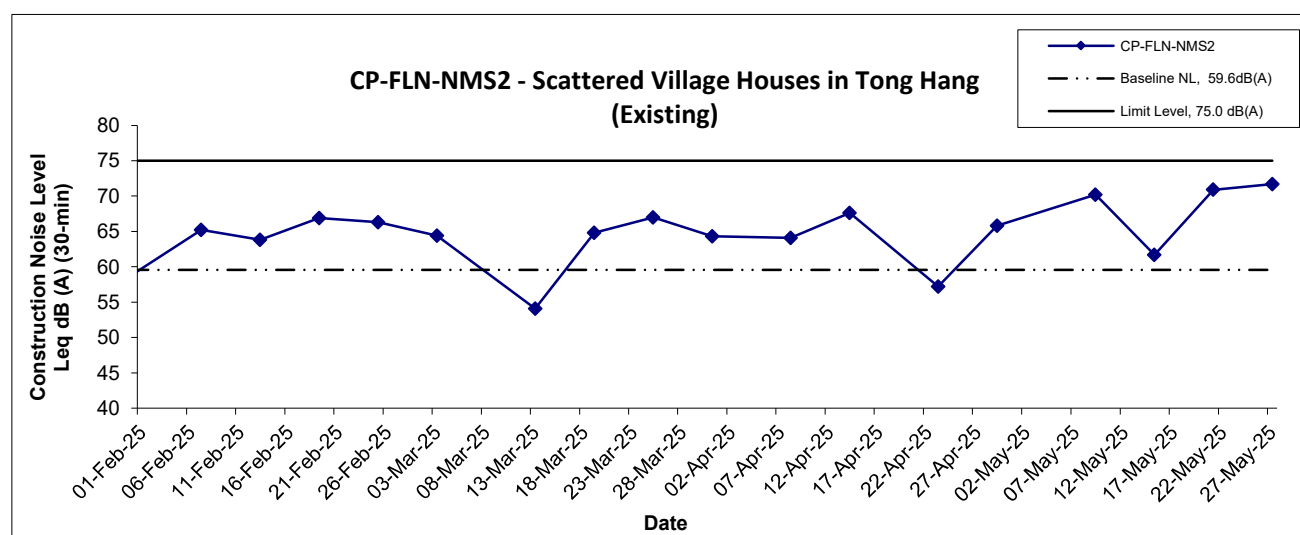
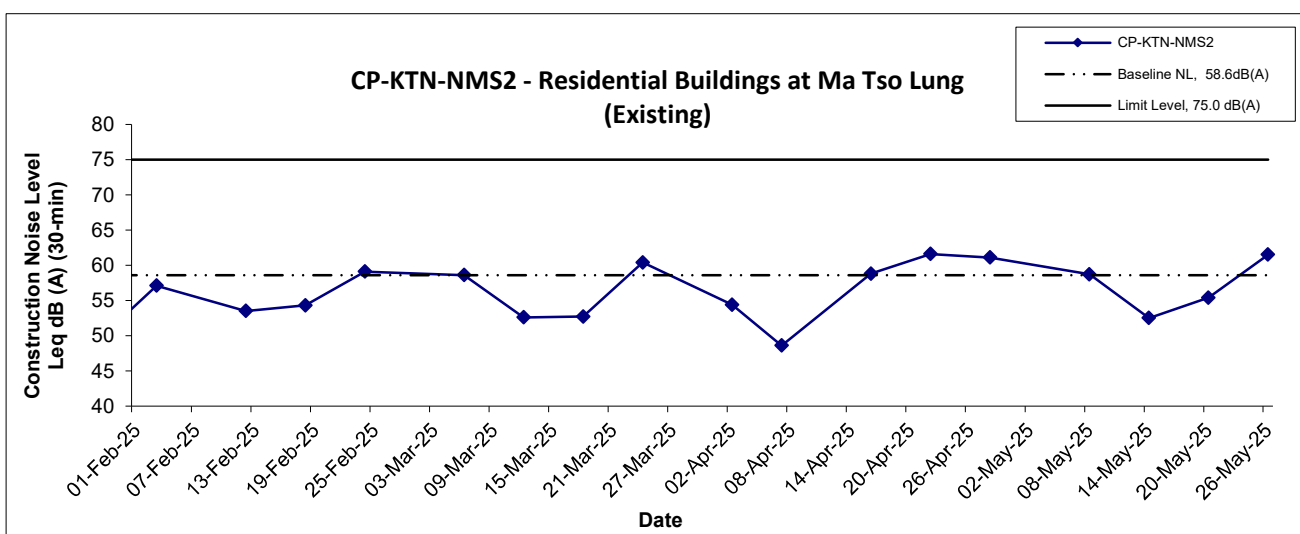
Noise Levels

Title Service Contract No. NDO 04/2019 Environmental Team for Environmental Monitoring and Audit Works in Construction Phase for the First Phase Development of Kwu Tung North and Fanling North New Development Areas Graphical Presentation of Construction Noise Monitoring Results	Scale N.T.S	Project No. WMA20002

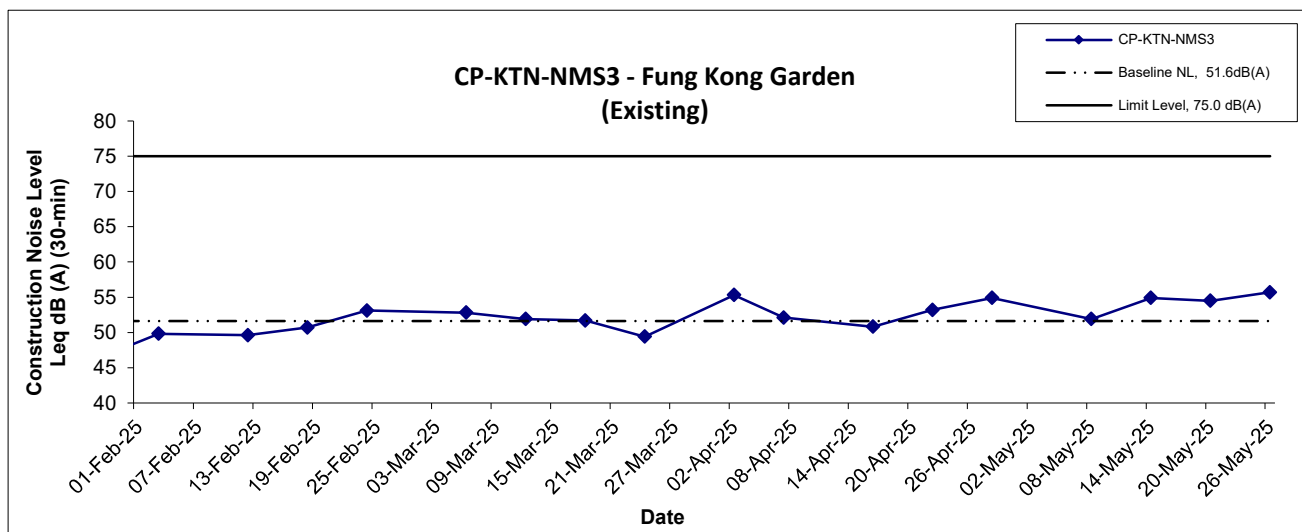
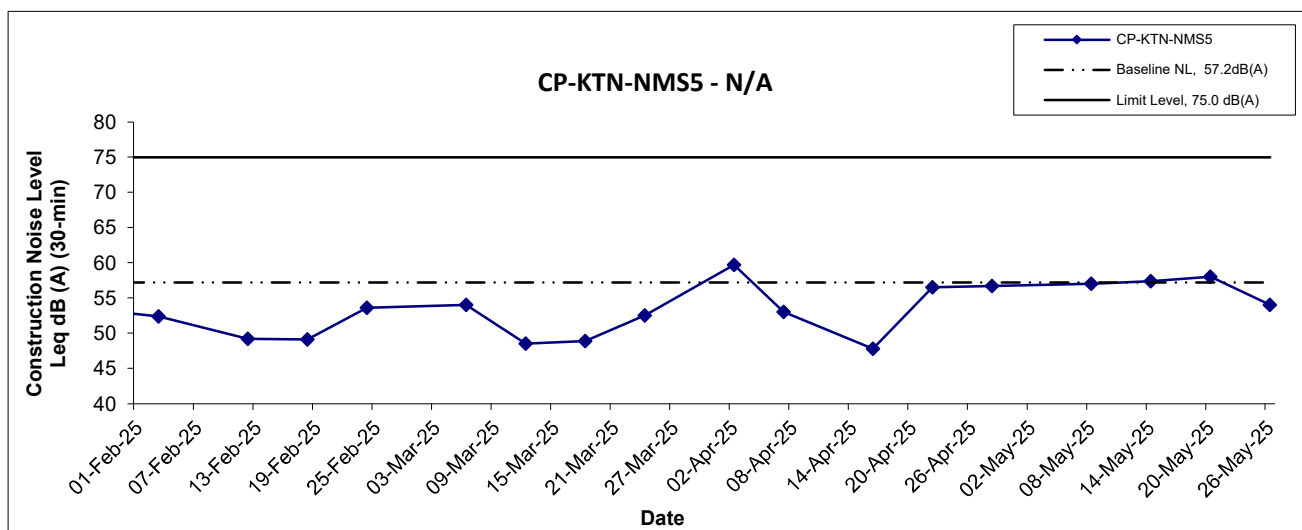
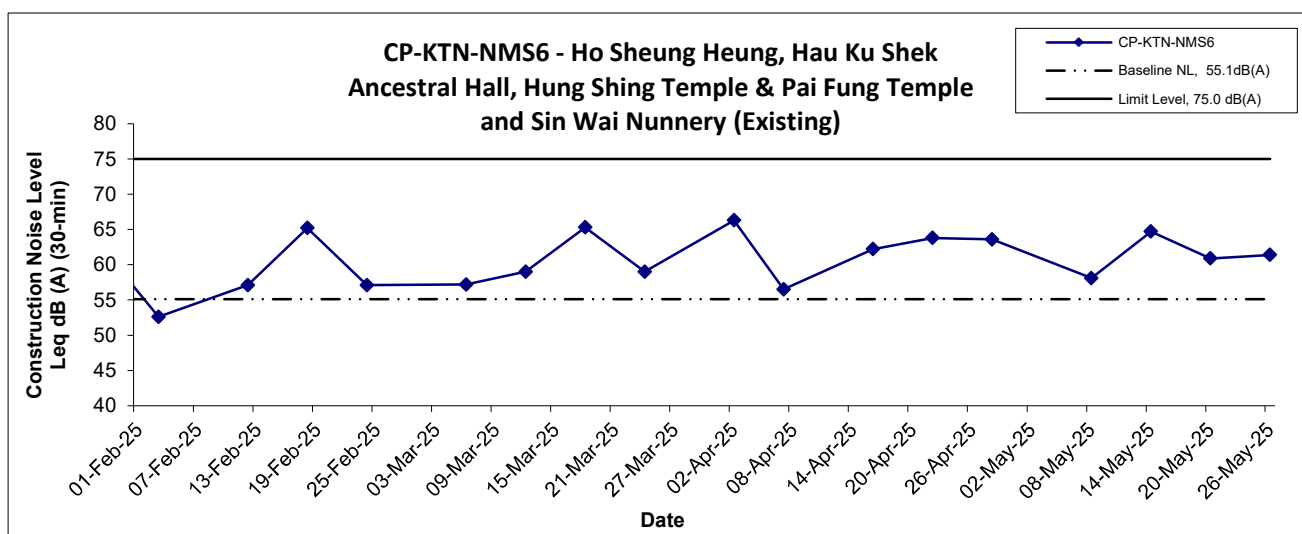
Noise Levels

Title Service Contract No. NDO 04/2019 Environmental Team for Environmental Monitoring and Audit Works in Construction Phase for the First Phase Development of Kwu Tung North and Fanling North New Development Areas Graphical Presentation of Construction Noise Monitoring Results	Scale N.T.S	Project No. WMA20002	
	Date May 25	Appendix F

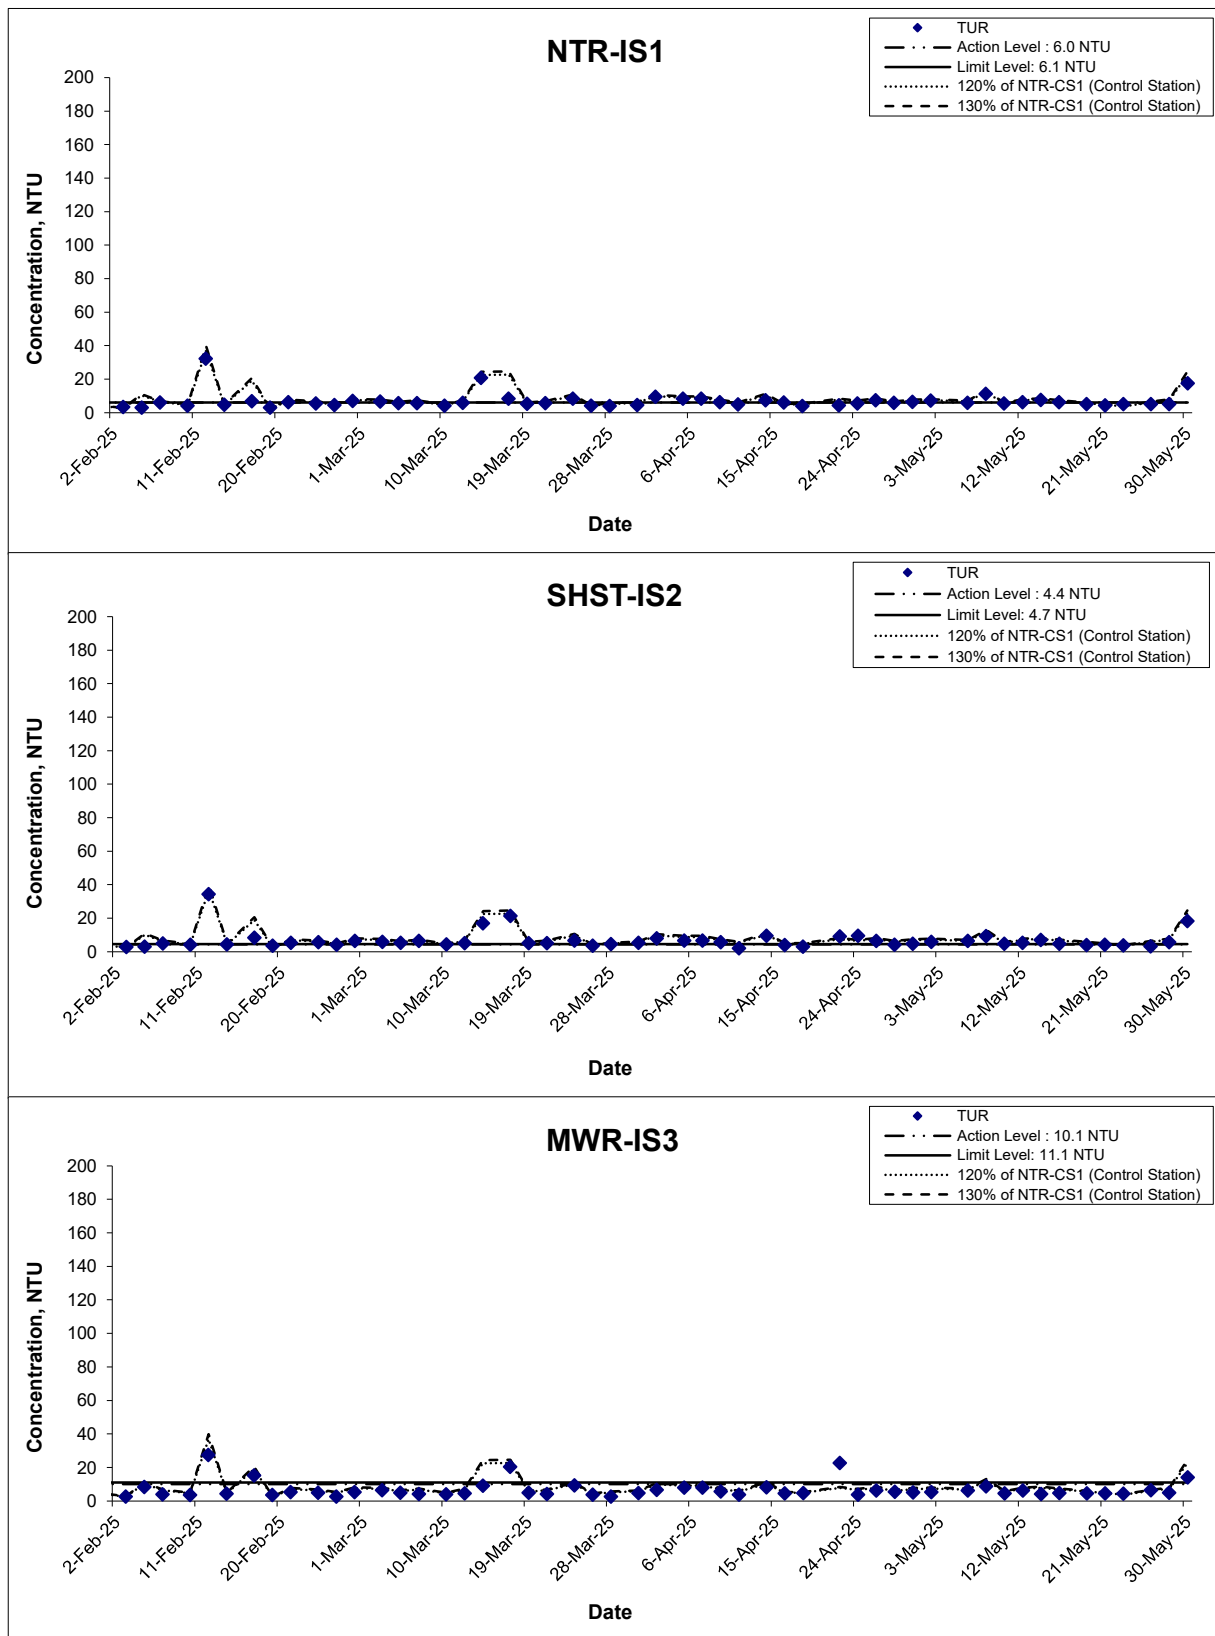
Turbidity (Depth-averaged)

Title Contract No. NDO 04/2019 Advance and First Stage Works of Kwu Tung North and Fanling North New Development Areas Graphical Presentation of Water Quality Monitoring Results	Scale N.T.S	Project No. WMA20002	WELLAB 匯力 consulting . testing . research
	Date May 25	Appendix G

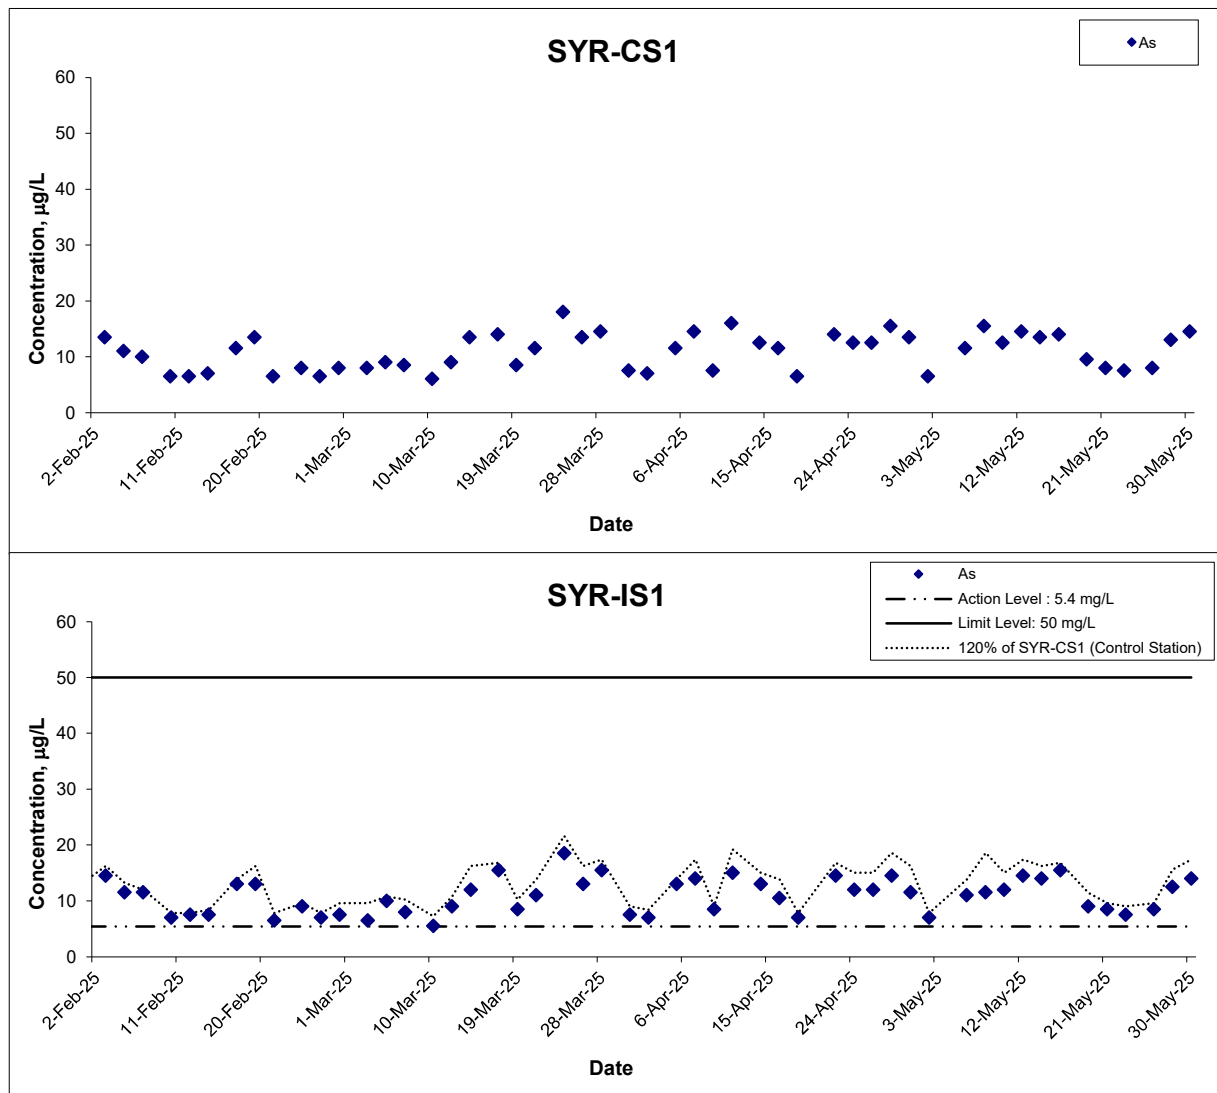
Arsenic (Depth-averaged)

Title	Contract No. NDO 04/2019 Advance and First Stage Works of Kwu Tung North and Fanling North New Development Areas Graphical Presentation of Water Quality Monitoring Results	Scale	N.T.S	Project No.	WMA20002
