Service Contract No. NDO 04/2019 Environmental Team for Environmental Monitoring and Audit Works in Construction Phase for the First Phase Development of Kwu Tung North and Fanling North New Development Areas

Monthly Environmental Monitoring and Audit Report for April 2025

Monthly Environmental Monitoring and Audit Report No. 66 (April 2025)

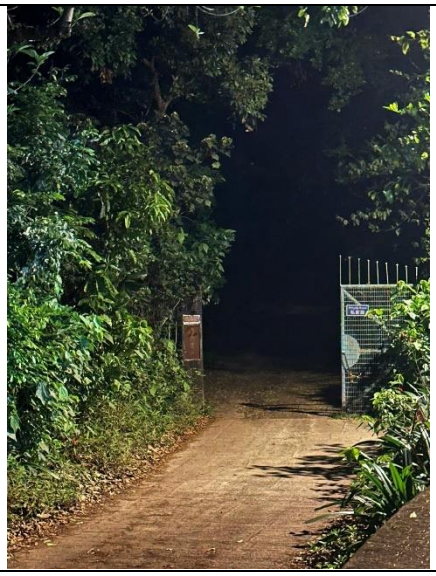
9.59 For the monitoring conducted on 30th April 2025 at Transect T5, a section of the transect route was found located within a private property and hence not accessible. The inaccessible part are shown in **Photo 1** below. The adjusted accessible transect route is shown in **Figure 11**.

Photo 1. Inaccessible part of transect T5 located within a private property.
