Condition Survey Report

ND/2019/05 - Condition Survey for Fanling North New Development Area, Phase 1 Fanling Bypass Eastern Section (Shung Him Tong to Kau Lung Hang)

Reference No.
Prepared for CRCC – Paul Y. Joint Venture
24 July 2020

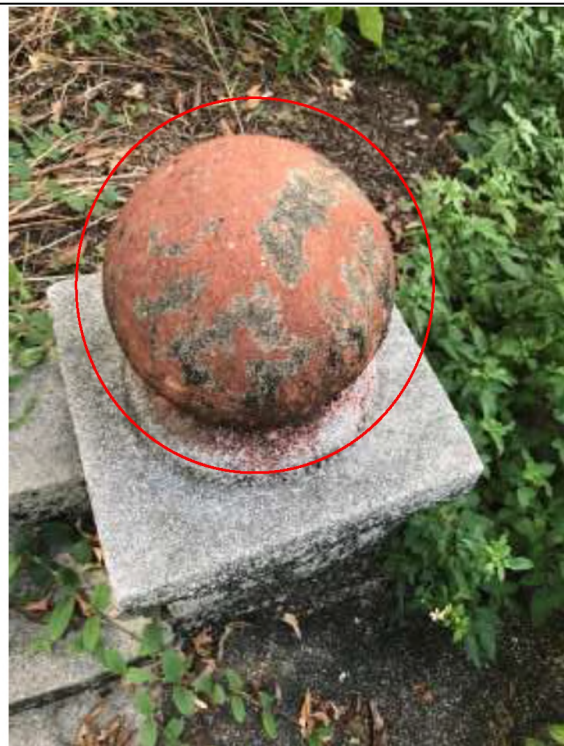
2A-D2(2) – Peeling Paint from Surface
