**Service Contract No. NDO 04/2019  
Environmental Team for Environmental  
Monitoring and Audit Works in  
Construction Phase for the First Phase  
Development of Kwu Tung North and  
Fanling North New Development Areas**

**Monthly Environmental Monitoring and  
Audit Report for April 2020**

**Monthly Environmental Monitoring and Audit Report No. 6 (April 2020)**

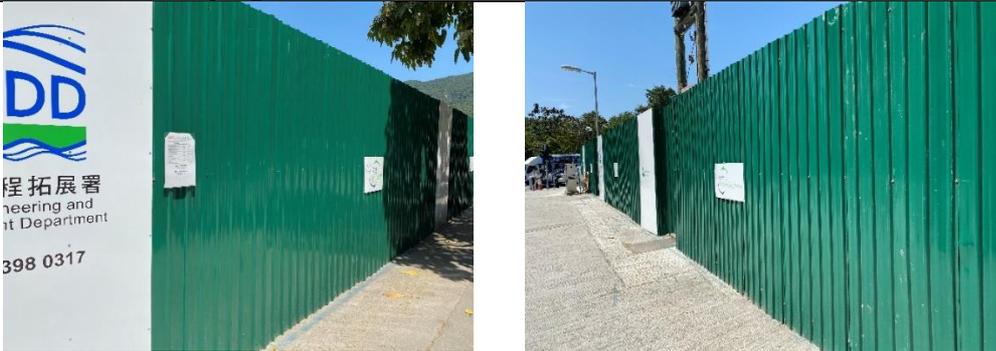
**Table 4.2 Photographic Records of Measures**

<p><b>Environmental Permit No. EP-475/2013/A Condition 2.7</b></p> <p>To minimise adverse impacts on habitats of ecological importance in the vicinity of the Project, 2m high solid dull green site barrier fences have be erected around all active works areas</p>

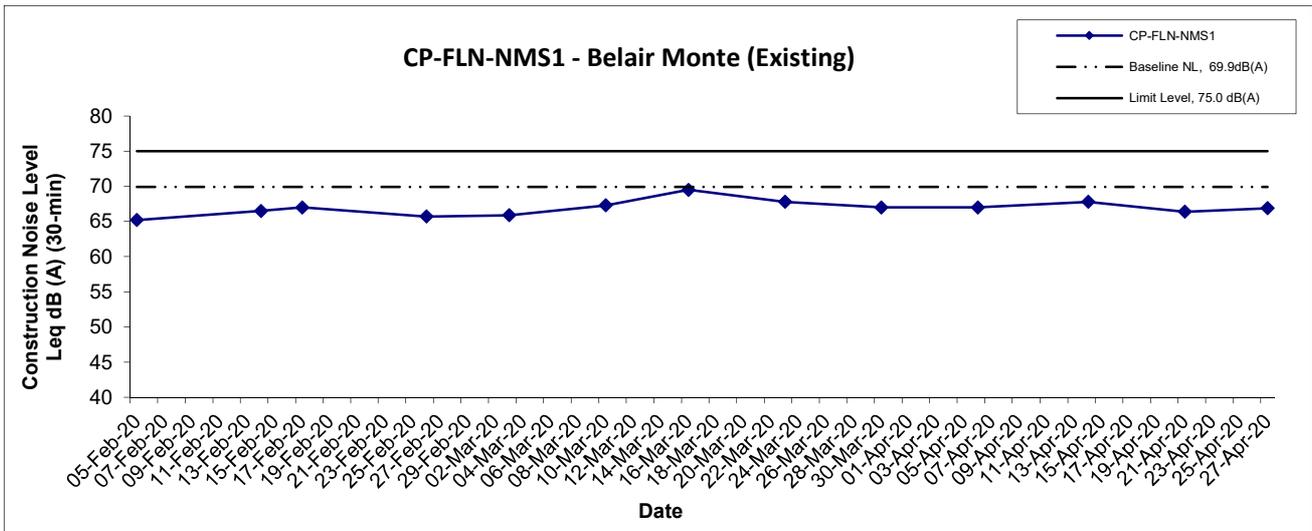
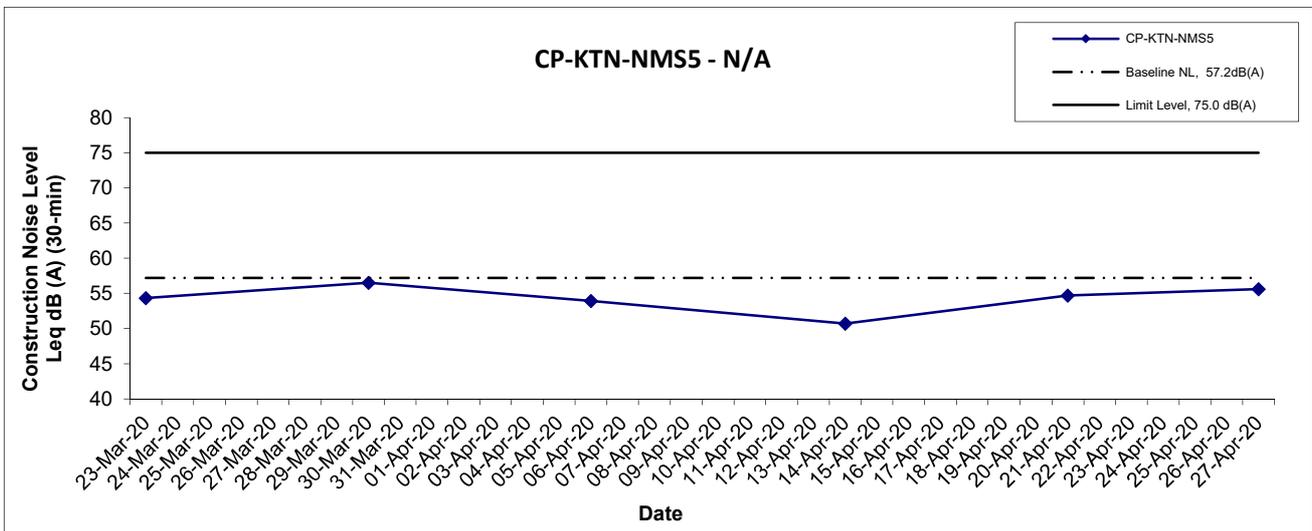
Title CEDD NDO 042019 ET Construction 1 Ph Dev Kwu Tung Fanling North Graphical Presentation of Construction Noise Monitoring Results	Scale N.T.S	Project No. WMA20002	
	Date Apr 20	Appendix E
