**Service Contract No. NDO 04/2019  
Environmental Team for Environmental  
Monitoring and Audit Works in  
Construction Phase for the First Phase  
Development of Kwu Tung North and  
Fanling North New Development Areas**

**Monthly Environmental Monitoring and  
Audit Report for May 2020**

**Monthly Environmental Monitoring and Audit Report No. 7 (May 2020)**

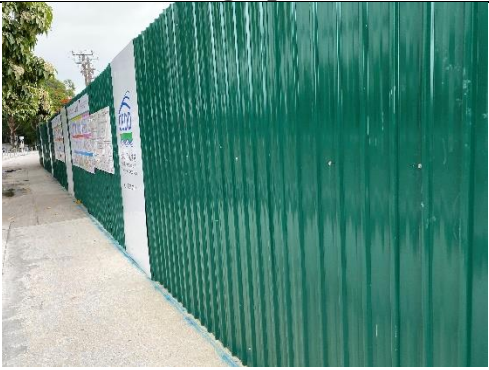
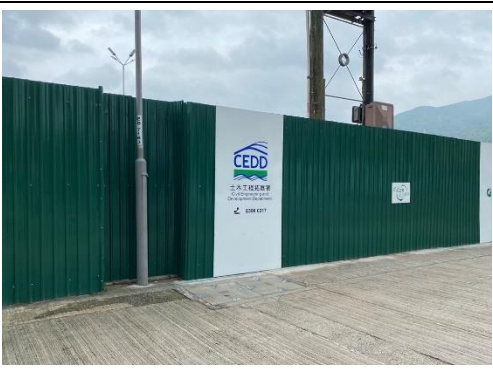
**Table 5.2 Photographic Records of Measures**

<p><b><u>Environmental Permit No. EP-475/2013/A Condition 2.7</u></b> To minimise adverse impacts on habitats of ecological importance in the vicinity of the Project, 2m high solid dull green site barrier fences have be erected around all active works areas</p>
