Condition Survey Report

ND/2019/05 - Condition Survey for Fanling North New Development Area, Phase 1 Fanling Bypass Eastern Section (Shung Him Tong to Kau Lung Hang)

Reference No.
Prepared for CRCC – Paul Y. Joint Venture
24 July 2020

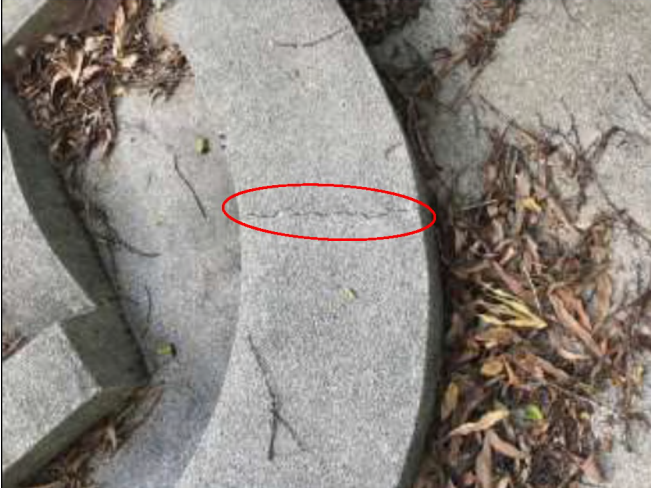
2A-D5(1) - Moderate Crack on Surface (General View)	2A-D5(2) - Moderate Crack on Surface (Length:250mm/Width:1.20mm)

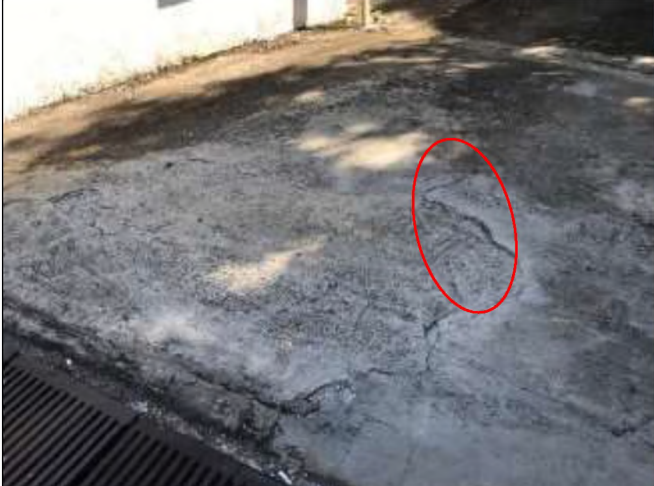
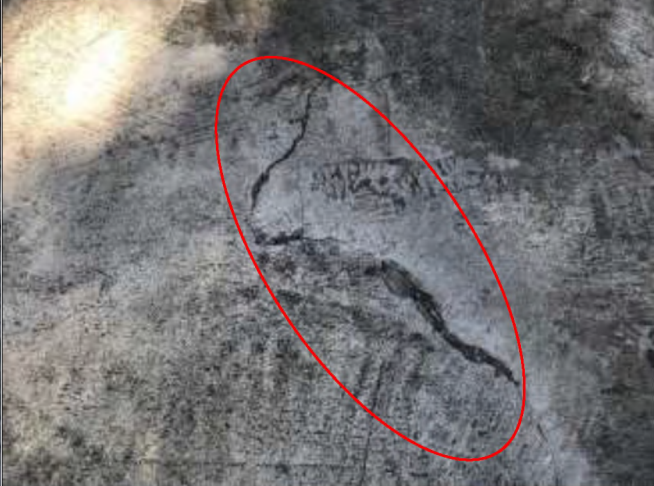
<p>4A-D1(1) - Wide Crack on Floor (General View)</p>	<p>4A-D1(2) - Wide Crack on Floor (Length:150mm/Width:5.00mm)</p>

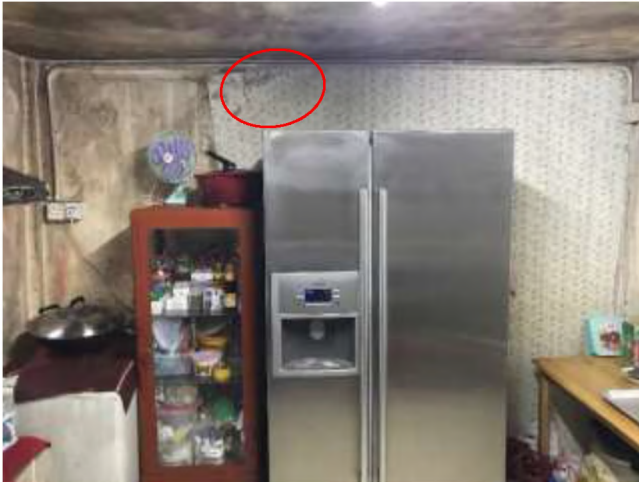
<p>5A3-D3(2) – Wide Crack on Wall (General View)</p>	<p>5A3-D3(2) – Wide Crack on Wall (Length:600mm/Width:3.00mm)</p>

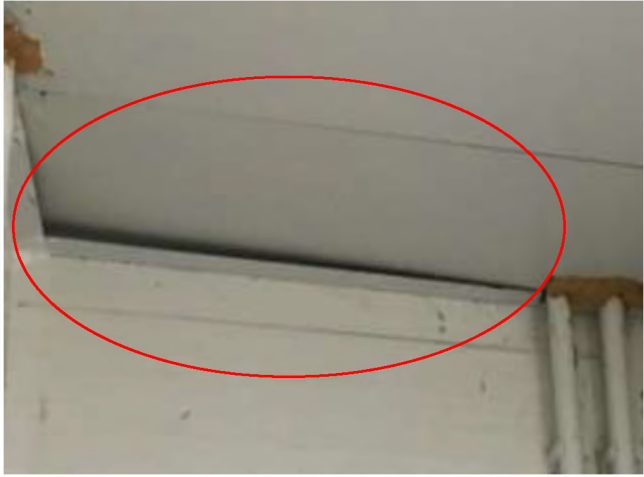
A close-up photograph of the dislodged ceiling panel. A red oval highlights the gap between the panel and the ceiling structure, showing the extent of the damage.
<p>5A4-D1(1) – Dislodged false ceiling (General View)</p>	<p>5A4-D1(2) – Dislodged false ceiling</p>

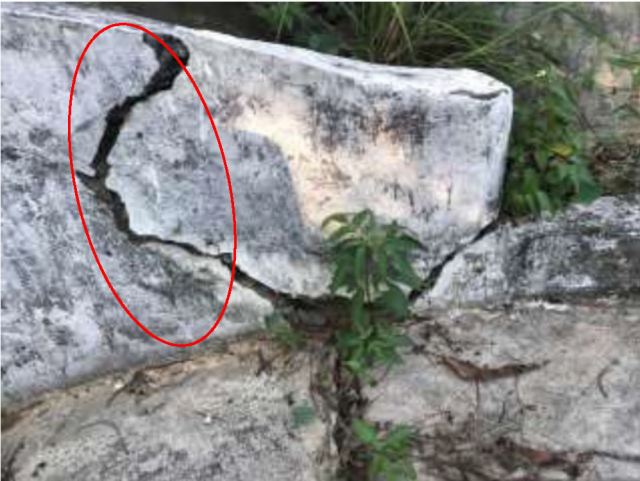
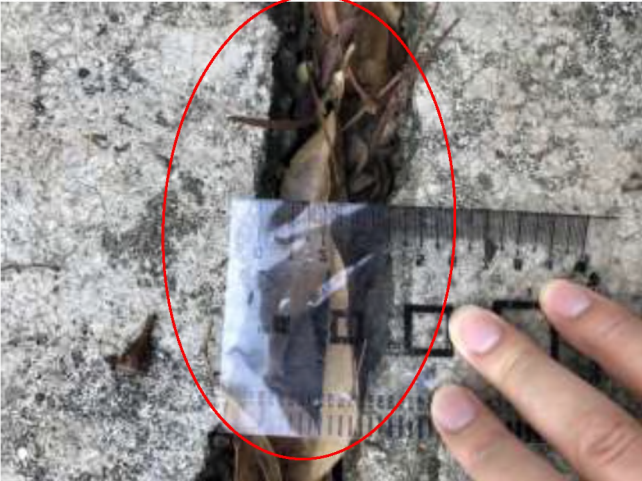
<p>6A-D1(1) - Wide Crack on Grave (General View)</p>	<p>6A-D1(2) - Wide Crack on Grave (Length:500mm/Width:45.00mm)</p>
